Bore Disruption: An Unusual Mechanical Failure of Two Hip Hemiarthroplasties

Joints 2017;5:51–56.

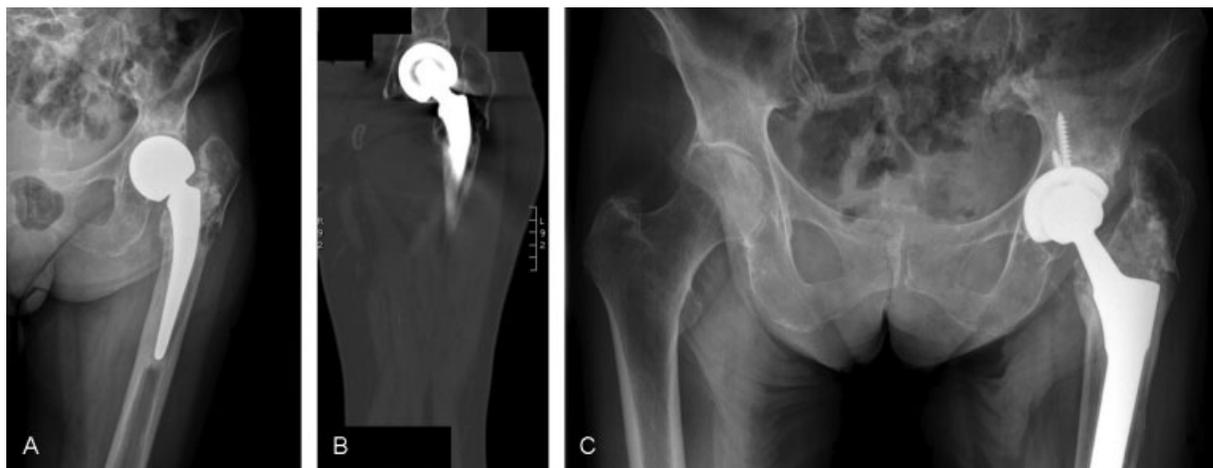
First case was of a 67-year-old woman affected by hypertension and a non-Hodgkin lymphoma, who was referred to our observation in 2008. She was plainly active at the time of trauma. The patient was affected by a femoral neck fracture, secondary to a lymphoma localization. An Ellittica (Samo, Bologna, Italy) cemented HA was implanted (47-mm head, M stem). After surgery, the patient returned to her normal life. She came back to our observation 5 years later, in 2013, for an atraumatic hip pain at the same hip. She was first evaluated in the emergency department, where a plain radiograph was performed. At a first sight, the diagnosis was not clear, and a computed tomography (CT) scan was requested. Observing the CT images, a dislocation inside the head of the neck and Morse taper of the stem was detected, and a prosthesis failure was diagnosed.

Fig. 1 Case 1. (A) Preoperative X-ray and (B) computed tomography scan of broken hemiarthroplasty. (C) Postoperative X-ray of conversion to total hip arthroplasty.

The HA was revised to a total hip arthroplasty (Wagner SL Stem with Trilogy cup, Zimmer Inc., Warsaw, Indiana, United States) (▶ Fig. 1). After surgery, the patient returned

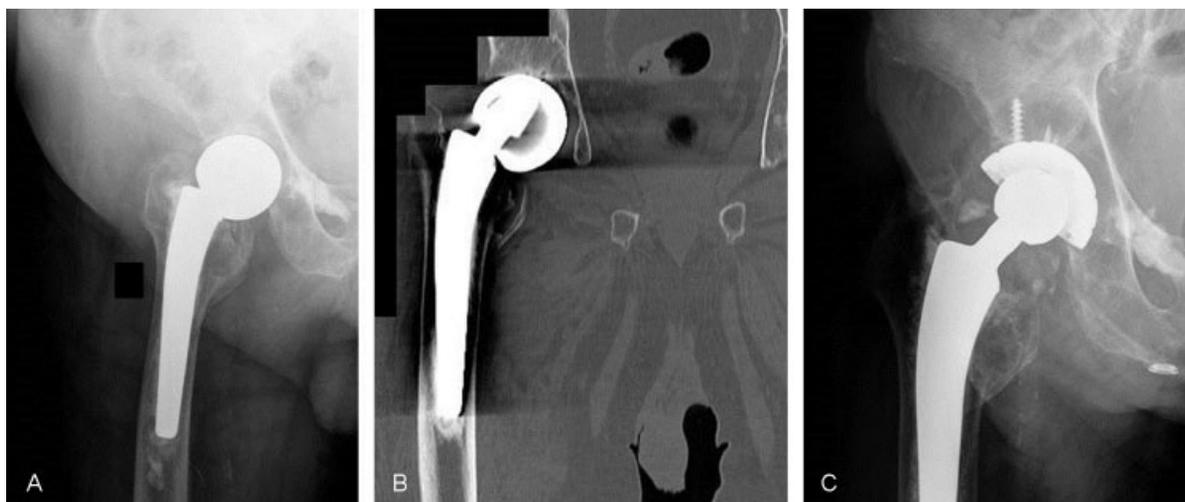
The second case was of an 80-year-old man affected by atrial fibrillation, non-Hodgkin lymphoma, and chronic renal insufficiency. He referred to our emergency department for a femoral neck fracture in 2003. Prior to the fracture, the patient was active, with complete deambulatory autonomy, and reported jogging twice a week. An Ellittica-cemented HA (Samo, Bologna, Italy) was implanted (51-mm head, XL stem). After surgery, the patient returned to his normal life, including sports. In 2010, he felt a sudden pain in the hip while walking and then referred to our emergency department. A plain radiograph was performed. A shortening of the stem neck was clearly detected; therefore, a CT scan was requested. The migration of the neck of the HA inside the head was clearly visible, and a breakage of the head cone was diagnosed.

Fig. 2 Case 2. (A) Preoperative X-ray and (B) computed tomography scan of broken hemiarthroplasty. (C) Postoperative X-ray of conversion to total hip arthroplasty.

The HA was converted to a total hip arthroplasty (THA), implanting an ABG cup (Stryker, Kalamazoo, Michigan, United States) (56 mm) with a polyethylene inlay, leaving the implanted stem and replacing the broken head with a ceramic head (Samo, Bologna, Italy) (► **Fig. 2**).

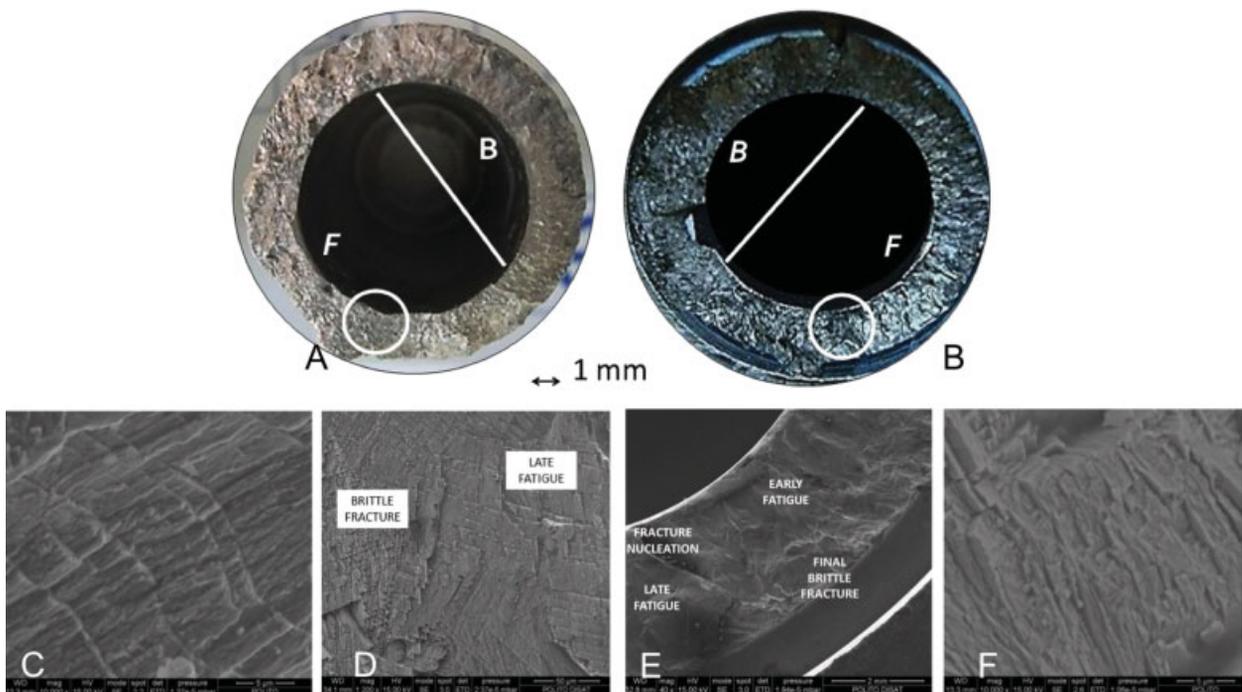
The fracture surfaces of case 1 were two annuli, with an inner diameter of 8 mm and an external diameter of 12 mm.

It was possible to observe only a single site of initiation of the fatigue fracture, with no morphological or microstructural defect near the initiation site. More than half of the fracture surface was due to a mechanism of fatigue, whereas the other half corresponded to final fracture. The mechanism of fracture observed was the so-called transgranular and not intergranular pattern. Striations appeared as relatively evenly spaced parallel lines; this pattern of fracture is often present on fatigue fracture surfaces of cobalt alloys. Each striation actually represents a shallow crack resulting from a single stress cycle of approximately 5 microns. Some zones with evidences of final fracture were observed only near the outer edge of the fracture surfaces with the presence of a lot of cleavage planes, in different directions on the different crystals, suggesting that final fracture occurs with a brittle mechanism. To check the chemical composition of the metal alloy of the prosthesis, an energy dispersive spectroscopy (EDS) analysis was performed: cobalt, chromium, and molybdenum have been identified in the ratios required for the cobalt-alloy 66Co-28Cr-6Mo (ASTM F 1537), declared by the manufacturer, without any trace of contamination (►Fig. 3).

Fig. 3 Scanning electron microscopy analysis of case 1. (A) Bore section. (B) Head side. “F” stands for “fatigue fracture” and “B” stands for “brittle fracture.” The circles correspond to the nucleation site of the fracture. (C) A magnification of the late fatigue zone on the bore. (D) A magnification of the transition area between the late fatigue and final brittle zone on the bore. (E) An overview of the nucleation site of the fracture on the head. (F) A magnification of the early fatigue zone on the head.

It can be stated that the failure of the prosthesis in case 1 has occurred for a high number of fatigue cycles. The appearance of the fracture surface of case 2 is consistent with the presence of a torsional stress and two initiation points. The second initiation point showed a macroscopic lateral groove that originated from mechanical processing by a tool. The defect, resulting from machining, was a stress concentration factor, critical for the initiation and propagation of the fracture. A responsibility of the machining

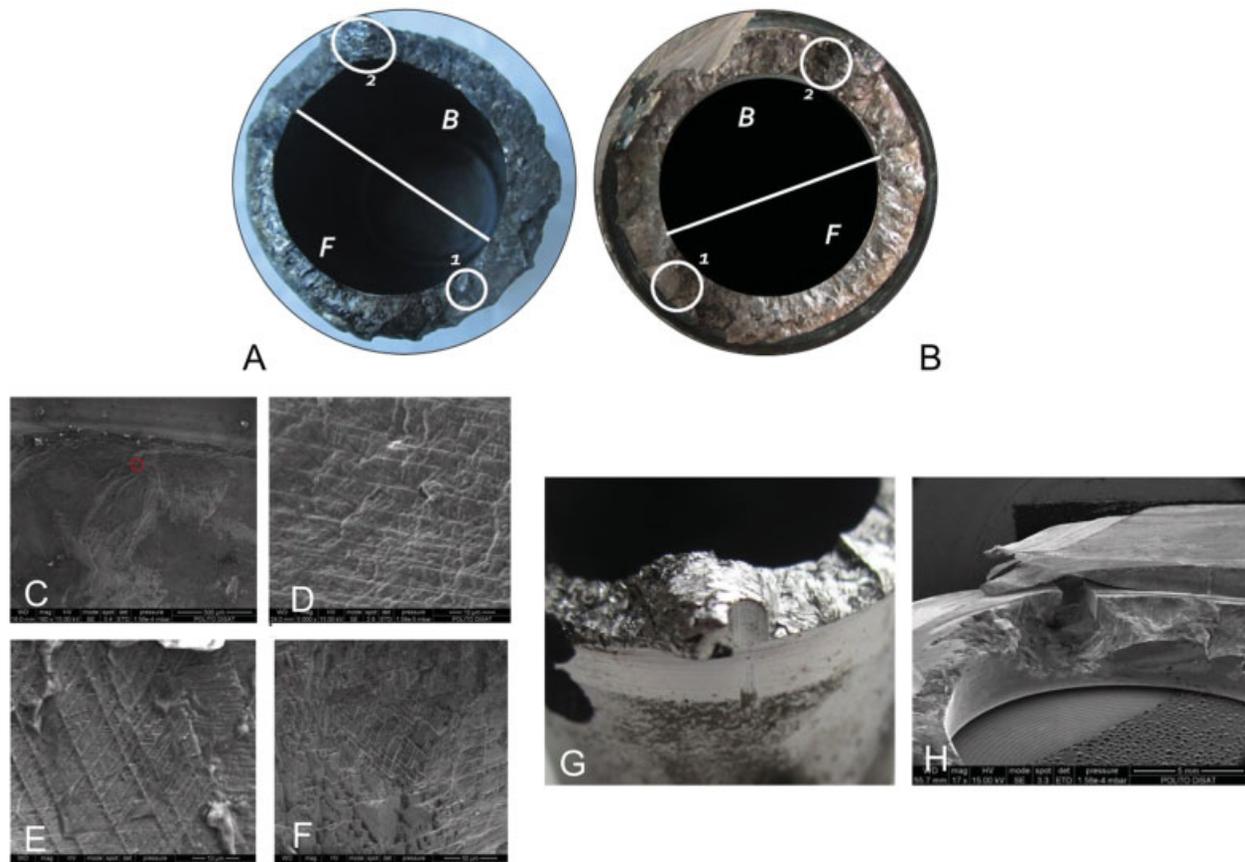
In case 2, the mechanism of fracture was transgranular, similarly to that noticed in case 1. Unlikely case 1, two initiation points of the fracture were identified, located on the outer edge of the samples, at approximately 180 degrees one from the other. The second initiation point (the most interesting) was identified in correspondence of an evident cavity in the fracture surface of the femoral head and in a protuberance of the fracture surface of the head cone. Moving radially from the outer edge (first initiation point) toward the center of the prosthesis, the propagation appeared

initially slow and then increasingly faster until the inner edge, where the final part of the fracture occurred, with wrinkled and uneven structure (brittle fracture). The difference observed between the two cases was a widespread presence of fatigue striations in multiple directions in case 2, according to the presence of two crack initiation points. Observing the second initiation point at a low magnification, a macroscopic lateral groove was noted. This groove came from mechanical processing by a tool, as shown by the regular streaks on its inner surface. Around this initiation, the fatigue fracture propagation was quite limited and evolved rapidly into final fracture. It can be concluded that the defect, resulting from machining, was a stress concentration factor, critical for the initiation and propagation of the fracture. Even in this case, the EDS chemical analysis did not record either contamination or relief or significant chemical differences in respect to the declared chemical composition (►Fig. 4).

Fig. 4 Scanning electron microscopy analysis of case 2. (A) Bore section. (B) Head side. “F” stands for “fatigue fracture” and “B” stands for “brittle fracture.” The circles correspond to the nucleation site of the fracture. (C) An overview of the nucleation site of the fracture on the head. (D) A magnification of early fatigue zone on the head. (E) A magnification of the late fatigue zone with striations in multiple directions. (F) A magnification of the final brittle fracture on the head. (G,H) macroscopic images of the fracture surfaces of the prosthesis, near point 2 of initiation of the fracture: a later groove can be seen on both the stem seat and the femoral head.
