**Terrestrial Photogrammetry and Numerical Modelling for the Stability Analysis of Rock Slopes in High Mountain Areas: Aiguilles Marbrées case**

## Terrestrial photogrammetry and numerical modelling for the stability analysis of rock slopes in high mountains: the case of Aiguilles Marbrées

The methodology has been applied in a case study, the North Face of Aiguilles Marbrées in the Mont Blanc massif, which suffers from frequent instability phenomena. A slope failure, which occurred in 2007, has been back-analysed using both, the Limit Equilibrium Method (LEM) and 3D Distinct Element Modelling (DEM). The method has been supported and validated with traditional in situ surveys and measurements of the discontinuity orientation and other rock mass features.

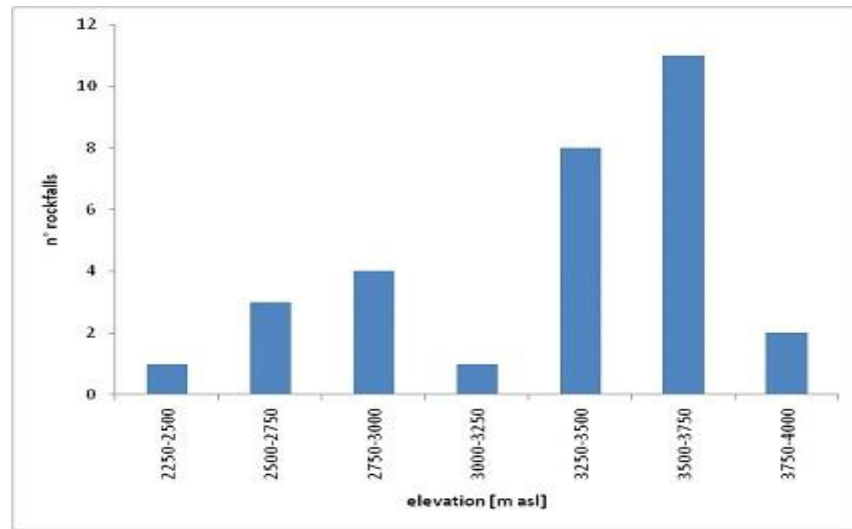
Figure 1. Rock fall events recorded in the Aosta Valley (Italy) between 2006 and 2009 (CENSI\_CRO final report, 2009).

collated by alpine guides. The work, which began in 2006 with UE founding, involved France and Switzerland (CENSI CRO) (Figure 1) and revealed results that are in agreement with Ravel and Deline's (2011) data.

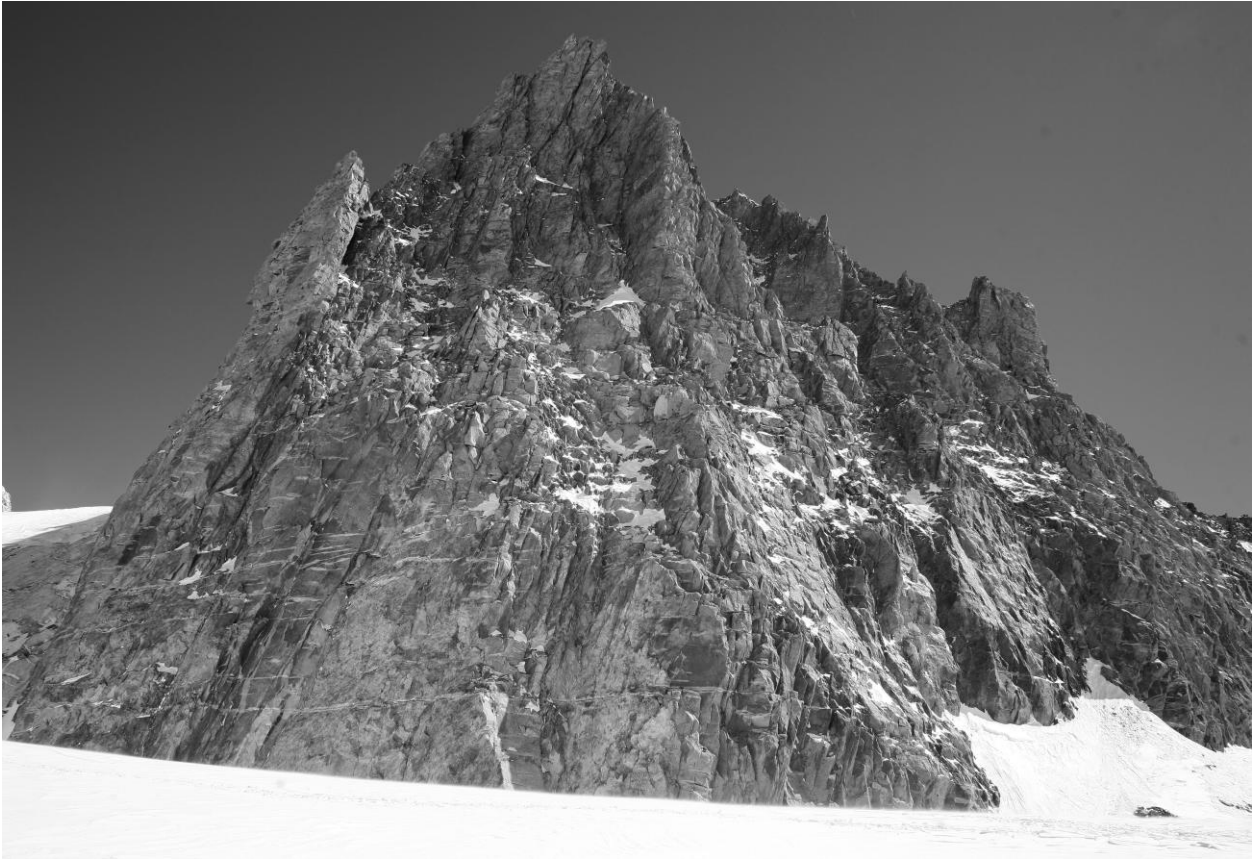
Figure 2. The Aiguilles Marbrées N and W faces.

33  
34 From a structural and geomechanical point of view, Aiguilles Marbrées can be separated into three  
35 principal domains (Figure 2). The results presented in this paper are based on the analysis of domain 3,  
36 where instabilities concentrate but can be applied to the whole slope because it shows a similar rock  
37 mass structure. Therefore, this study could easily be extended to the entire Aiguilles Marbrées in the  
38 future.  
39  
40  
41  
42  
43  
44  
45  
46  
47  
48  
49  
50  
51  
52  
53  
54  
55  
56  
57  
58  
59  
60  
61  
62  
63  
64  
65

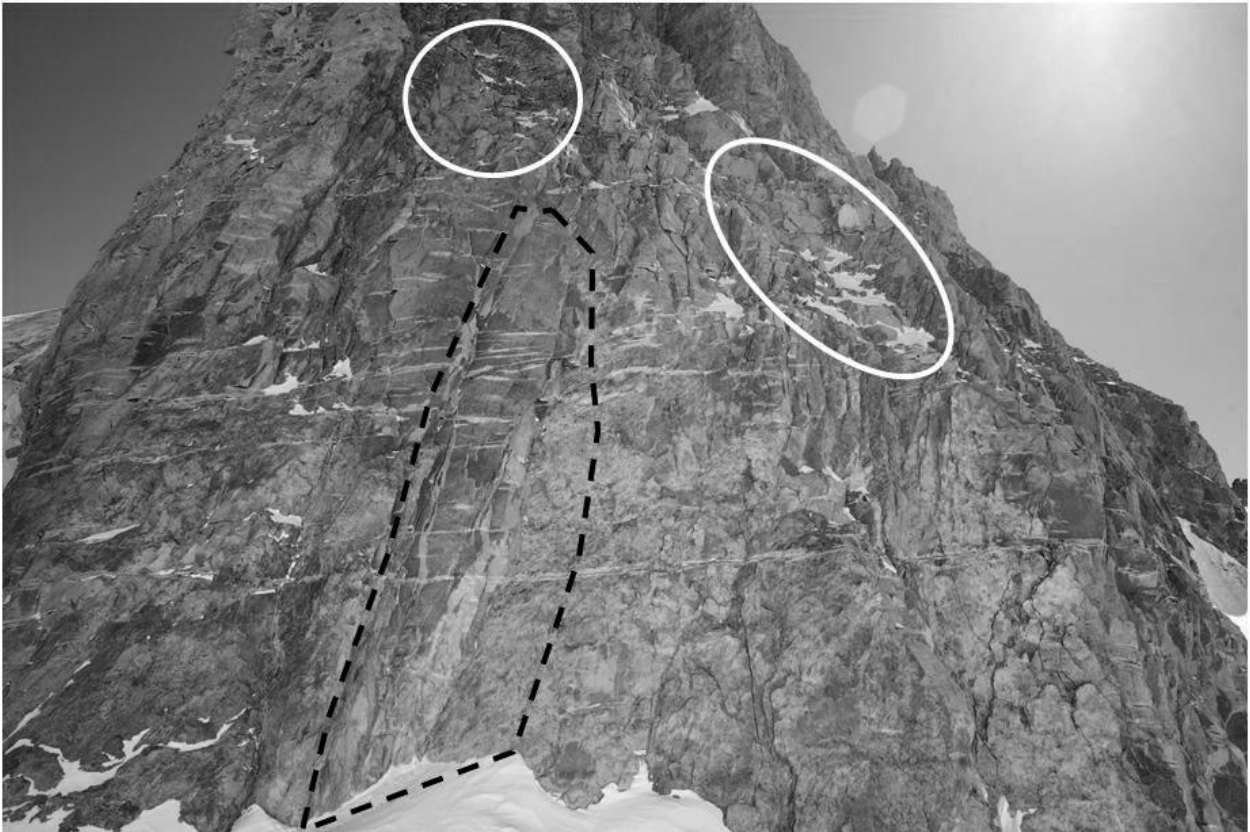
Figure 7. Comparison between the DSMs at different times and identification of the differences (7a). In Figure 7b the same areas are evidenced in a photo where: white areas indicates places of snow accumulation; 2007 phenomenon area is delimited in black.

As the distance of the object with respect to the subsequent camera positions is relatively low (between 55 and 80 m), at least for the area considered in the production of the DSM and assuming a point restitution accuracy of between 1.5 and 3 cm (evaluated through variance propagation in the least squares bundle adjustment), any difference higher than 6–8 cm between the DSMs acquired at different times should be considered significant from a statistical point of view. The model outlines the zones of geometrical differences that are in good agreement with the in situ observations, as shown in Figure 7, which indicates the presences of snow accumulation.

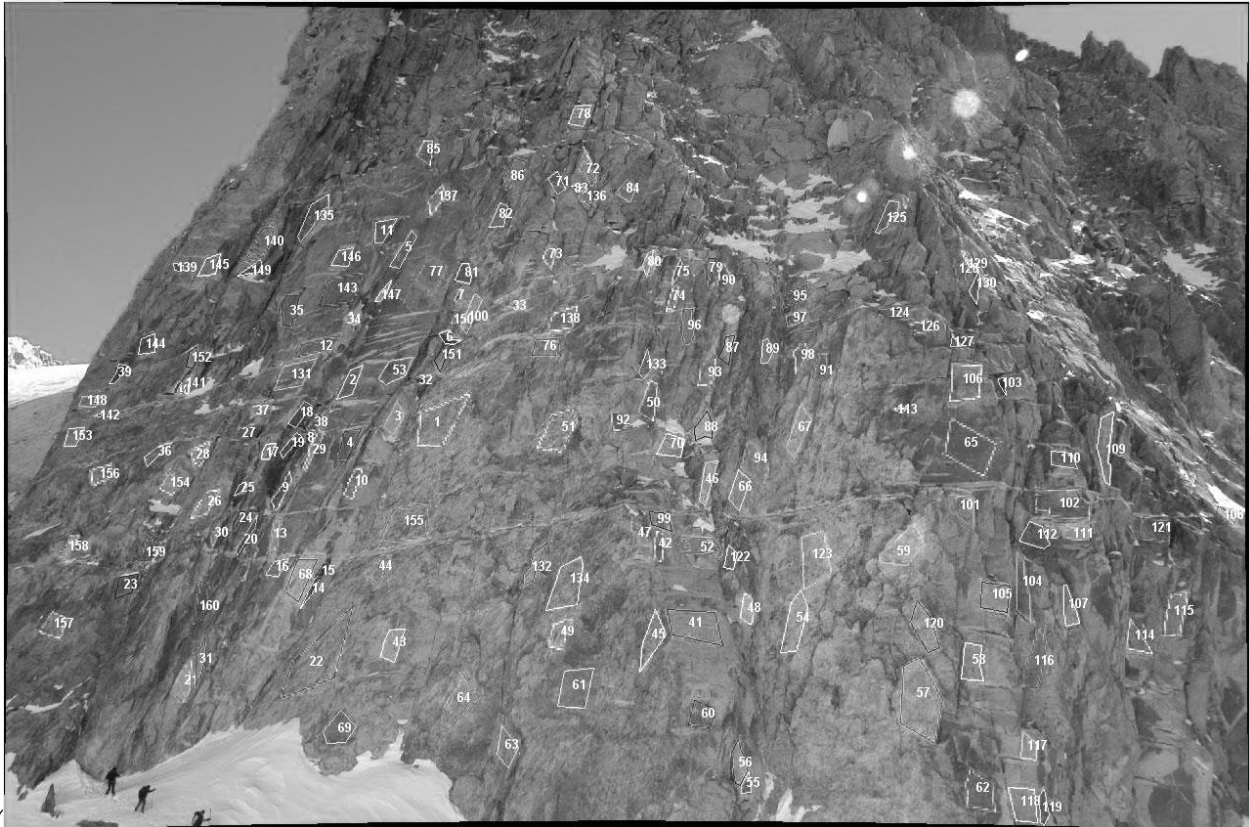
In this study, four photographs were used to obtain a representative sample of the rock mass discontinuity sets. A total of 441 discontinuity planes were identified. The dip and dip direction were

calculated for each plane using the Rockscan software

(Figure 8).

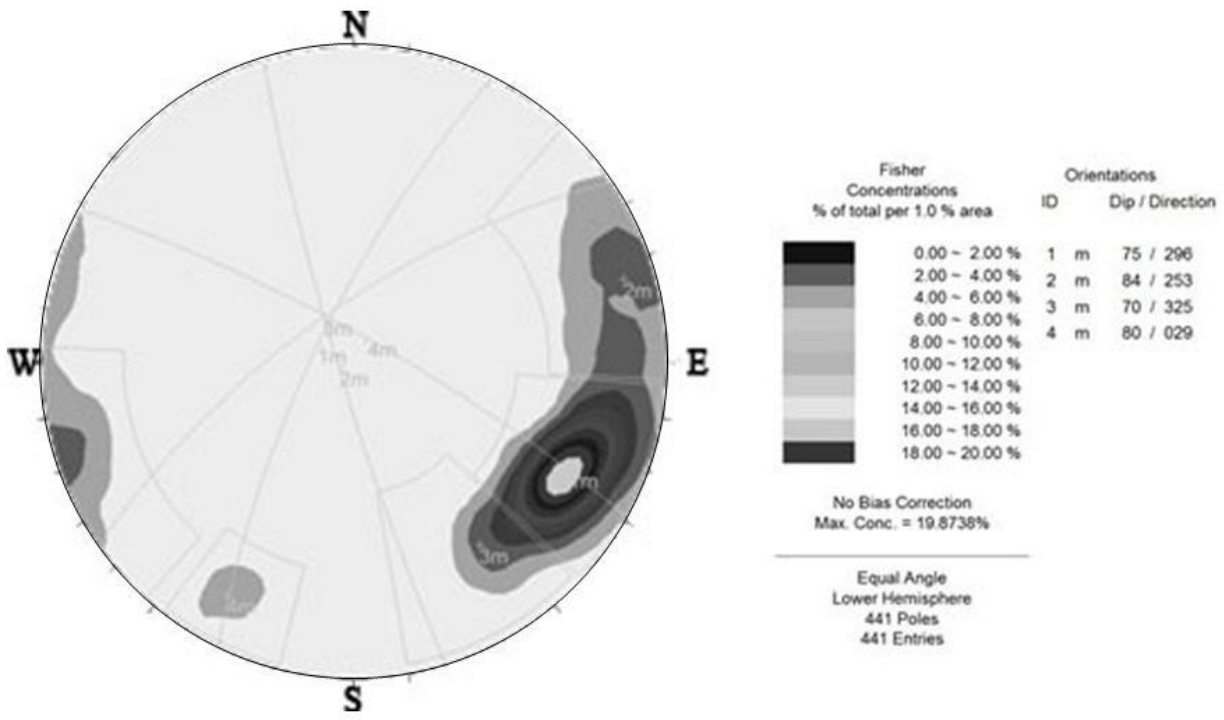
Figure 9. Contoured stereonet of the planes identified using the Rockscan software.

The orientation data of all the discontinuities were processed with the DIPS® (Rocscience, 2009) software, which permits a stereographic projection of poles and the identification of discontinuity clusters. These can be contoured and discontinuity sets identified. The pole distributions may be biased because of the difficulty involved in resolving certain plane orientations (i.e., sub-horizontal sets). By projecting all of the 441 sampled planes onto a concentration stereogram, four principal discontinuity sets (ID 1m, 2m, 3m and 4m) can be identified (Figure 9).

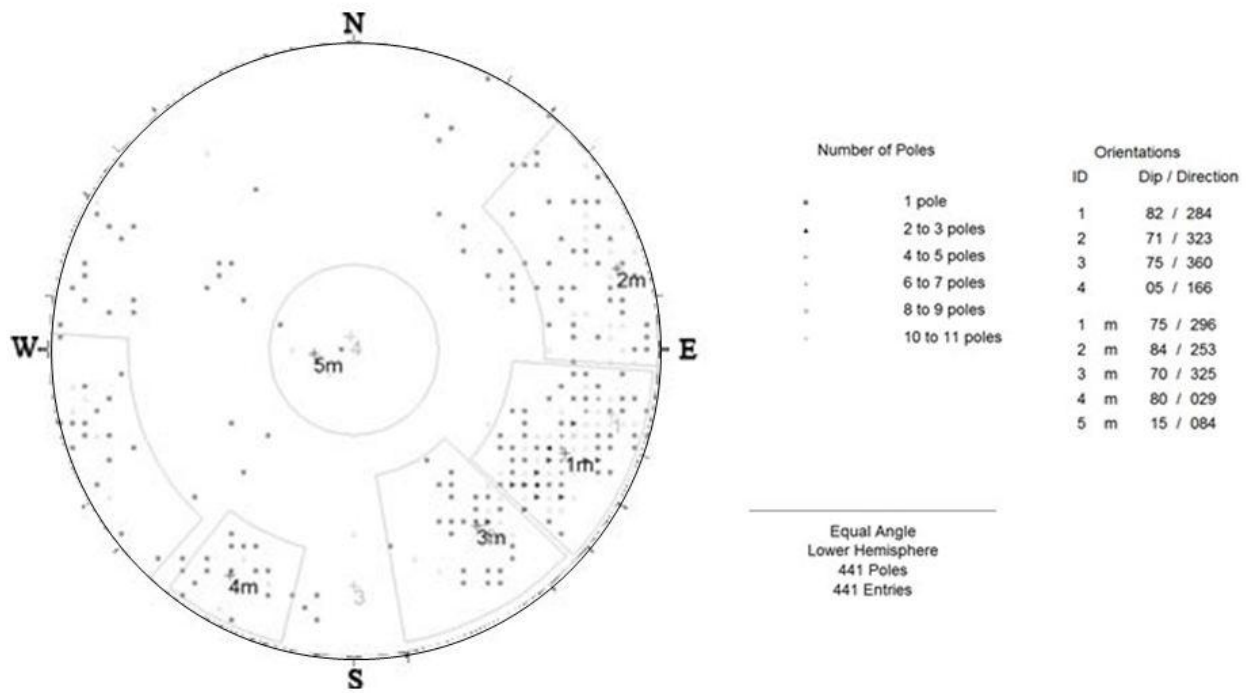
Figure 10. Discontinuity stereonet of the poles identified using the Rockscan.

It is important to notice that only sets with a certain number of poles emerge from the contoured stereonet and therefore, sub-horizontal sets are absent because only a few planes were delimited, as previously explained. Consequently, it is necessary to carefully analyse the stereonets in which the poles of that set are visible (ID 5m in Figure 10).

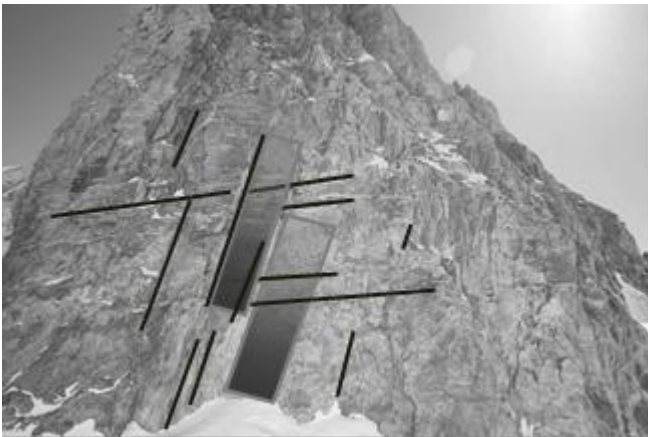
Figure 11. Identification of the rock fall phenomena. The sub-horizontal set (ID 5m) creates roofs and the sub-vertical set (ID 4m) isolates rock slabs laterally; slab sliding occurs on the set parallel to the fall (ID 1m).

As shown in Figure 11, the sub-horizontal set (ID 5m) creates roofs and the sub-vertical set (ID 4m) isolates rock slabs laterally; slab sliding occurs on the set parallel to the fall (ID 1m).

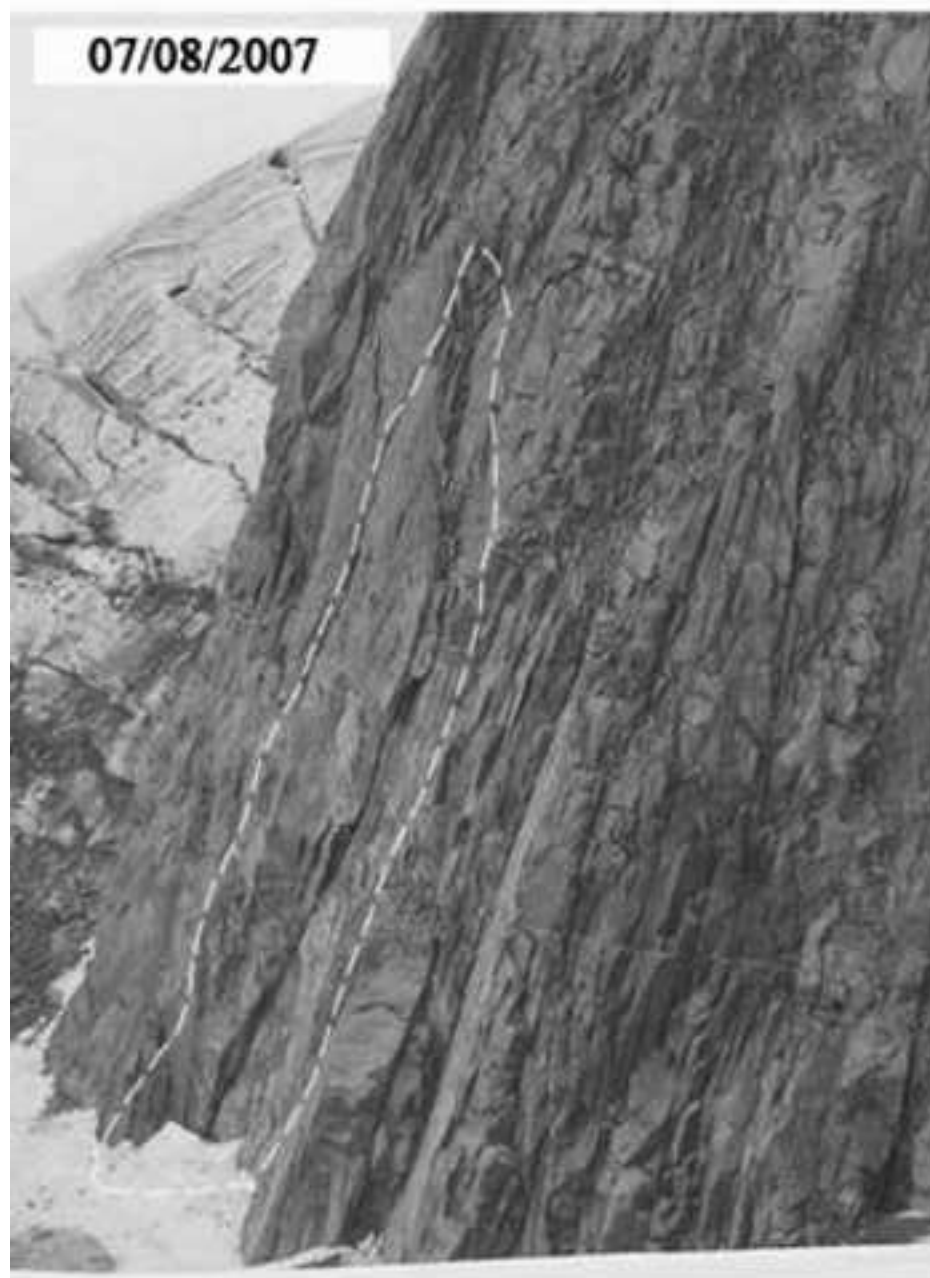
Figure 3  
[Click here to download high resolution image](#)

Figure 3. Observed instability phenomena. Comparison between photos taken on August 7, 2007 and September 24, 2007. The exact dates of rockfalls are unknown. Total dotted area is about 60 m high, 15 m wide and 4 m deep.

The fall that occurred in September 2007 can be delimited by fractures that were visible before the movement. The failed mass was geometrically composed of two overlapping parallelepiped rock slabs, the larger of which rested on top of the smaller, separated by a discontinuity plane roughly parallel to the slope face. From the available information, it was not possible to discern how the kinematic mechanism evolved (either the larger slab first and then the other, or both at the same time). Hence, in the analyses described herein, it was presumed that the slab failures occurred simultaneously, as if the two slabs were a single rock block (Figure 3). The observation of the rock surfaces exposed after the failure indicated the presence of rock bridges that had broken just before the rock fall. In other words,

the main hypothesis on the failure mechanism evolution implies that the presence of rock bridges guaranteed the rock block stability observed before the event.

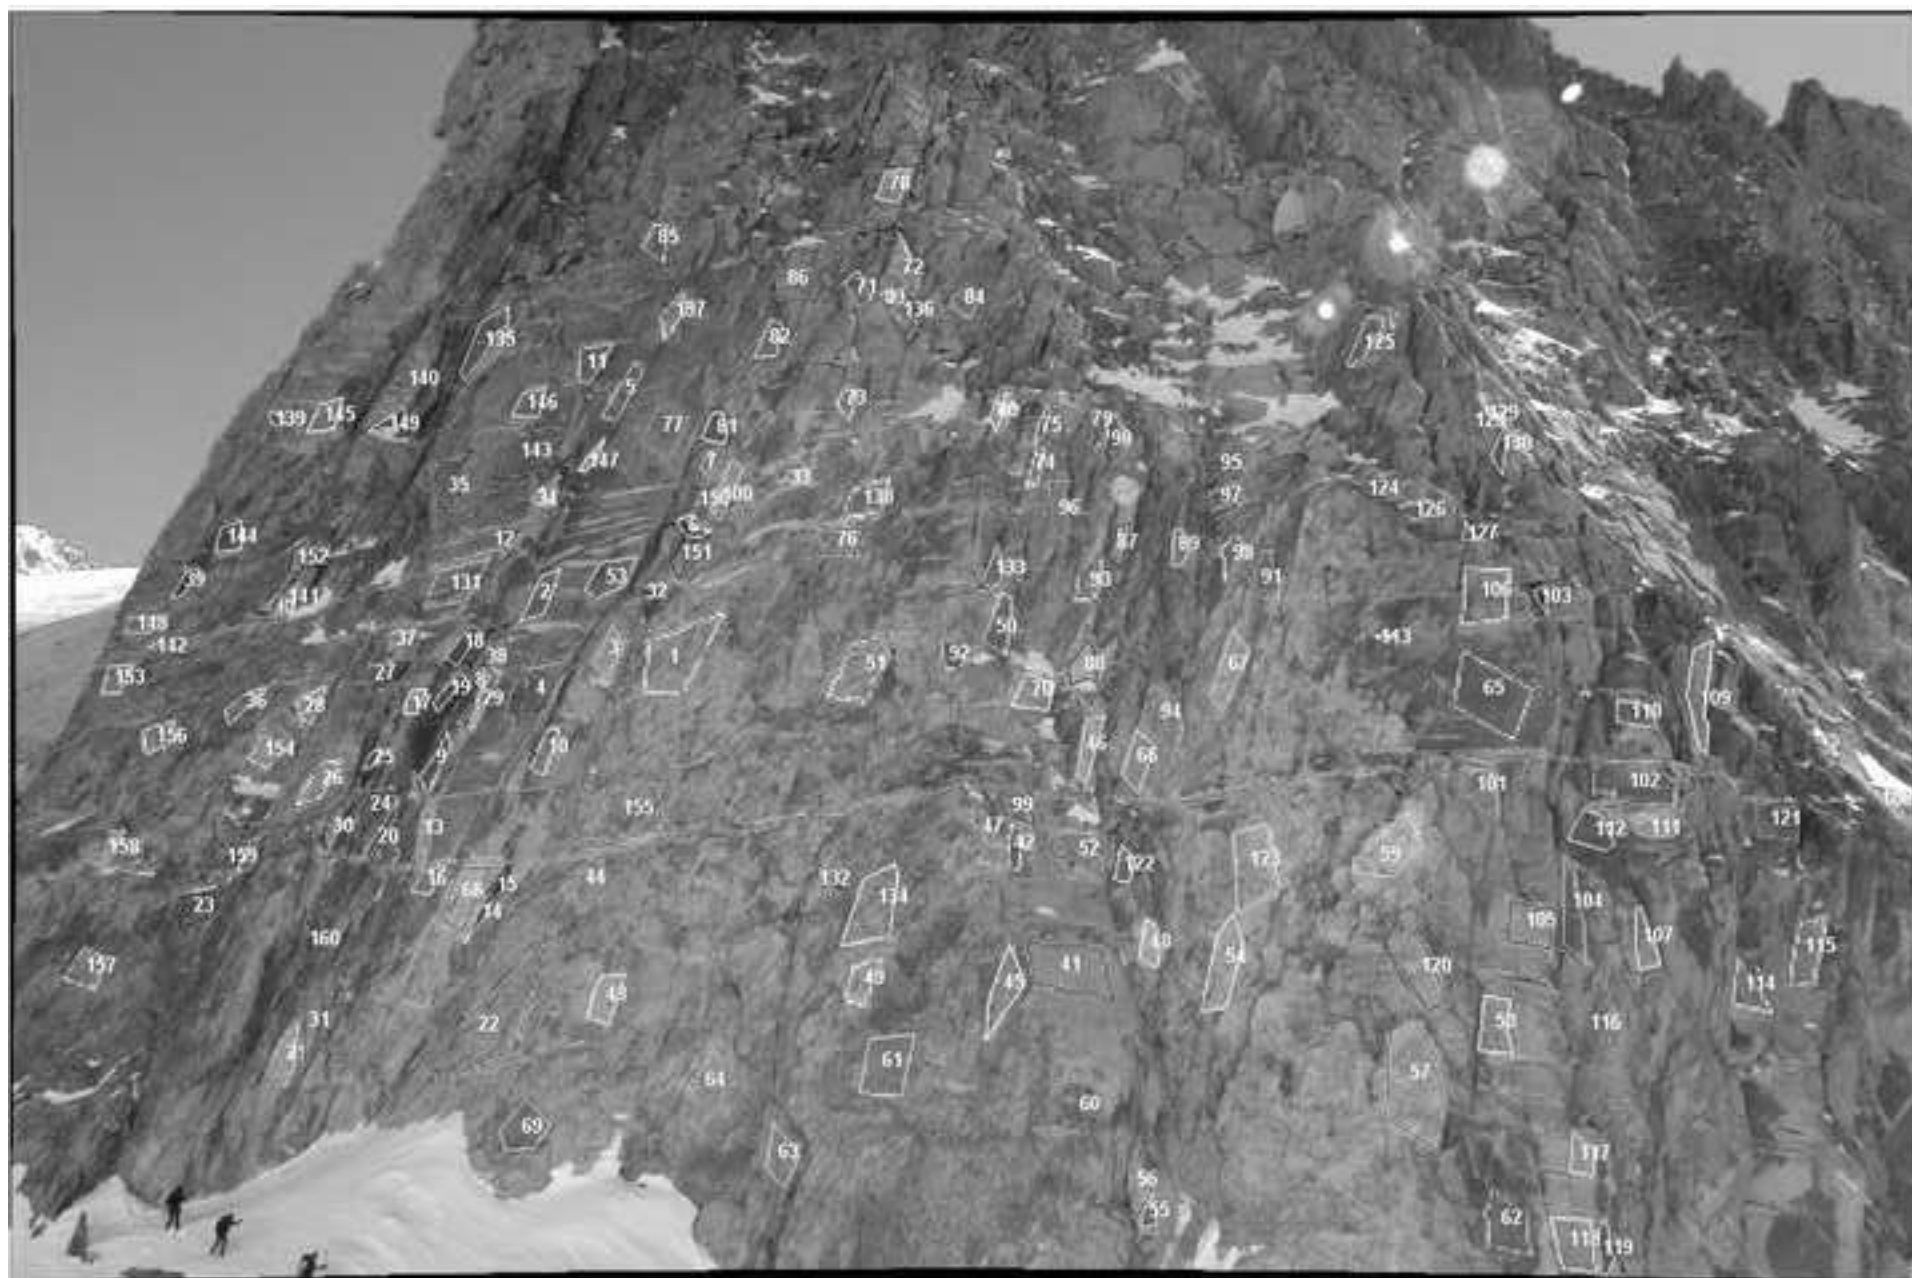
Figure 8  
[Click here to download high resolution image](#)

Figure 8. Discontinuity planes delimited manually on a photograph.
