## Technical Note

# Landslide Deposit Erosion and Reworking Documented by Geomatic Surveys at Mount Meager, BC, Canada

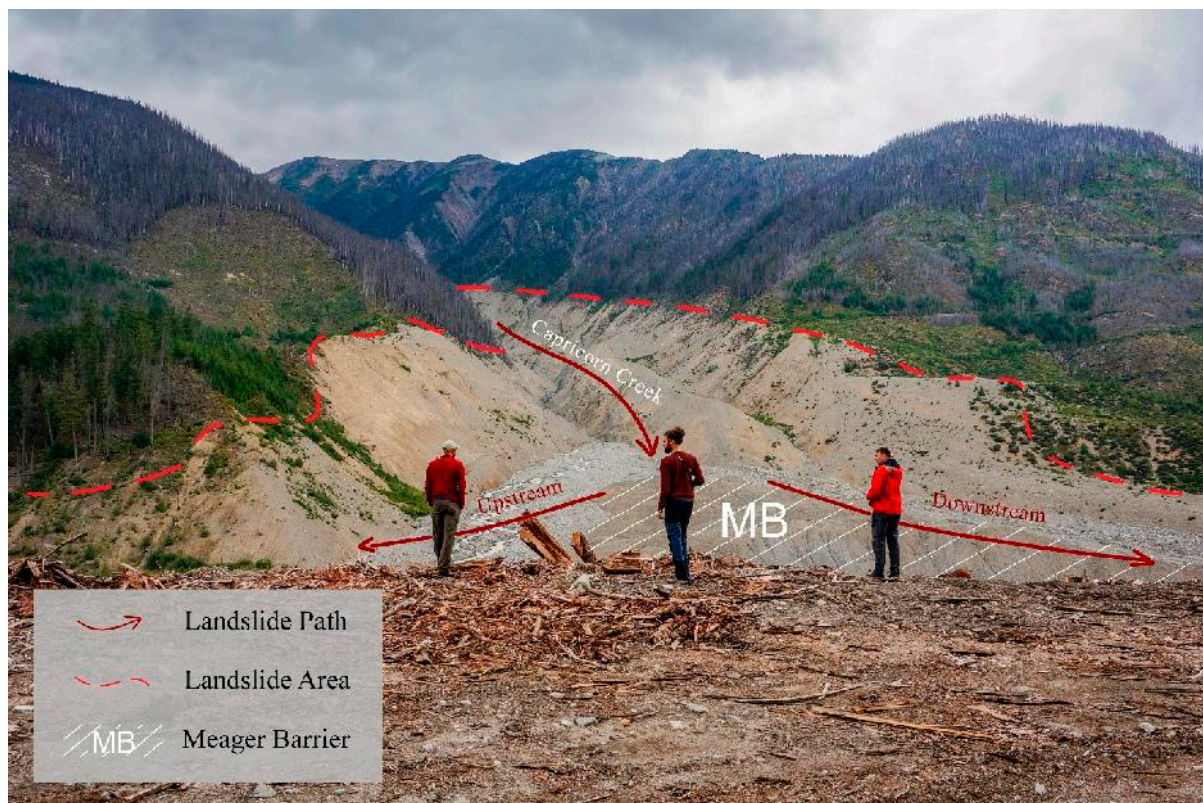
**Figure 2.** View to the northwest near the confluence of Capricorn and Meager creeks; Meager Creek barrier (MB) in the foreground. Part of the landslide travelled up Meager Creek (left side of image), but most of it travelled down Meager Creek to Lillooet River.

The landslide achieved its peak velocity when it reached the mouth of Capricorn Creek [31]. There, it struck the rising valley slope bordering Meager Creek on the southeast and ran 270 m up it. The flow split into two lobes, one of which traveled southwest up Meager Creek, and the other downvalley to Lillooet River. It left a hummocky deposit up to 10 m thick at the mouth of Capricorn Creek that created a dam blocking Meager Creek. The deposit downvalley of the barrier consists of compressional ridges formed of mixed debris and large gray blocks. The water rose rapidly behind the barrier; upon overtopping it, it rapidly incised the debris dam at the mouth of Capricorn Creek and spread the reworked debris downstream [32].

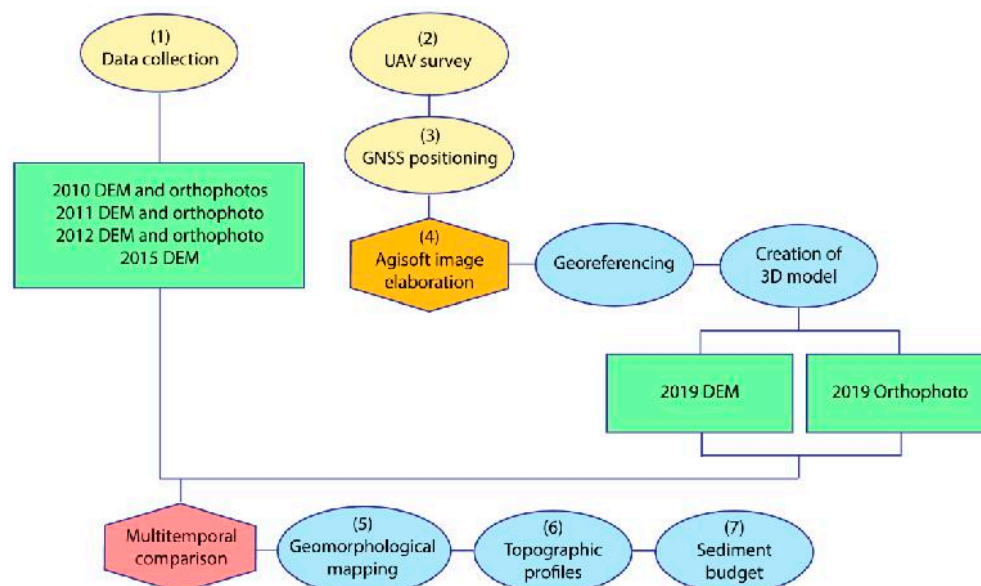
**Figure 3.** Workflow summarizing research procedures used in this study. The yellow ellipses are data collection activities; the orange hexagon is the SfM elaboration; light-blue ellipses are singular data processing and analysis steps; green rectangles are cartographic products; and the red hexagon is the multi-temporal comparison of the entire dataset. The numbers indicate the sequence of steps.

The research workflow for this study included the use of UAVs, GNSS, and satellite images (Figure 3). We first reviewed available orthophotos and DEMs, planned a UAV survey to create up-to-date base maps, and carried out a GNSS campaign to georeference the UAV products. Next, we processed the UAV images with Agisoft Metashape [33] in order to create orthophotos and a Digital Surface Model (DSM). Finally, we mapped geomorphic features, created and compared multi-temporal topographic profiles, and performed sediment budget volume calculations based on DEM differencing. There is no vegetation within the landslide area; therefore, the surface model matches the terrain model. For this reason, all DSMs are generically called DEMs.

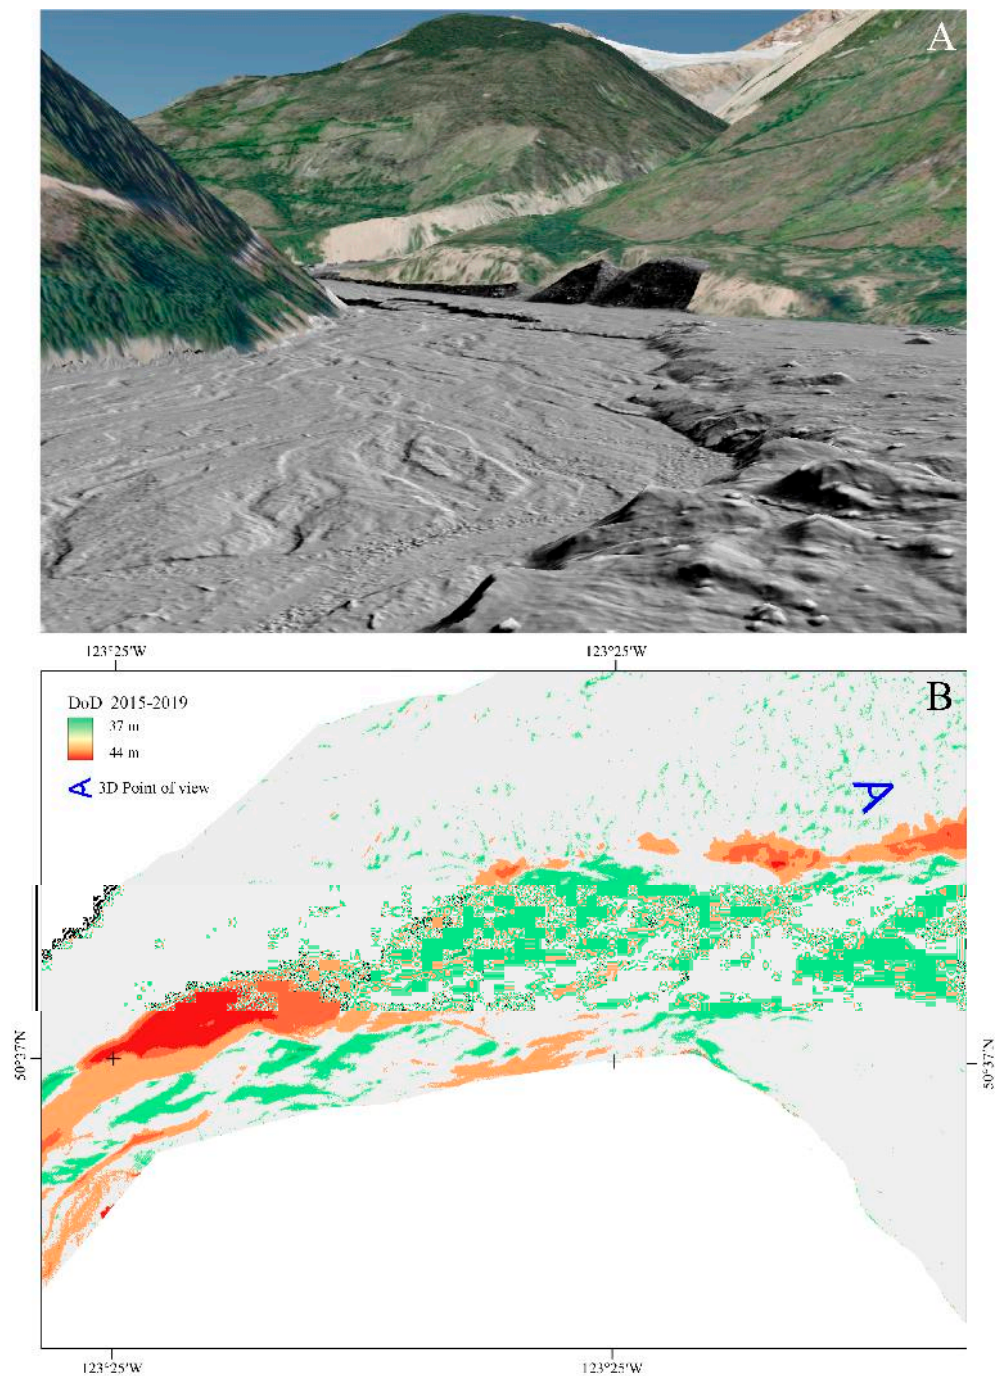
**Figure 5.** (A) 3D view of the 2019 DEM (hillshade view), providing a better understanding of the study area landscape. (B) DoD created by subtraction of the 2015 and 2019 DEMs. Areas of erosion are shown in red, and deposition is indicated in green. The blue symbol at the upper right corner of (B) indicates the viewpoint and direction of (A).

The two profiles in Figure 4 provide only limited views of erosion and deposition over the survey area. Thus, to better understand and display the pattern over the entire study area, we performed a DoD analysis on the two datasets with the best resolution: the 2015 and 2019 DEMs. In Figure 5, we show a comparison between the 2019 DEM (hillshade view) and the DoD. The figure reveals areas dominated by erosion and areas where there has been net deposition.

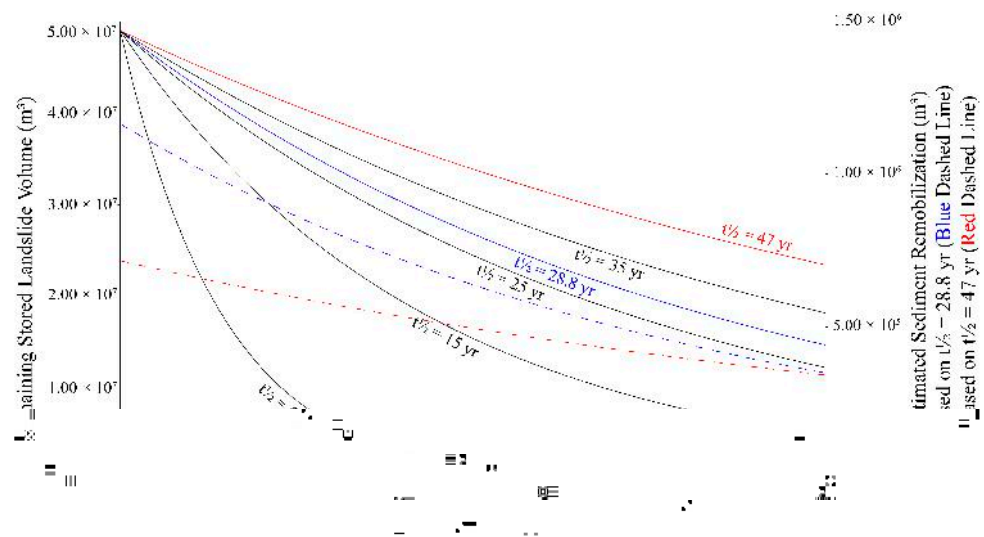
**Figure 9.** Graphs summarizing remobilization of the sediment deposited by the Mount Meager landslide in the lower Meager Creek Valley. Solid black lines represent volume changes of the landslide body over time for a specific half-life curve. The curves show trends in erosion, rapidly at first but diminishing over time. The blue solid line represents volume changes calculated using the data for the period 2010–2015, with a corresponding half-life of 28.8 years [29]. The red solid line represents the volume changes calculated for the period 2010–2019, with an overall half-life of 47 years (this study). The blue dashed line shows the annual sediment reduction based on  $t_{1/2} = 28.8$  years [29]. The red dashed line shows the annual reduction in the volume of sediment for the period 2010–2019 based on the half-life value of 47 years.

where  $t_{1/2}$  is the half-life of the decay function,  $t$  is the time a measurement is made,  $v_i$  is the initial volume of the accumulation, and  $v_f$  is the volume at time  $t$ . Figure 9 shows some representative half-life decay curves based on Equation (2). The curve for the Mount Meager landslide was generated from differences in volumes of sediment evacuated from the landslide area at two different times, based on our data and those reported by Northwest Hydraulic Consultants [29]. We have made a new estimate of 47 years for  $t_{1/2}$  based on the entire period of our study (2010–2019). Our results suggest that remnants of a landslide as large as this might persist for centuries (see also ([45,46,51–53])).
