Properties, best management practices and conservation of terraced soils in Southern Europe (from Mediterranean areas to the Alps); a review

Properties, best management practices and conservation of terraced soils in Southern Europe (from Mediterranean areas to the Alps): a review

S. Stanchi¹, M. Freppaz¹, A. Agnelli², T. Reinsch³, E. Zanini¹

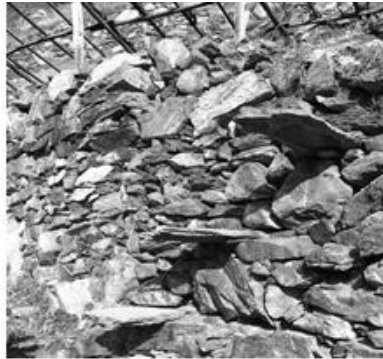
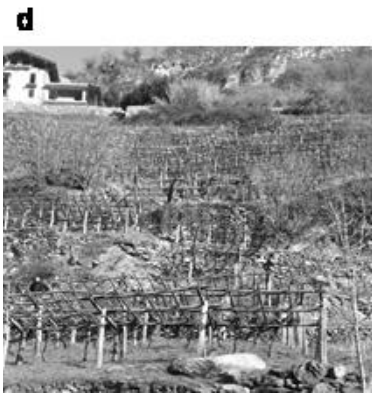
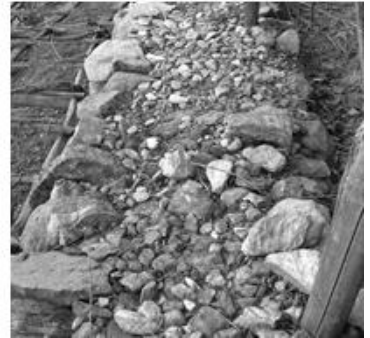
Figure 2: terraced slopes in Valle d'Aosta. Structural typologies and details (Photos M. Freppaz). a) wall foundation; b) connection between terraces; c) example of restored wall; d) terraced slope - vineyard; d) terraced slope – chestnut wood; e) detail of wall structure

The most common typologies of terracing (table 2) for the Alpine area were collected in the Alpter database (www.alpter.net, Scaramellini & Varotto, 2008). They include: building typology (dry stone, wooden, concrete, solid wall), foundation (on rock, sediments, terrain, mixed material), wall length (from decimetres to hundreds meters), height (from 2-3 decimetres to several meters), wall and tread slope, tread width (very diverse, terracing density, average terrain slope (often more than 100%). Terraces can be linked by ramps, stairs (parallel or perpendicular to walls), suspended stairs, mobile stairs, or mixed systems. The drainage network may be parallel or perpendicular to treads, sometimes overlapping with paths and main accesses (Scaramellini & Varotto, 2008). Figure 2 illustrates some of these features for the terraced area of Aosta Valley Region (NW-Italy).
