Editorial

Special Issue: Results of the II National Research Project of AIAR: Archaeometric Study of the Frescoes by Saturnino Gatti and Workshop at the Church of San Panfilo in Tornimparte (AQ, Italy)

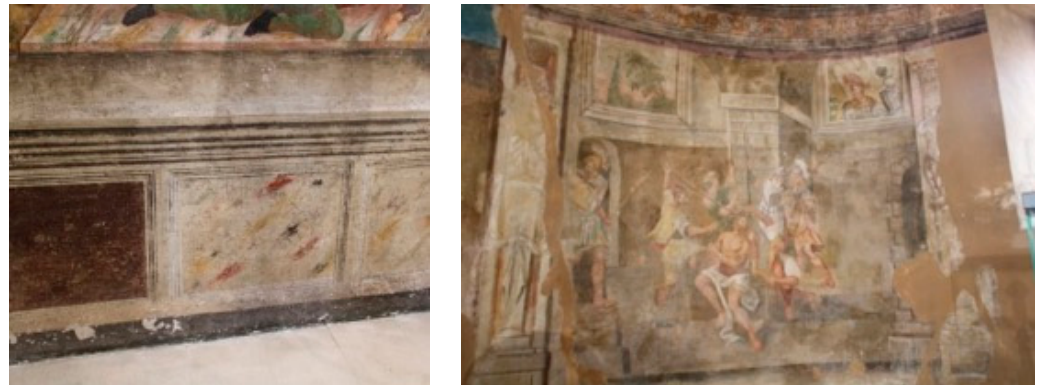
Figure 3. Examples of typical alterations found in the lower and upper portions of the apsidal basin.

In fact, the site has undergone various restoration interventions over time, not all of which have been documented, that have variously attempted to address the conservation issues and have had aesthetic results that were not always respectful to the formal and stylistic reading of the original figurative complex (Figure 3). At a first macroscopic evaluation, these interventions were faced with different criteria from time to time, generating a palimpsest that needs to be reconstructed for a correct diachronic and stratigraphic interpretation of the remakes in relation to the original layers still present under the repaintings. The interpretation of the diagnostic results constitutes objective support for evaluating the removal of areas of renovation which currently partially or totally hide traces of the Renaissance frescos.

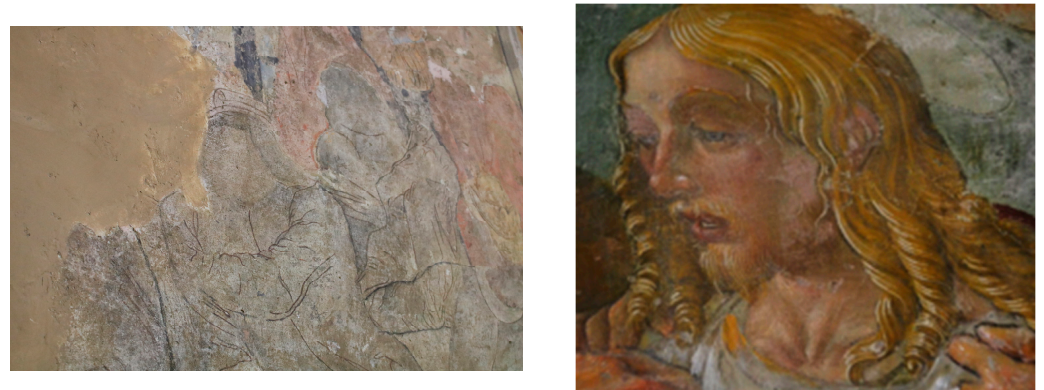
Figure 4. Examples of the several engravings visible both in the pictorial portions characterized by total collapse and in those with a good state of conservation.

- E. Study Saturnino Gatti’s artistic technique and the organization rules of his workshop by obtaining information on the techniques of transporting the drawing and the construction of the figurative system, in an attempt to identify operational peculiarities that could distinguish portions painted by Saturnino Gatti from those painted by collaborators. During the preliminary inspection, it was possible to observe the complex system of engravings, particularly in some exposed areas due to the partial or total lacunae of the pictorial layer (Figure 4). Furthermore, in a close view of the surfaces, the typical dots of the “spolvero” technique are visible.

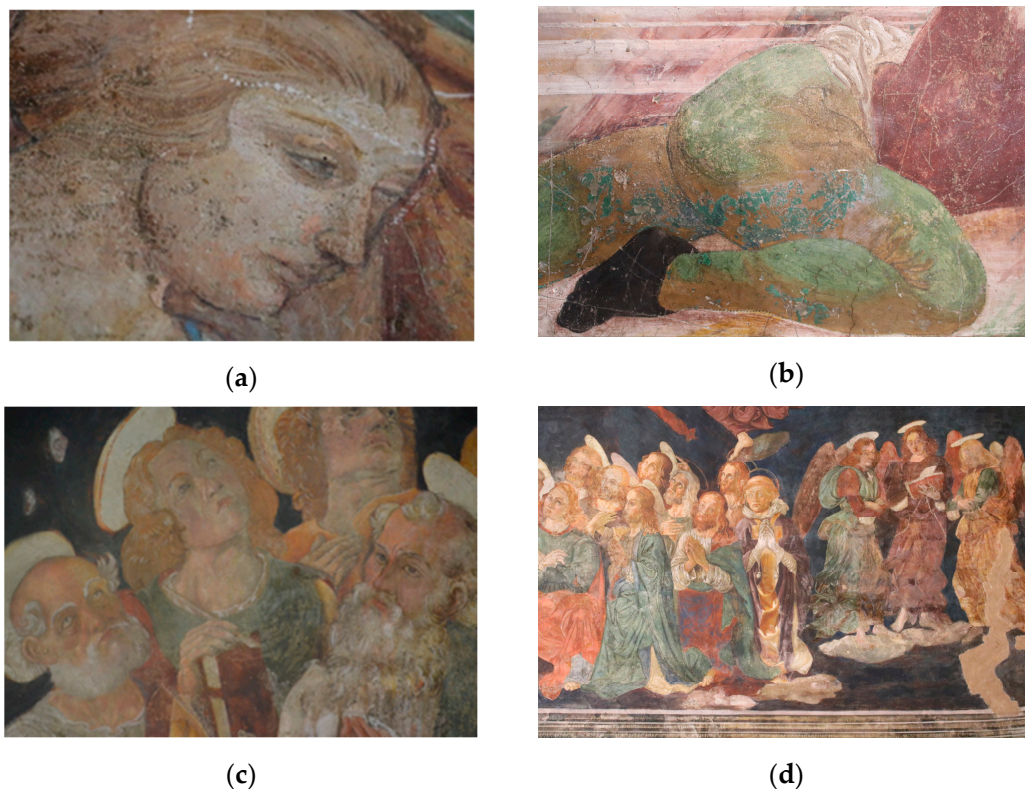
Figure 5. Details of the alterations observed at the different levels of the pictorial surfaces: (a,b) details of the pictorial surfaces altered along the apse; (c,d) details of the alterations affecting the pictorial surfaces of the vault.

they stand (Figure 5). This phase of the study returned a lot of fundamental information to document the different types of degradation, to guide the design choices and to guarantee the durability of the future restoration intervention. In fact, suitable analytical methodologies were used to locate the pictorial or wall areas affected by water infiltration from windows or roofing and capillary rising damp.

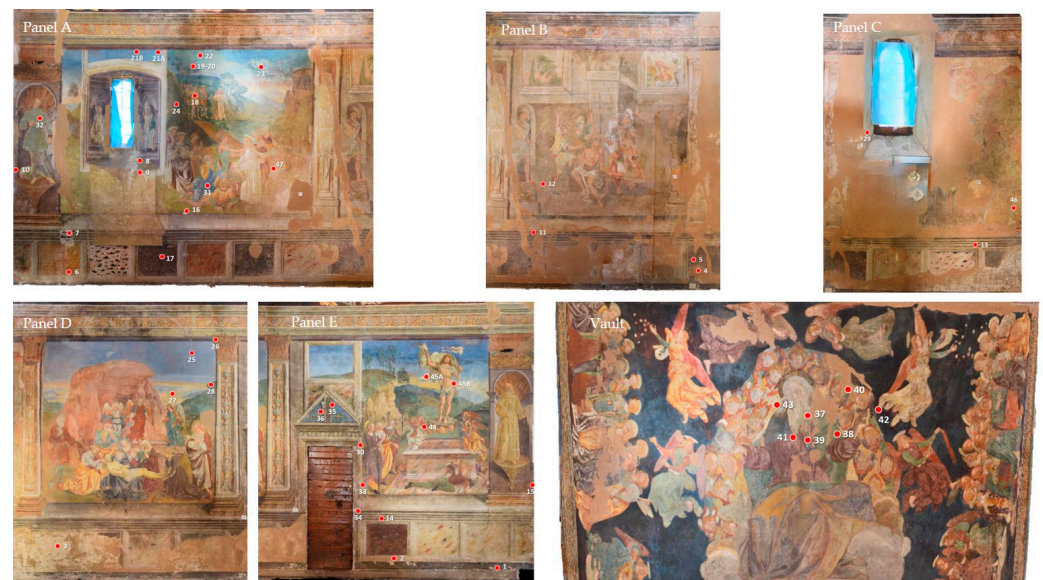
Figure 6. Panels (from left of the apse) (A–E) and (vault): Location and denomination of the areas where the 47 fragments of plaster and pictorial layers were taken. Each sampling areas have been selected on the basis of the first results of the in-situ investigations.

Figure 6 showed the sampling areas of the 47 micro-fragments sampled from the apsidal basin and on the central part of the vault. In particular, the five pictorial panels were been identified with the letters A, B, C, D, E as follows:

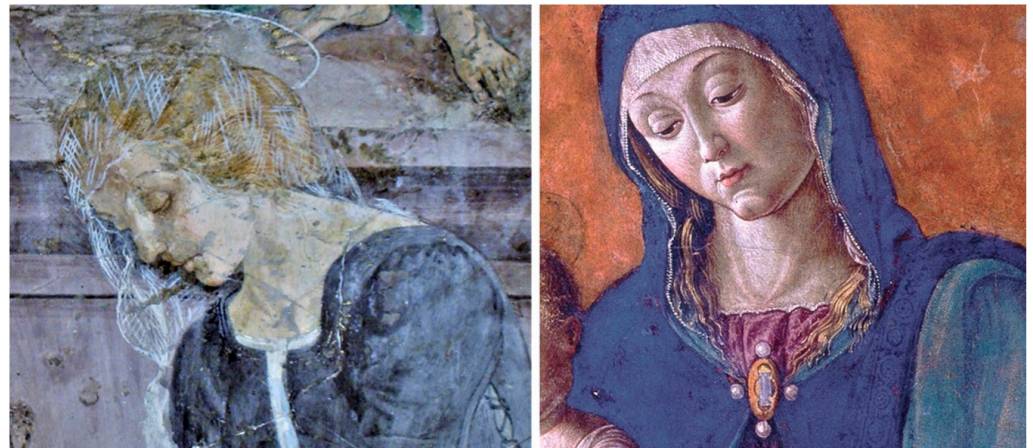
Figure 7. A comparison between Mary Magdalene in the Lamentation panel (**left**) and the detached fresco Madonna with standing Child (L'Aquila, church of Santa Margherita) (**right**) reveals identical executive technique in highlights made in “bianco di calce” (calcium white) for the finest details like the veils, and traces of gold leaf used for the gilding of halos and edges of robes.

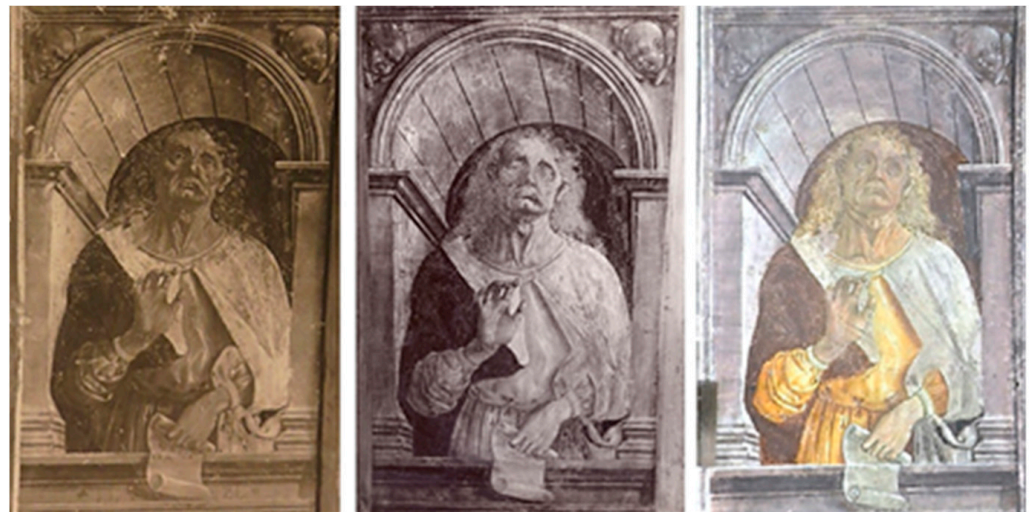
Figure 8. Prophet Daniel appearing in the sub-arch reveals, through the comparison of pictures dating back from 1920 to 2020 (from left), the almost total loss of the “a secco” finishes located in the incarnate, eyes, hair and in the scroll held in the left hand.

Other retouches almost certainly took place at the same time, for which zinc white was used and therefore cannot be dated before the mid-19th century [17]. Another interesting aspect that emerges from the surveys is the possibility of recognising and consequently preserving the finishing touches applied “a secco”: the petrographic and chemical studies have demonstrated the tendency of Saturnino to apply colour corrections onto the dry plaster [18].
