Case Report

Hardware-Related Skin Erosion in Deep Brain Stimulation for Parkinson's Disease: How Far Can We Go? An Illustrative Case Report

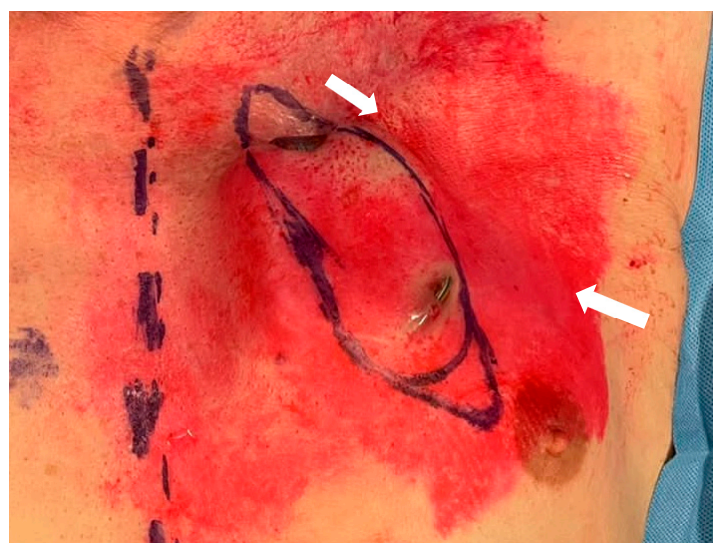
After six months, the patient was again admitted to our hospital with a skin erosion above the IPG and another one above the extension cables (Figure 1).

Figure 1. Skin erosions (arrow) above the IPG and above the extension cables. The boundaries of the excised skin portion are drawn.

discussion with the plastic surgeons, a more invasive approach was chosen. The skin overlying the IPG and the caudal portion of extension cables was completely excised up to 1 cm away from the erosion (Figure 1). By blunt dissection, the generator, extension cables, and the previously implanted adapter were isolated. No signs of infection were observed. A swab for culture examination was carried out on the pocket with negative result. A right pectoralis major myocutaneous flap (PMMF) was prepared after identification of the vascular peduncle (Figure 2).

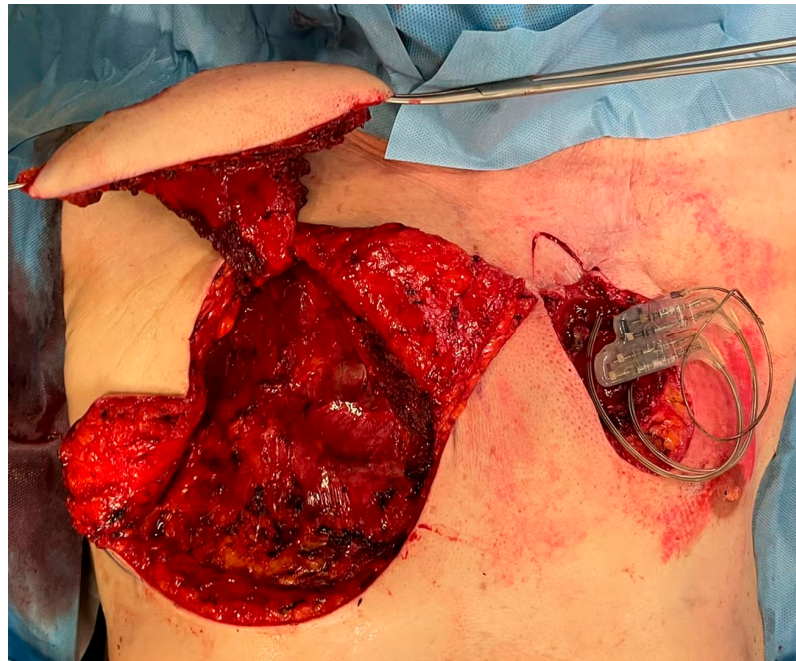
Figure 2. A right pectoralis major myocutaneous flap (PMMF) was prepared after identification of the vascular peduncle.

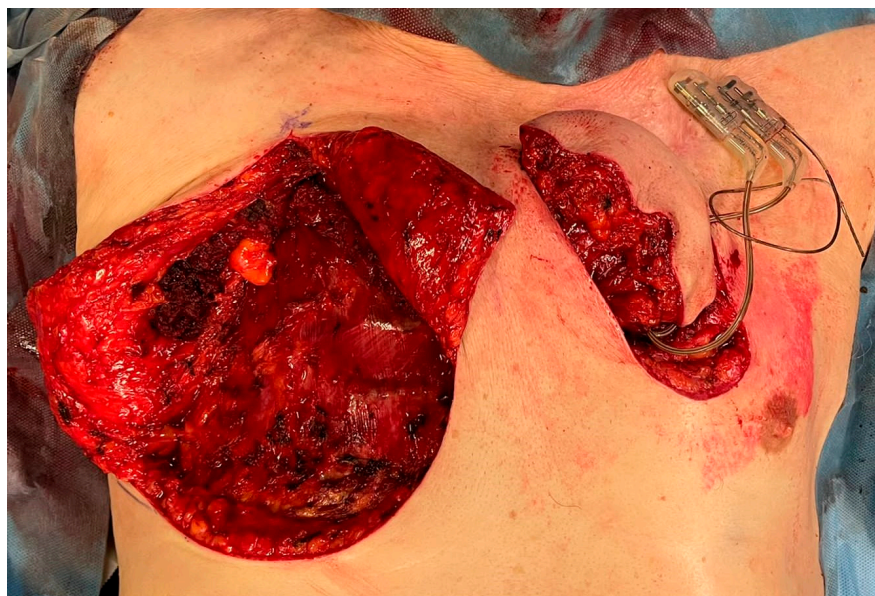
The flap was tunneled and brought contralaterally to cover the skin defect (Figure 3).

Figure 3. The PMMF was tunneled and brought contralaterally.

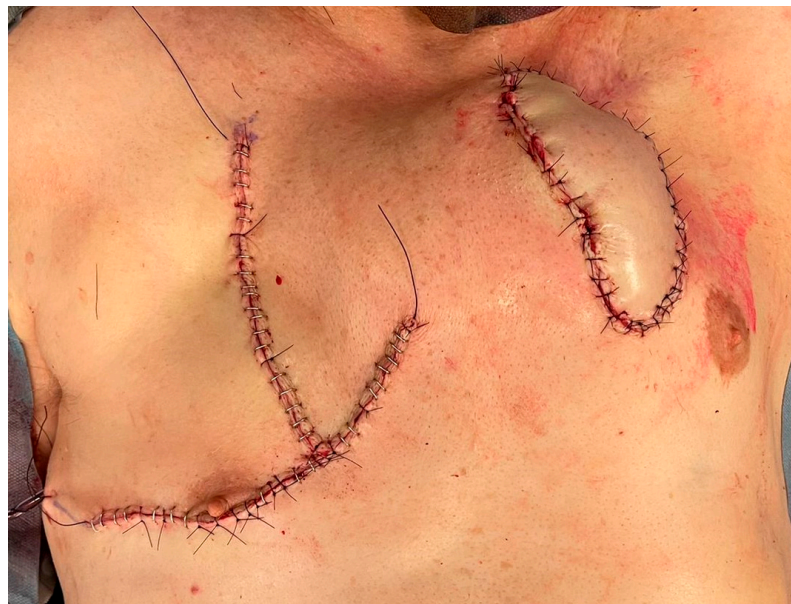
Wounds were irrigated with physiological solution. After right pectoral drainage placement, muscular, subcutaneous, and cutaneous planes were sutured (Figure 4).

Figure 4. Final wound closure.

Impedances were checked and the stimulator was switched on again. Wounds healed regularly. Drainage was removed after 5 days. At 15 days postoperatively, all the stitches were removed.

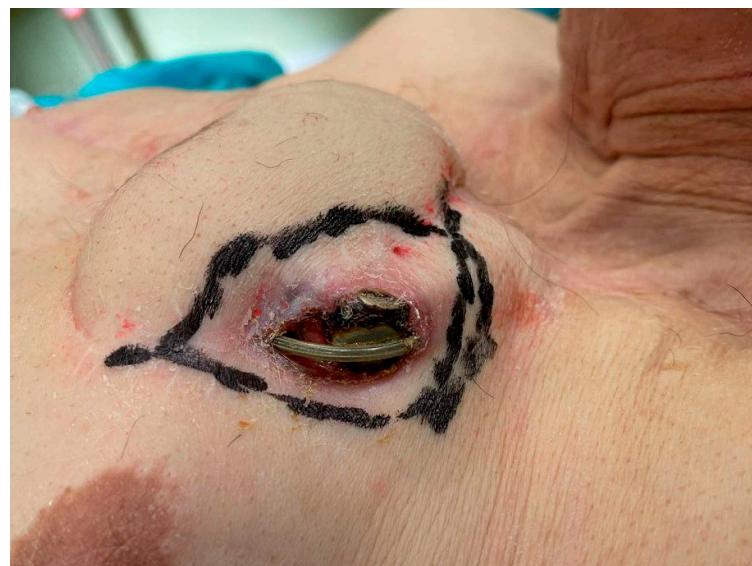
Six months later, the flap was healthy with no signs of infection or further skin erosion. DBS efficacy on Parkinson's control was preserved. One month later, however, a new erosion developed near the surgical scar of the last surgery with IPG and wire exposure (Figure 5).

Figure 5. New skin erosion near the surgical scar.

Given the failure of even the more complex and invasive surgical approach, it was decided to definitely remove the IPG. The edges of the skin erosion were excised and the wound was closed directly with an interrupted suture. The wound healed regularly, but the patient presented a severe progressive worsening of PD symptoms despite several
