# ***In-vivo* degradation of poly(carbonate-urethane) based spine implants.**

Fourteen explanted Dynesys<sup>®</sup> spinal devices were analyzed for biostability and compared with a reference, never implanted, control. Both poly(carbonate-urethane) (PCU) spacers and polyethylene-terephthalate (PET) cords were analyzed. The effect of implantation was evaluated through the observation of physical alterations of the device surfaces, evaluation of the chemical degradation and fluids absorption on the devices and examination of the morphological and mechanical features. PCU spacers exhibited a variety of surface damage mechanisms, the most significant being abrasion and localized, microscopic surface cracks. Evidence of oxidation and chain scission were detected on PCU spacers by ATR-FTIR. ATR-FTIR, DSC and hardness measurements also showed a slight heterogeneity in the composition of PCU. The extraction carried out on the PCU spacers revealed the presence of extractable polycarbonate segments. One spacer and all PET cords visually exhibited the presence of adherent biological material (proteins), confirmed by the ATR-FTIR results. GC/MS analyses of the extracts from PET cords reveale

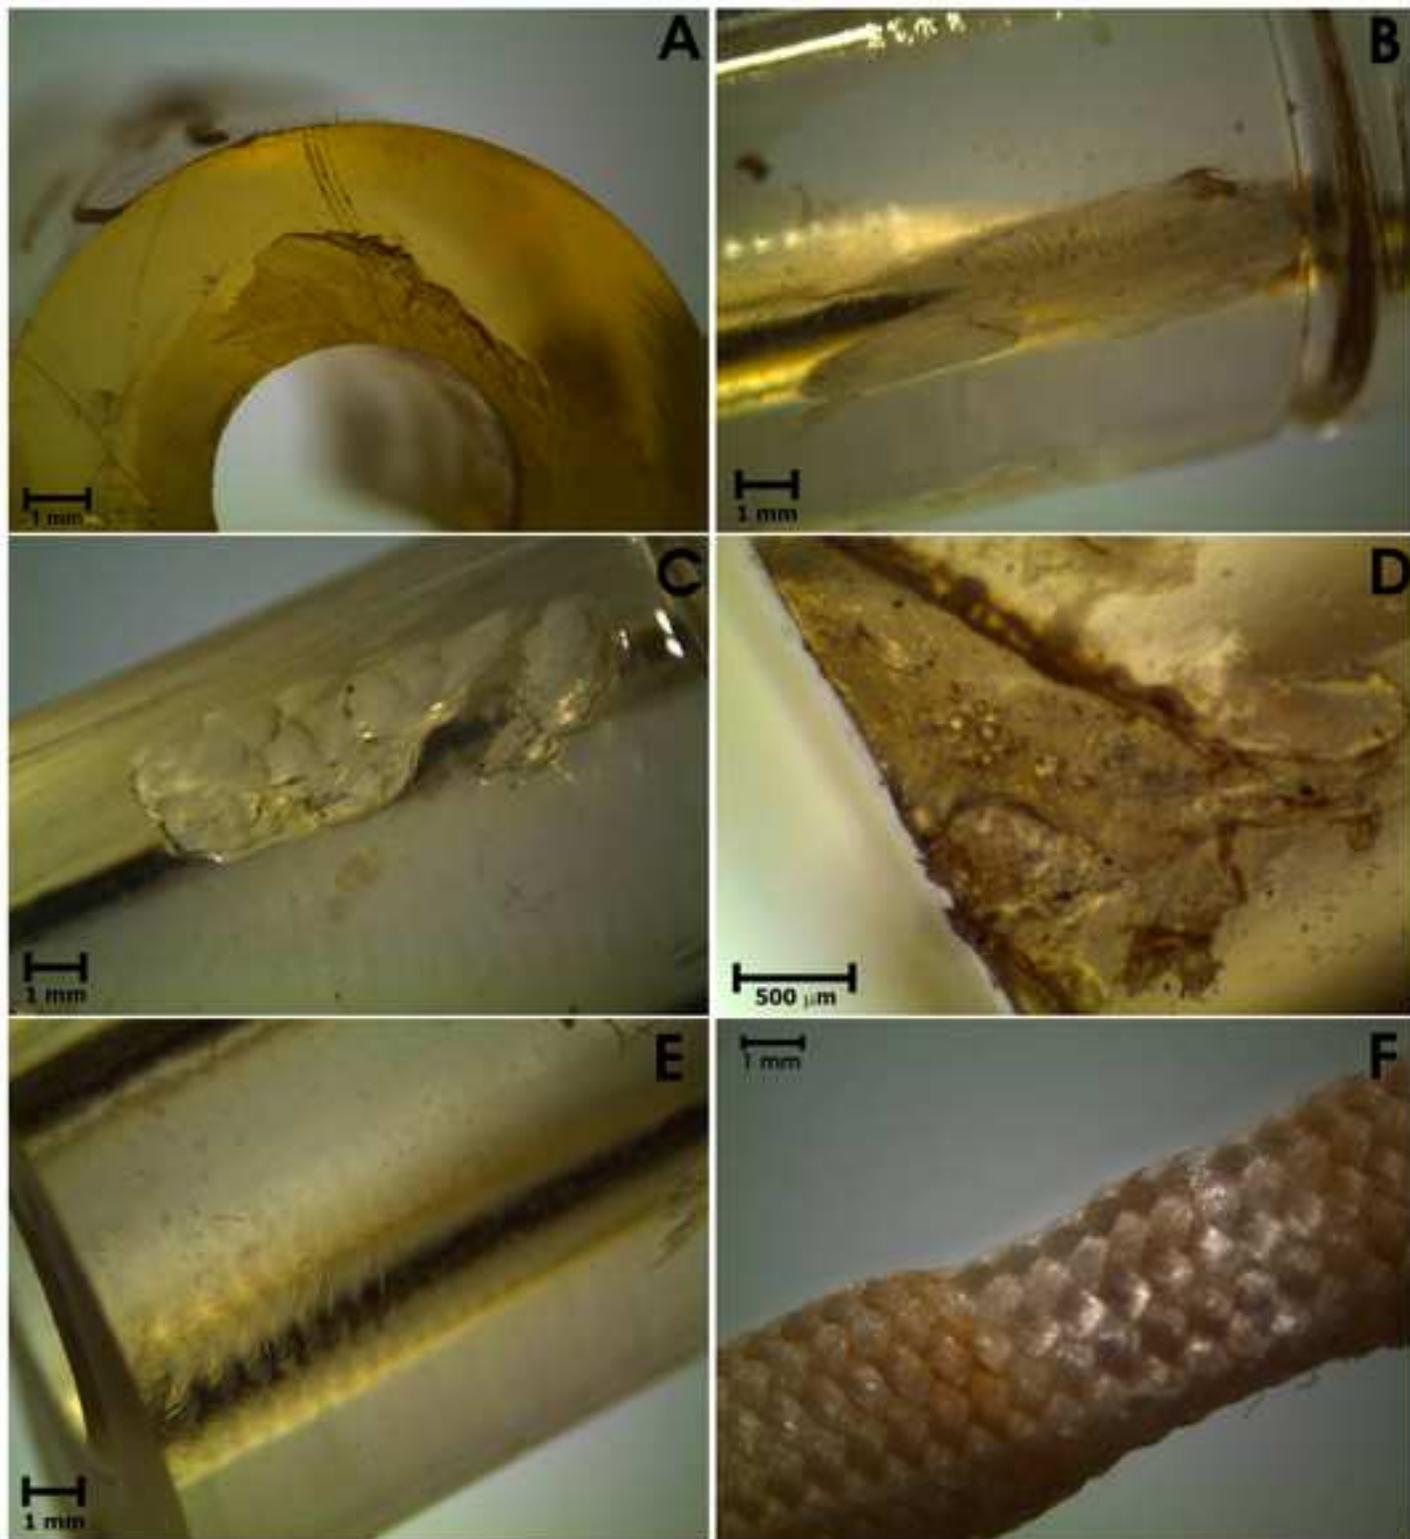
Figure 2.tif  
[Click here to download high resolution image](#)

At a microscope inspection, the spacers exhibited a variety of surface damages, summarized in Figure 2, likely due to different causes. Commonly observed superficial damage include small cuts and scratches along the spacers, which were mostly attributed to the surgical removal, since the features of the scratches can be connected with scalpel marks; in one case a small crack, in another case a fracture were also observed on the molded end. A circular mark and superficial erosion at the end of the spacer were present in most spacers, an example is showed in Figure 2A. They were attributed to the imprint of the pedicle screw head.

The loss of glossy and smoothness can be attributed to impingement with bone, due to abrasive wear, or to a visible action of biodegradation on the surface. The most representative images of both these phenomena are reported in Figure 2B-C and Figure 2D respectively. Imprints on the inner wall of the devices, indicating plastic deformation due to the contact with the cord, were also frequently observed (Figure 2E). Also the cord is characterized by plastic deformation, in the segment where the screws anchor the device to the spine. In this zone, the fibers are less yellowed and the braided network results compressed, as it is showed in Figure 2F.

The zones of the surface that appeared opaque at the optical microscope, exhibit various form of alterations when inspected with SEM. The surfaces characterized by an evident eroded and opaque region, as visible in Figure 2B-C, show a typical abrasive wear pattern (Figure 3B), characterized by a rubber like behavior. One of the most interesting sample (Dyn 10) showed a surface that looks inhomogeneous at unaided-eyes, with an alternation of lighter and darker areas at the optical microscope. The lighter and darker zones look, in the SEM images, reported in Figure 3C (left), like a succession of smooth surface and attached micro-aggregates. Branched fissures were also observed on this devices, as it is showed in Figure 3C (right), more emphasized near the micro-aggregates. Branched fissures can be attributed to environmental stress cracking (ESC), a result of residual polymer surface stress, which may be introduced during fabrication of the device and not sufficiently reduced by annealing. The contact with human fluids may speed up this phenomenon, because of the absorption/desorption of species [40].

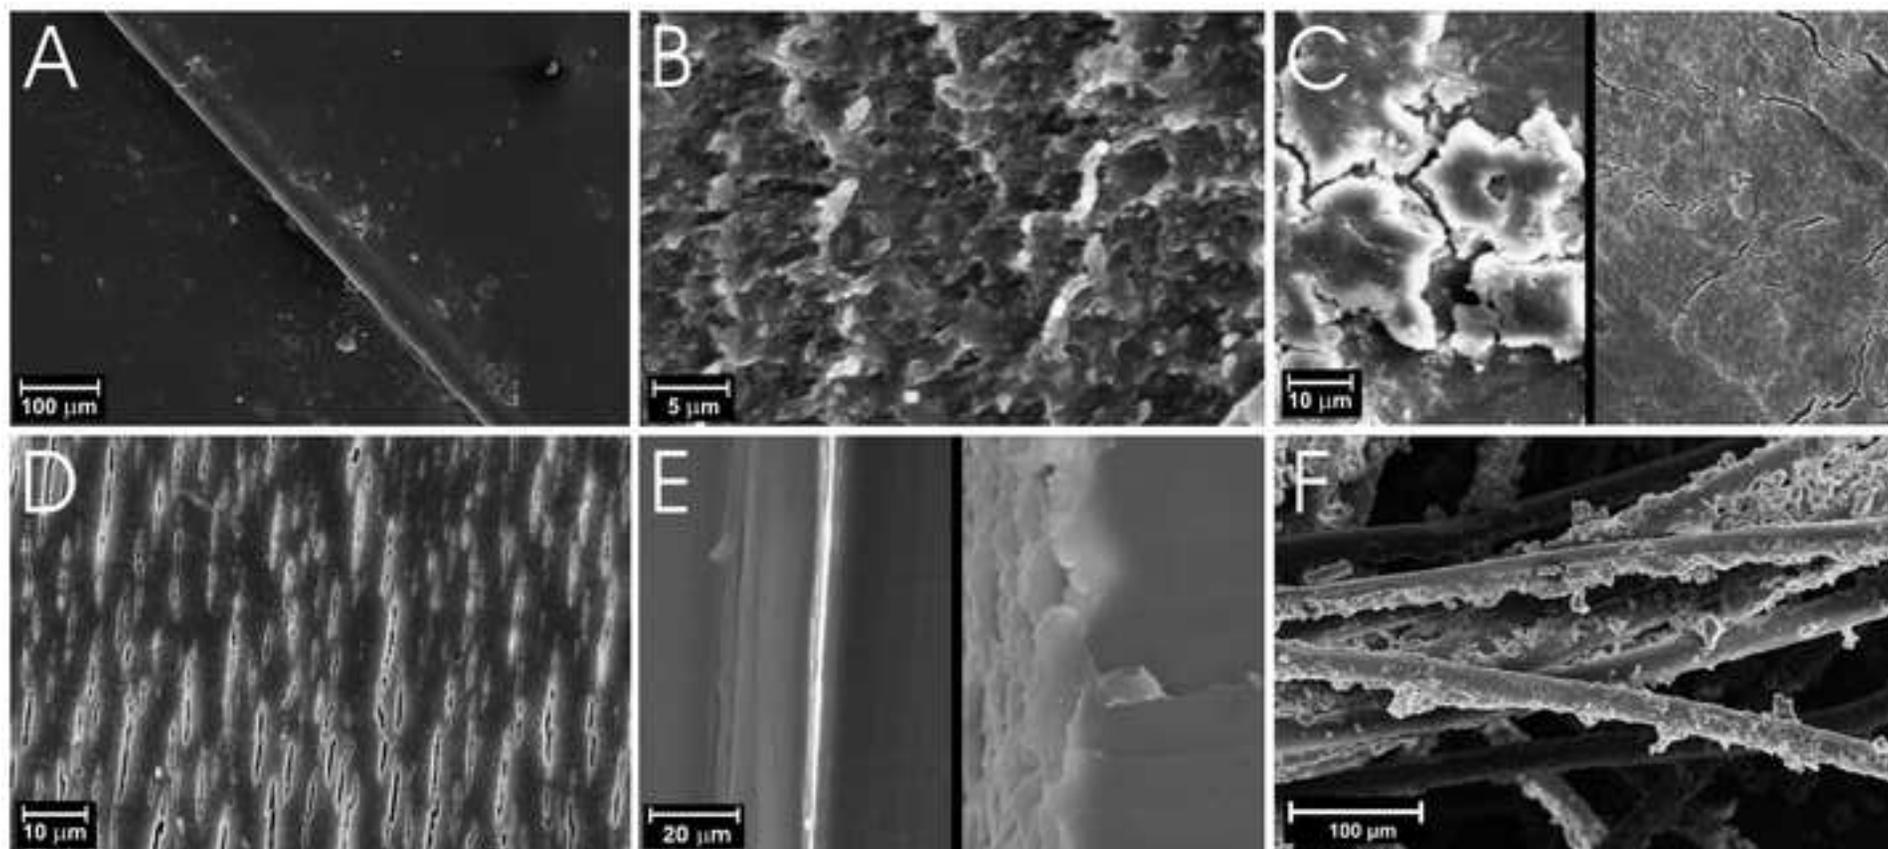
Figure 3.tif  
[Click here to download high resolution image](#)

After visual and optical microscope inspection, SEM images were taken from the most attractive zones and samples. The most interesting observations are reported in Figure 3. The undegraded surfaces of the retrievals, as that of the exemplar, show a smooth surface (Figure 3A).

In 2/5 observed samples, aligned fissures or microscopic surface cracks were detected (Figure 3D). The opaque side of Dyn20 was characterized by aligned fissures extended to a large area of the surface. On restricted zones, erosion and presence of micro-aggregates were observed in addition to the fissures. These results indicate that the devices were subjected to a degradation phenomenon involving crack formation and

To investigate how deep these surface alterations propagate, Exemplar and Dyn 10 devices were observed in section and their comparison is shown in Figure 3E. The edge of the Exemplar (left) is completely smooth, while the edge of Dyn 10 (right) is jagged, due to the cracks. This alteration involves no more than the first 10  $\mu\text{m}$  of the surface, suggesting no influence on the mechanical properties of the entire device.

Micro-aggregates, characterized by a organic composition, were observed also on the fibers of the PET cord, mainly on the external fibers, directly exposed to the body fluids, as it can be seen in Figure 3F.

Figure 3. SEM images of the most representative microscopic alteration observed on PCU spacers and PET cords.

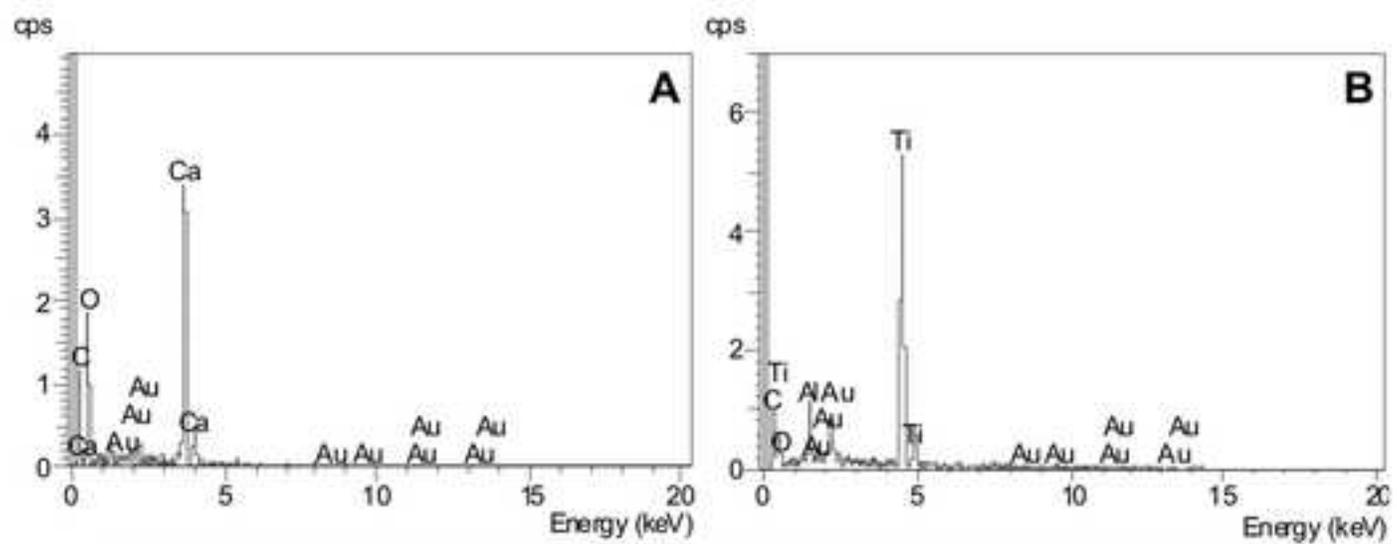
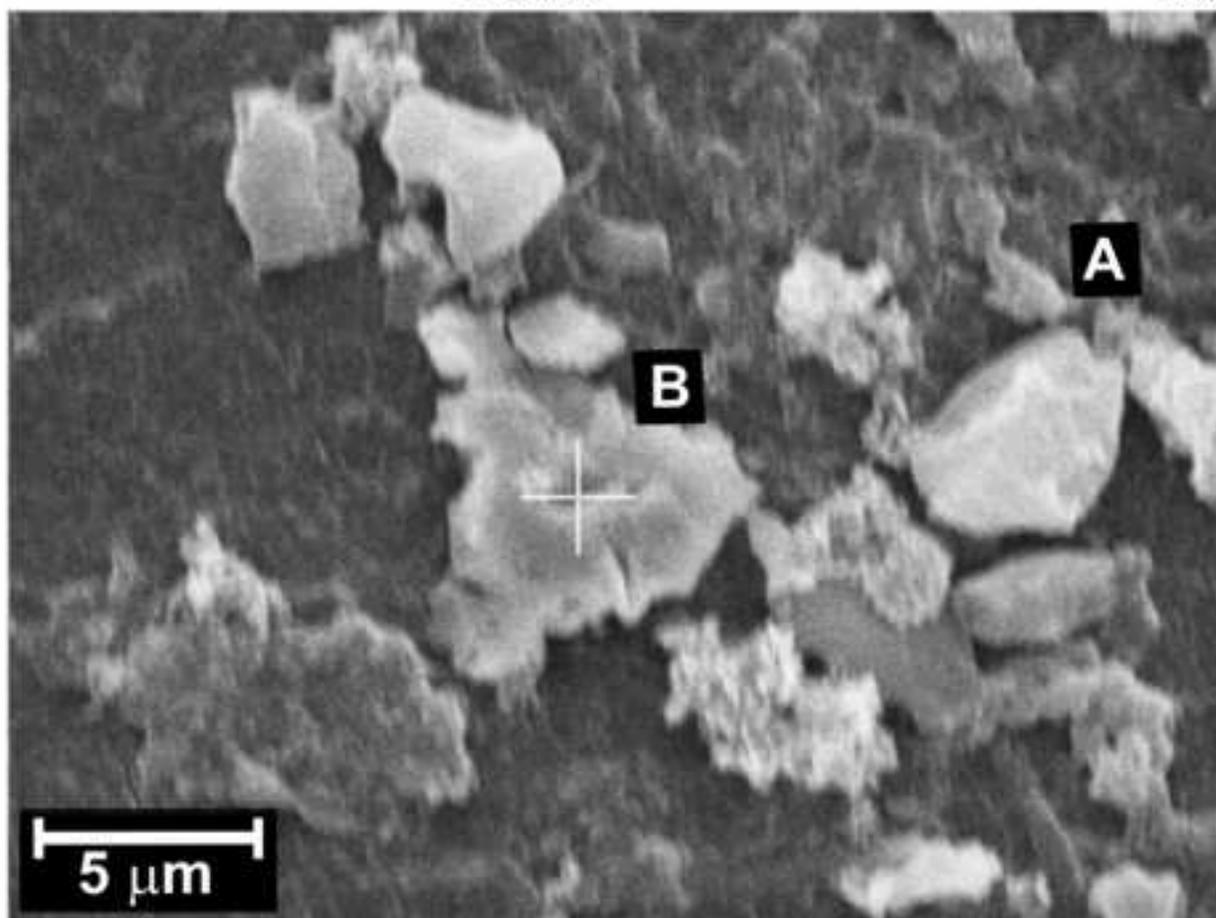
Figure 4.tif  
[Click here to download high resolution image](#)

Figure 4. SEM image and EDS results of micro-aggregates observed on the surface of PCU spacers.

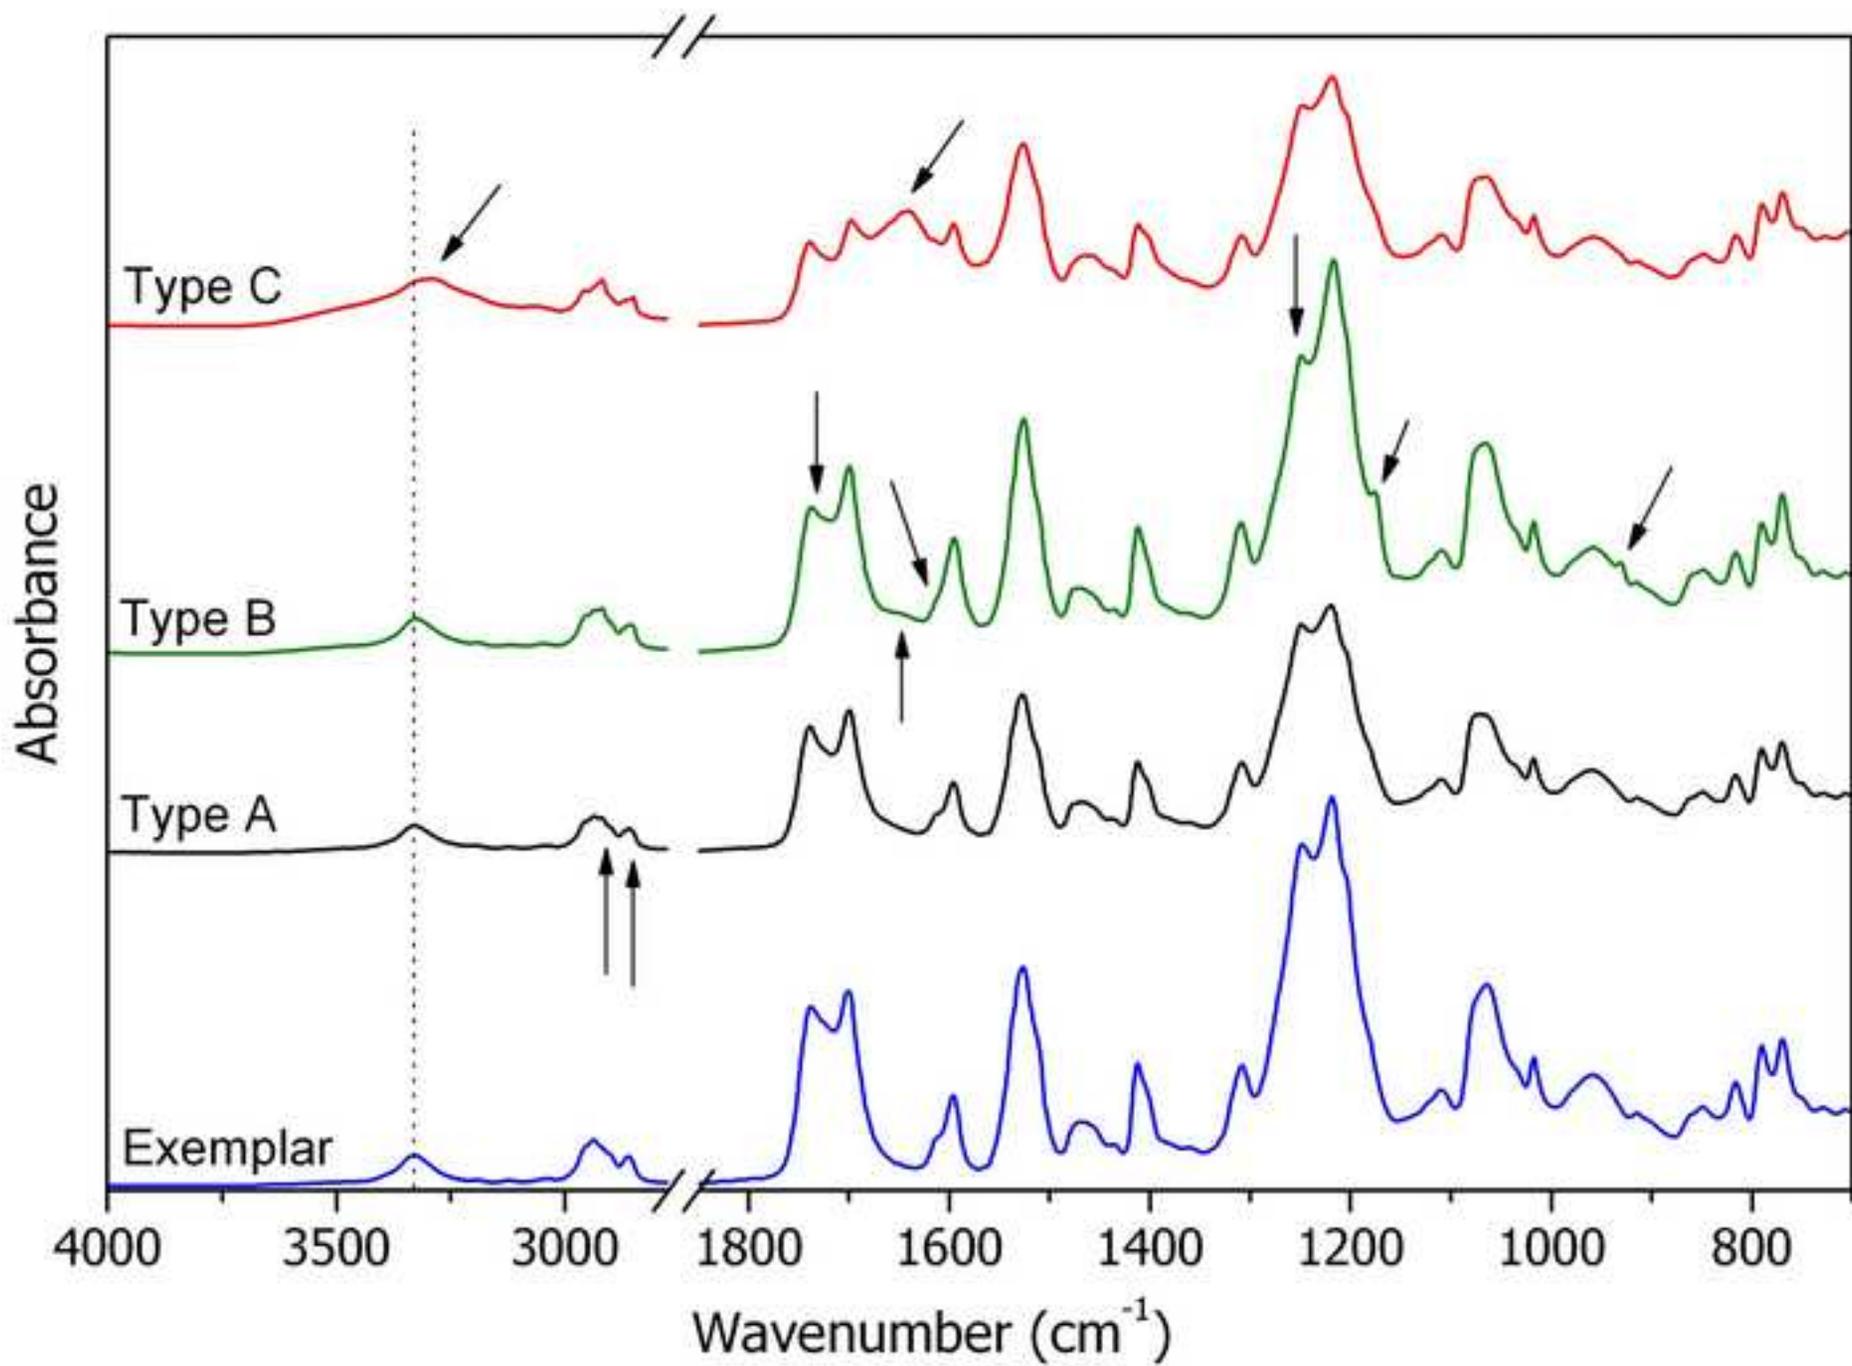
Figure 5y.jpg  
[Click here to download high resolution image](#)

6/14 spacers exhibit an ATR-FTIR spectrum similar to that reported in Figure 5 (Type B). The appearance of two new absorption at 1175 and 930  $\text{cm}^{-1}$  is related in the literature to the oxidative degradation of the PCU [22,49]. The increase of the new signals is strictly connected to a change in the shape of the signal at 1600  $\text{cm}^{-1}$  and to disappearance of the shoulder at 1614  $\text{cm}^{-1}$ . For high levels of oxidation a new, low signal was detected at 1645  $\text{cm}^{-1}$ . The change in the phenyl signal indicates a mechanism of oxidative degradation that involves the urethane segment.

In addition, in the most degraded samples, the absorption at 1736, 1248 and 790  $\text{cm}^{-1}$  show a dramatic decrease, if compared to those at 1700, 1219 and 770 respectively. The decrease of all the signals related to the carbonyl groups of carbonate species suggests a decrease in the amount of carbonate segments, indicating also an involvement of carbonate species in the degradation mechanism.
