JOURNAL OF MATERIALS SCIENCE. MATERIALS IN MEDICINE
(2014)

Correlation between in vivo stresses and oxidation of UHMWPE in total hip arthroplasty

M. Regis, P. Bracco, L. Giorgini, S. Fusi, P. Dalla Pria, L. Costa, C. Schmid

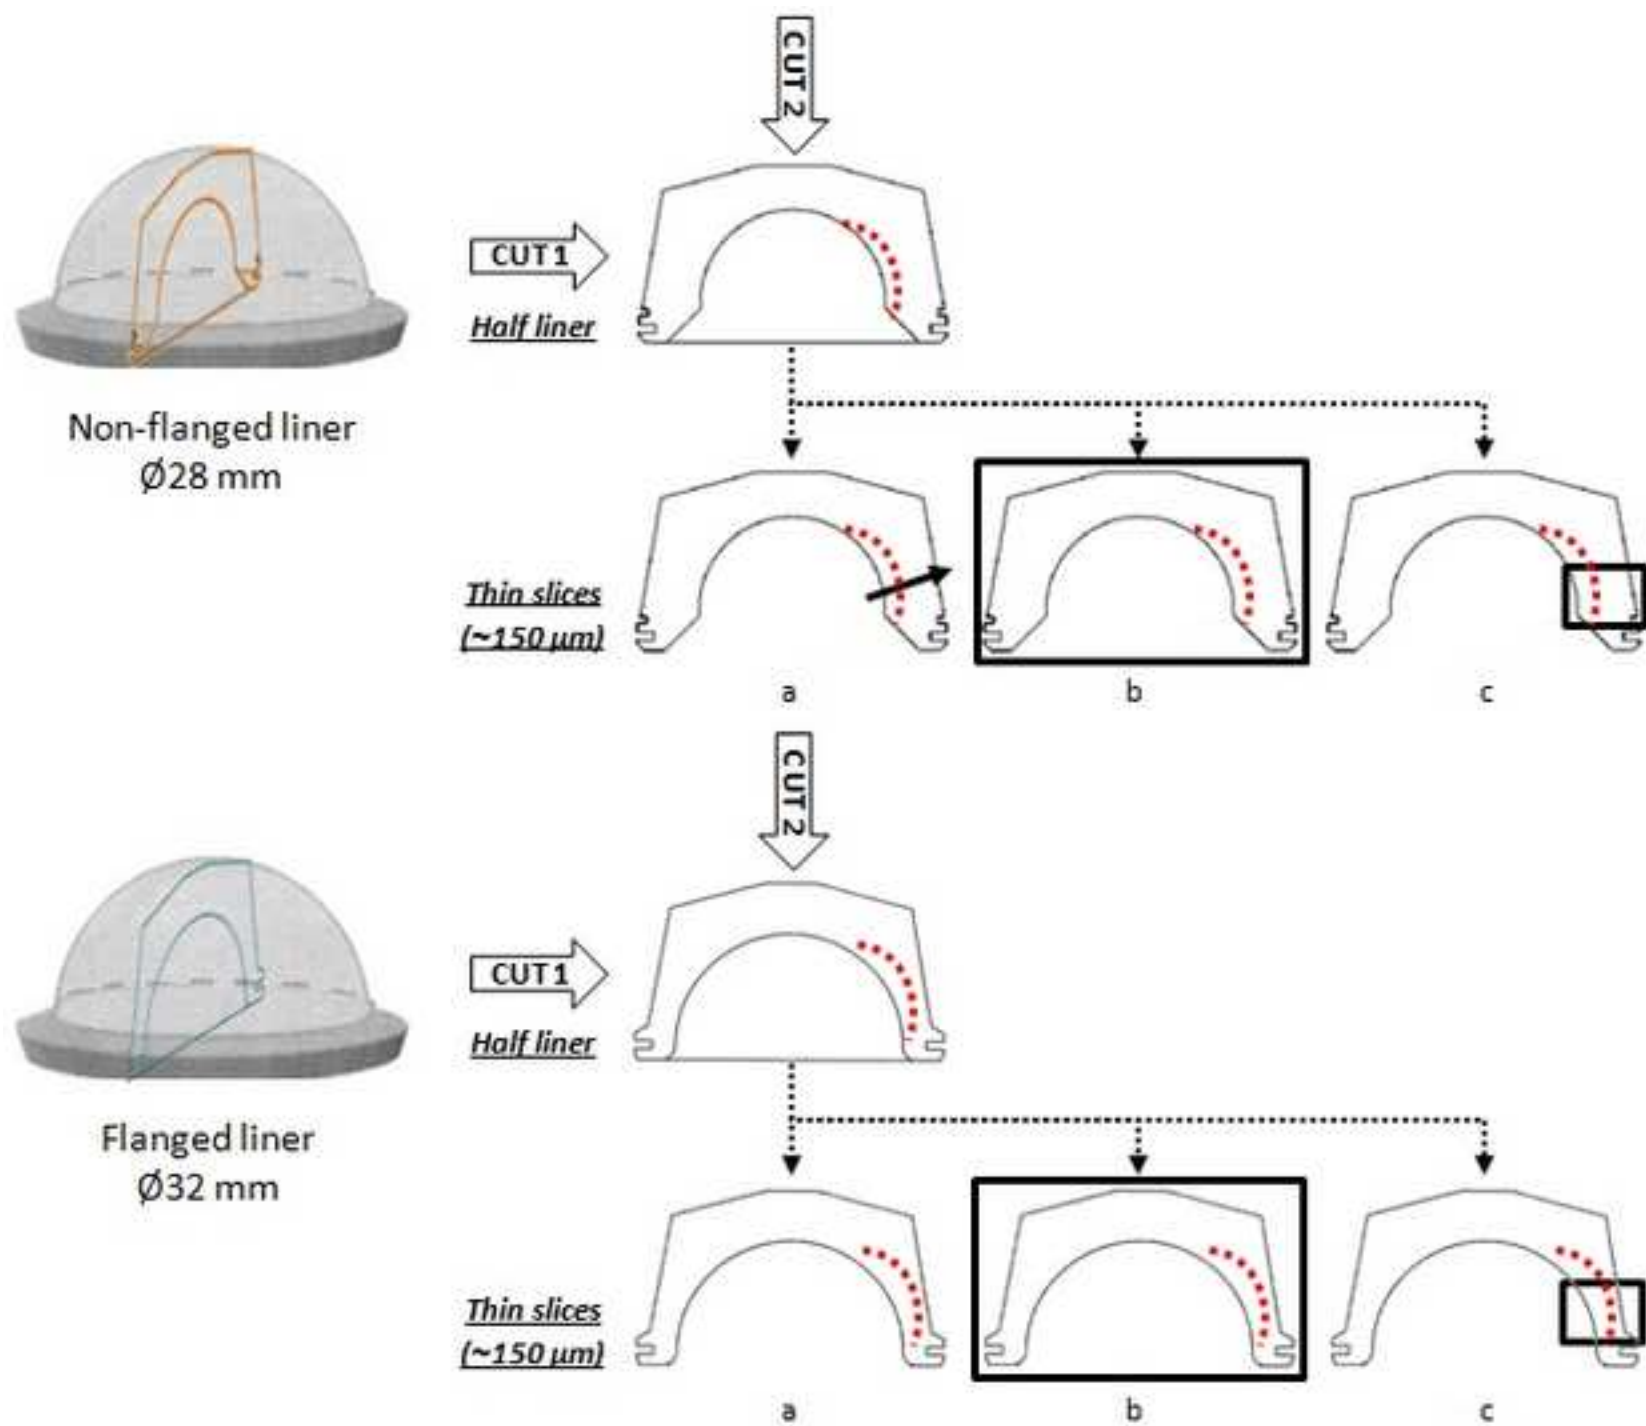
Figure 1
[Click here to download high resolution image](#)

Figure 1. Thin slices preparation of E1-E4 liners for FTIR analysis and investigated areas. From a to c, line scan path and direction (points collected every 100 μm); global IR map (surface scanned at 100x100 μm spot size); worn side detailed IR map (surface scanned at 25x25 μm spot size). Red dotted line indicates the most worn region.

After wear evaluation, liners were cut in half so that their cross-section contained both worn and unworn areas, and microtomed into thin sections (~150 µm) for FTIR analysis, using a Reichert-Jung POLYCUT S microtome (cutting speed 4 cm/s, at room temperature). The same microtoming conditions were used to obtain thin films of the reference materials. Cutting scheme and FTIR analysis for all the considered liners are summarized in Figure 1. After a cyclohexane Soxhlet extraction, performed to remove in vivo absorbed lipids, FTIR analyses were conducted using a Perkin-Elmer SPOTLIGHT microscope, to assess the oxidation level and distribution in all samples. At first, FTIR line scans (100x100 µm spot size, 16 scans at 4cm⁻¹ resolution) of E1-E4 samples were performed along the thickness of the worn cross section. The sections were scanned in 100µm deep increments from the articulating surface towards the backside (Figure 1a). E0 shelf-aged sample and the reference virgin block were also line-scanned for comparison. Then, FTIR spectral maps were collected (transmission mode, 16 scans at 4 cm⁻¹ resolution for each point, autofocus every 10th scan). Maps allowed to gain information on the oxidation level of both worn and unworn liner areas (Figure 1b and c). The spot size for the IR maps varied from 100x100 µm to 25x25 µm, depending on the size of the scanned area (the whole area or the rim area by the worn side, respectively). This determined a more accurate data acquisition in the most worn areas of the samples. All spectra were normalized at 2020 cm⁻¹, a combination band associated with the twisting of CH₂, which can be regarded as unaffected by minor changes in the polymer structure [31]. A ketone index (KI) was calculated as the peak ratio between the deconvolved carbonyl peak centered at 1718 cm⁻¹ and the reference band at 2020 cm⁻¹. Oxidation index (OI) calculation (following ASTM F2102 and F2381) was not performed, in order not to introduce measurement deviations in terms of esters presence introduced by microtoming [32].

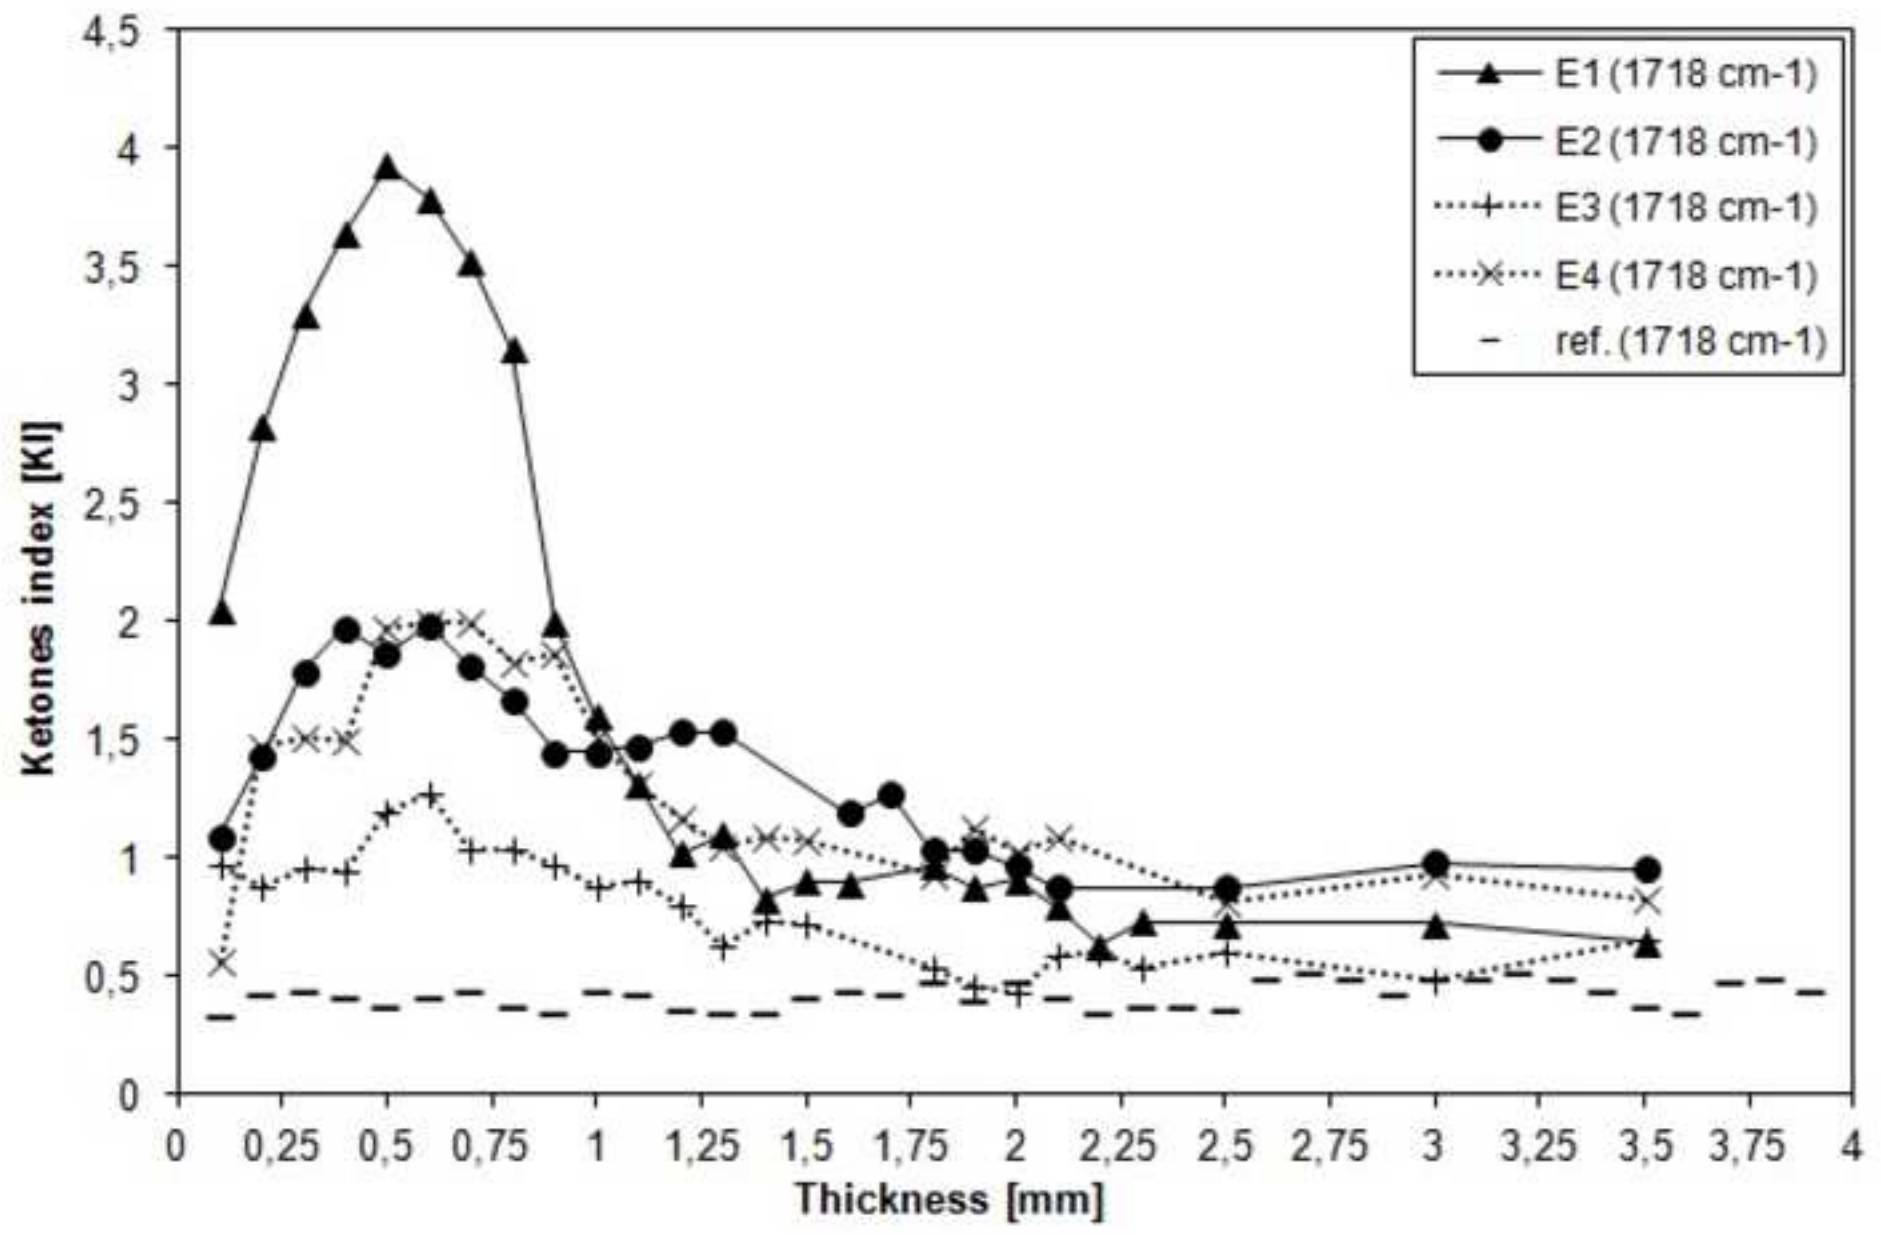
Figure 2
[Click here to download high resolution image](#)

Figure 2. Ketone index profiles across the most worn section of E1-E4 and Reference profile. The 0 depth value is located at the inner rim of the liner.

Figure 2 reports the oxidation profile (in terms of KI) at the worn side of samples E1-E4 throughout the liners cross section (first 4mm from the bearing surface), along with that of the reference UHMWPE block, obtained from the line scan analyses. All the explanted samples show the same oxidation distribution across the liner thickness, having a maximum peak either at the inner bearing surface or in the first subsurface region. The strongest oxidation was observed in sample E1, with a

peak KI index of 3.92 at 0.5-0.6 mm depth. The amount of oxidation then decreases moving towards the bulk and the backside of the liner. The KI trend across the liner section seems not to follow any diffusive law, since the highest amount of oxidation was observed in the subsurface areas.

Moreover, the oxidation throughout the explanted liners cross-section is limited to the surface and first subsurface region of the inner worn side of the liner (Figure 2 and 4). In all the other scanned areas, the oxidation level was equal or lower than that of the reference material. Therefore, oxidation seems to be strongly localized in the ball and socket coupling area, in which the sliding motion between femoral head and liner occurs and where physiological load is applied. As well as for the linear wear data, it can be hypothesized that differences in patient weight, activity and other external factors have influenced the results.

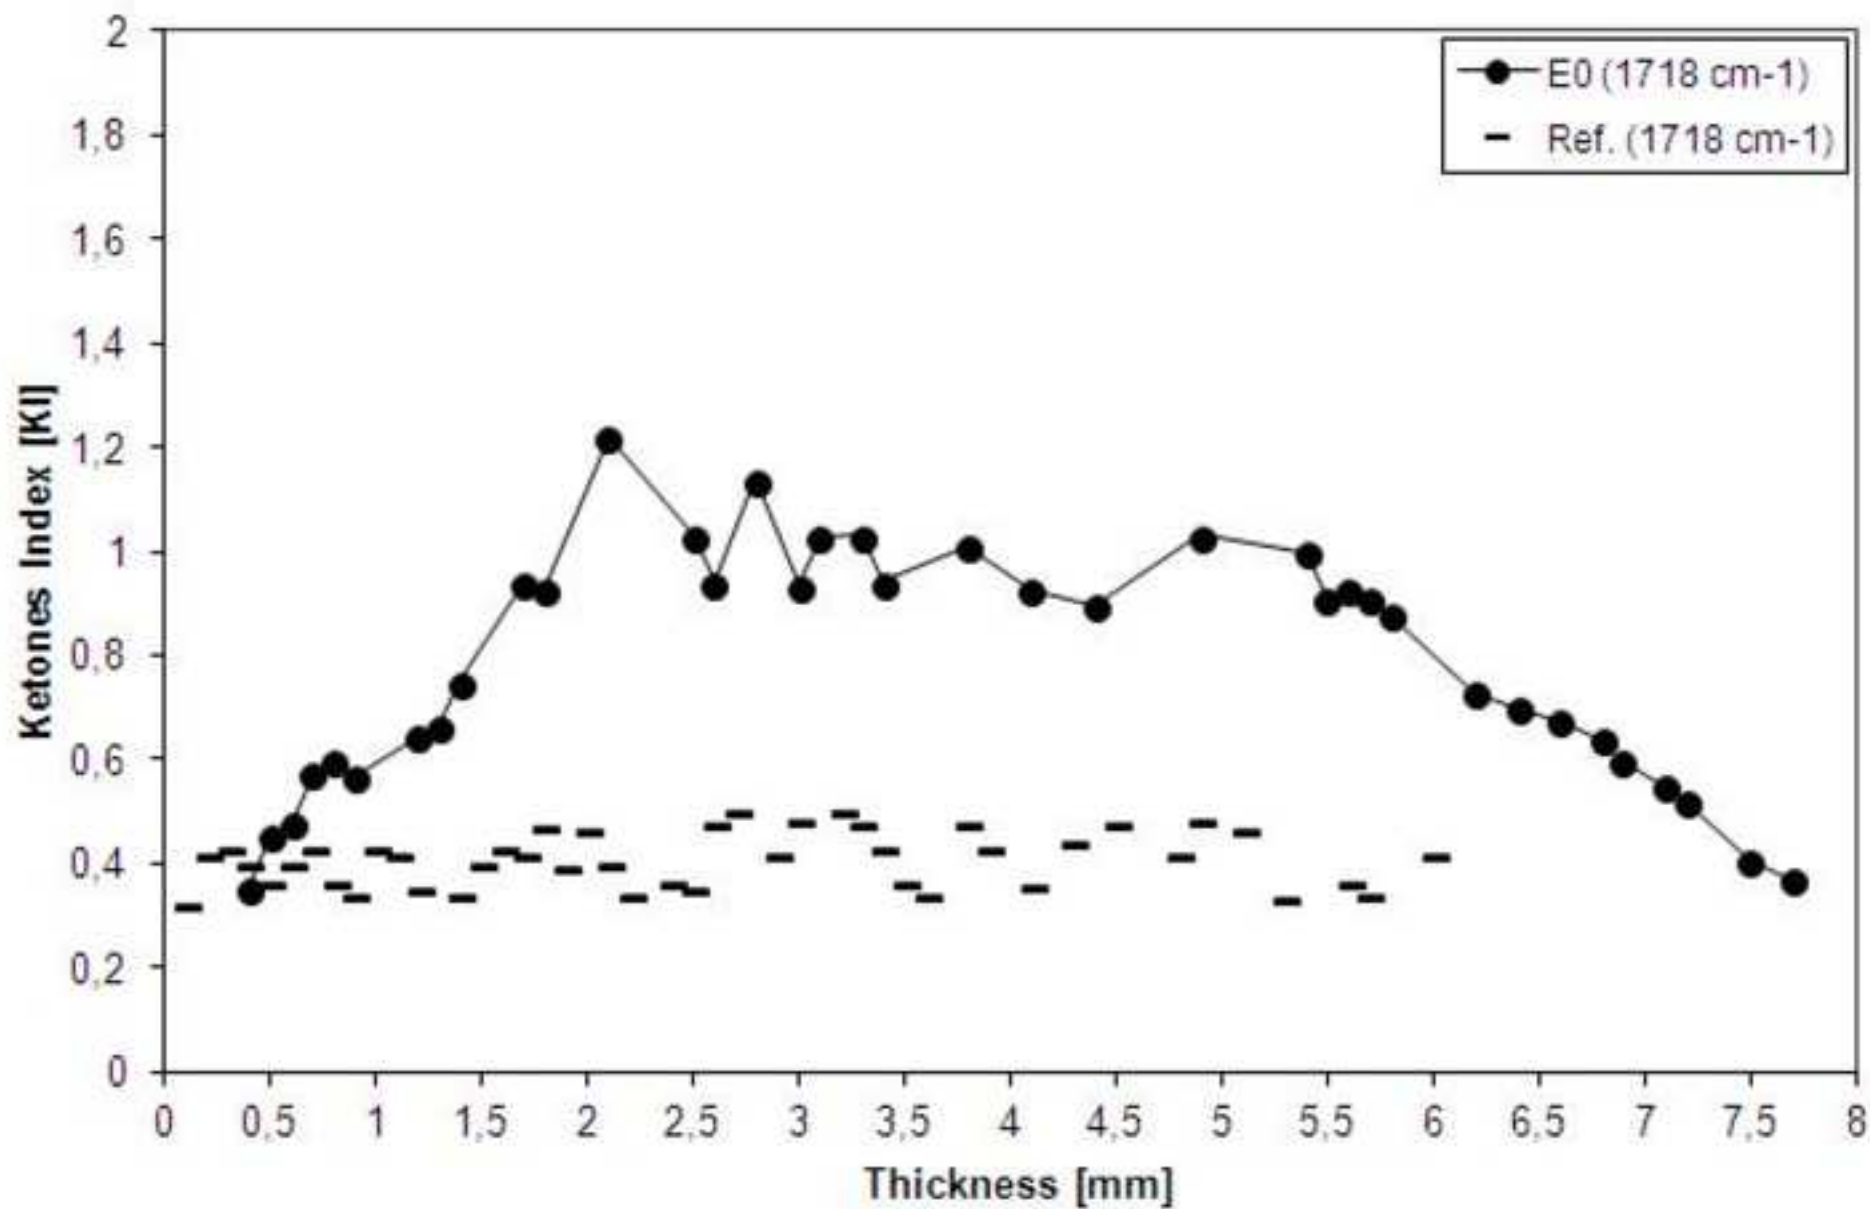
Figure 3
[Click here to download high resolution image](#)

Figure 3. Ketone index profiles across the cut section of shelf aged E0 liner, and Reference profile. The 0 depth value is located at the inner rim of the liner.

No correlation between linear wear data and oxidation could be detected. However, it is noticeable that for the highest in vivo time (E1 liner), the highest amount of oxidation products was observed. The reference UHMWPE block did not show any significant oxidation, while the shelf aged liner (E0) had a different oxidation profile, as reported in Figure 3 (note the difference in the KI trend, when compared to Figure 2). According to similar literature studies [24, 25], the oxidation profile throughout E0 cross section shows a symmetric path, with a maximum peak in the central region of the liner. When comparing the oxidation profiles of the explanted liners to that of the shelf aged one, no similarities can be found, neither in terms of KI trend, nor in terms of peak oxidation, as for the shelf aged liner the oxidation amount was lower than in the retrieved components.

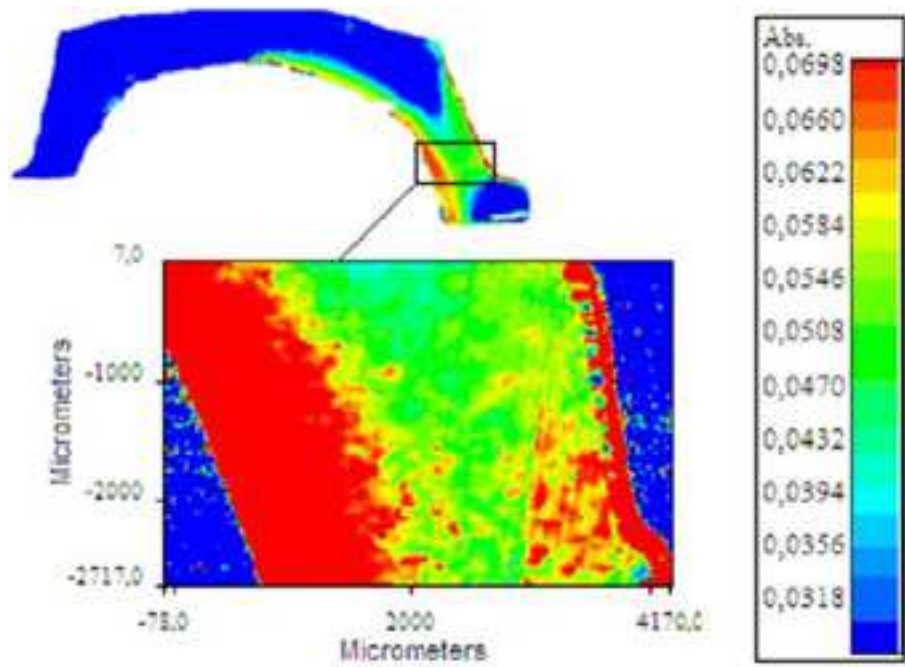
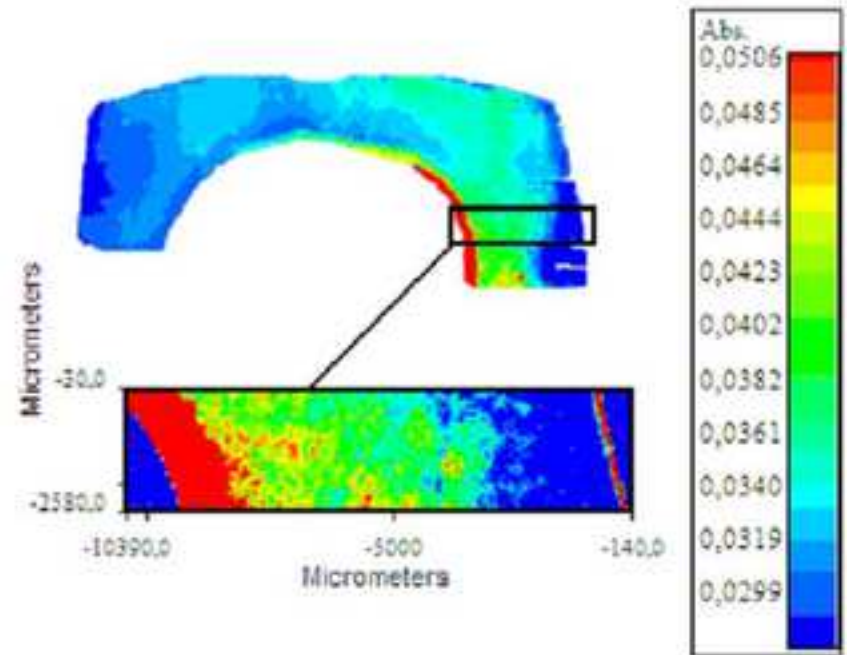
Figure 4
[Click here to download high resolution image](#)

Figure 4. FTIR maps of the ketones absorption (1718 cm^{-1}) in the retrieved liners (left sample E3, right sample E2). The distribution of the oxidation products is asymmetric, with the highest concentrations in correspondence of the worn area. On the opposite side of the section, no relevant oxidation was retrieved.

Figure 4 shows the FTIR maps obtained from the whole area scan of E3 and E2 with the detail of the most worn area for each liner. Oxidation distribution is asymmetric and strongly localized, and significant presence of ketones was found in the worn areas only. No traces of oxidation were found at the opposite region of the liners cross section, indicating that oxidation occurred in correspondence of the loaded areas, that is where the contact between femoral head and liner occurred and, consequently, where the majority of wear concentrated.

Comparing the IR maps to the FEA results (Figure 4 vs. 6), there is an evident correlation between the concentration of oxidation products and the stress distribution for both liners geometries. The asymmetric stress and oxidation maps reveal that these phenomena are related to the joint compliance, strongly depending upon the head and cup positioning. These data confirm that lifetime

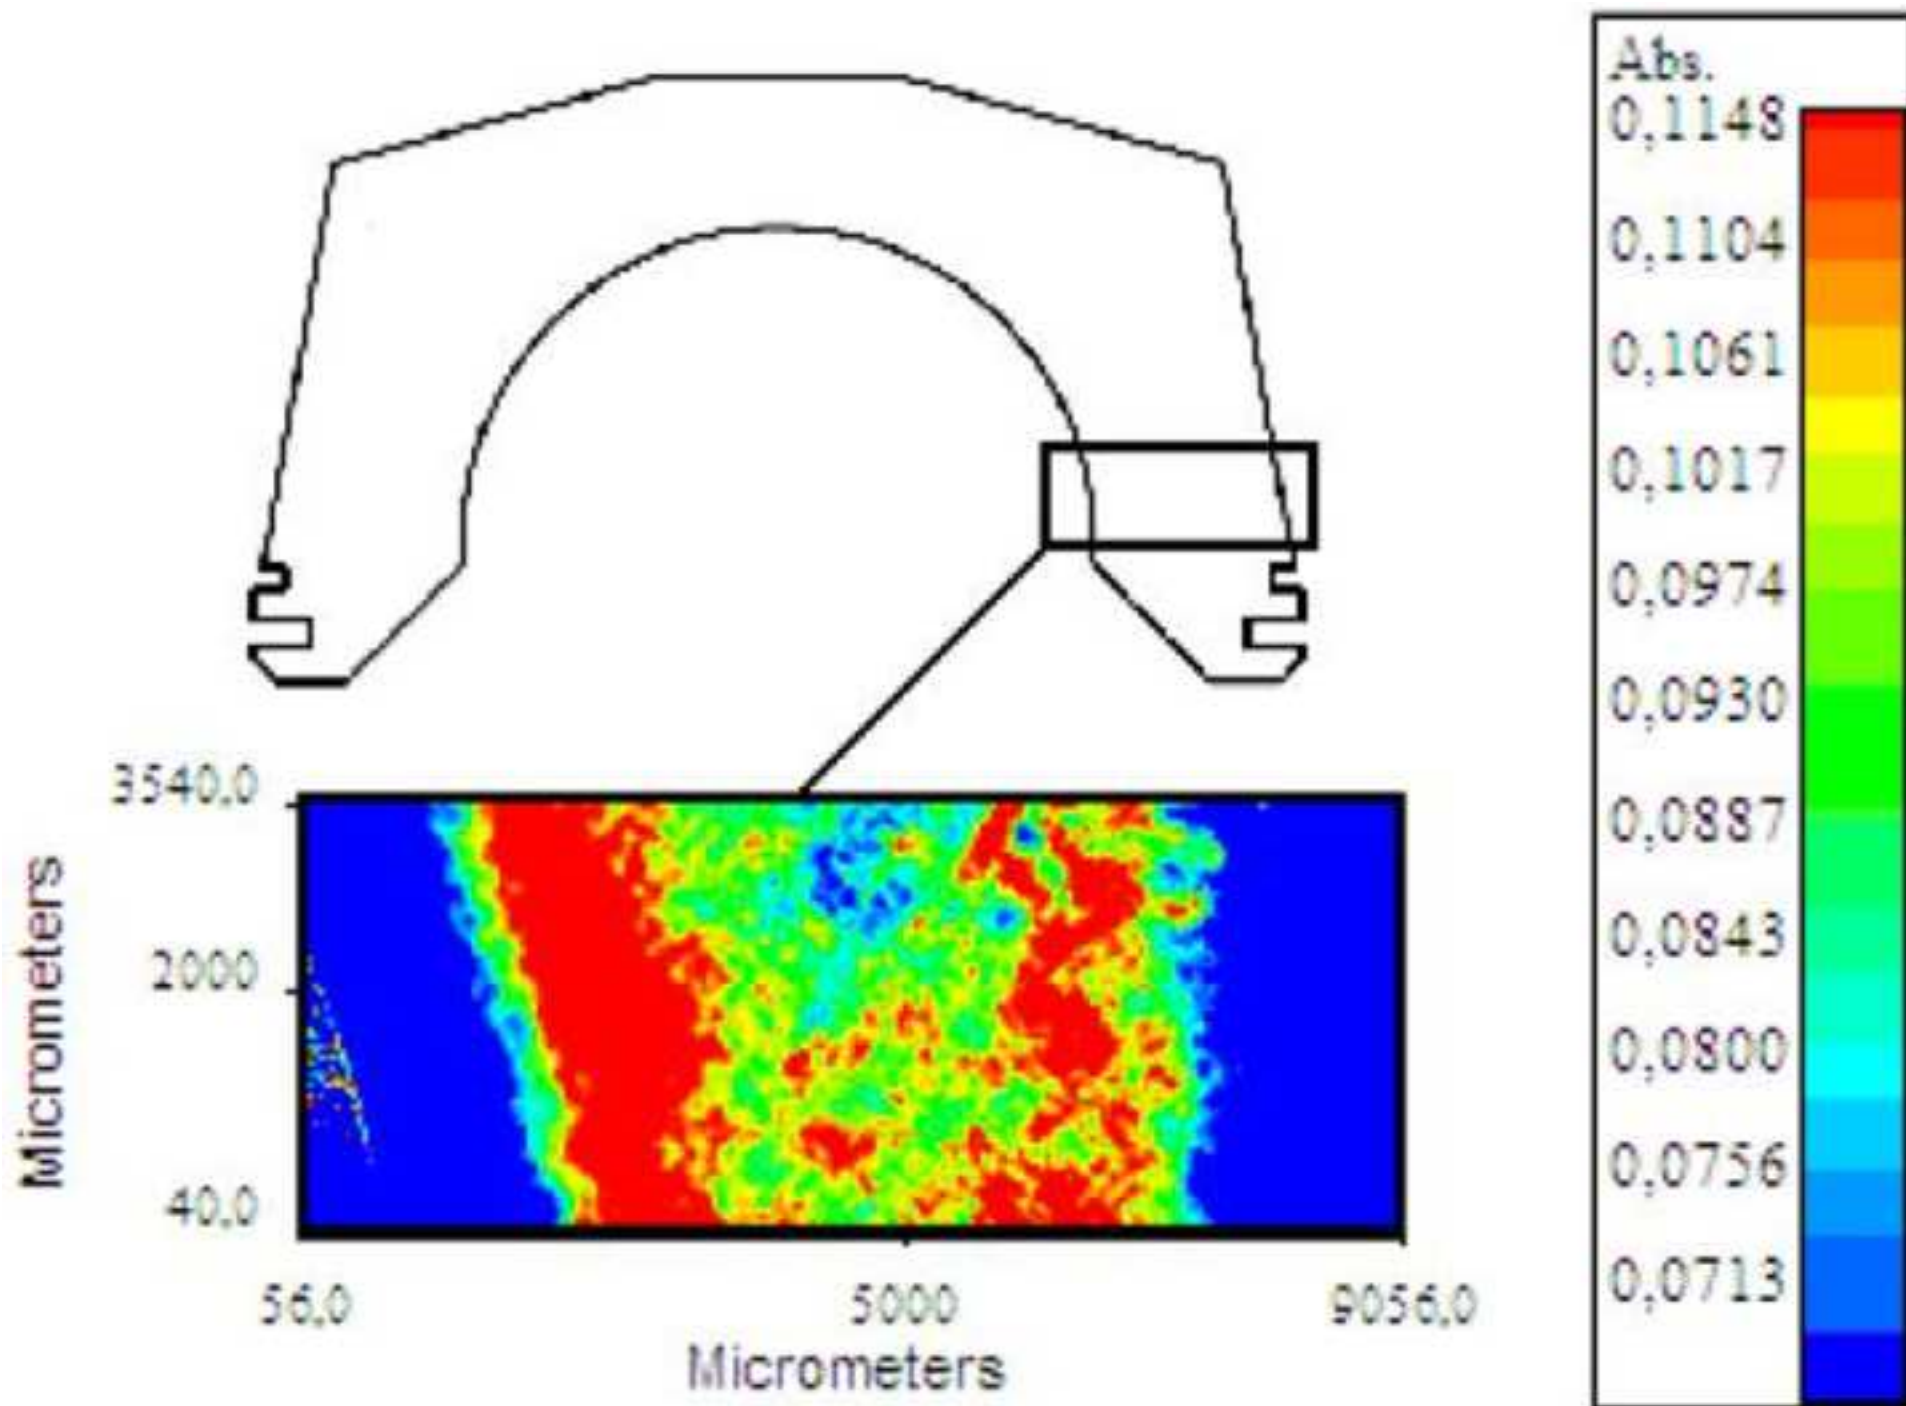
Figure 5
[Click here to download high resolution image](#)

Figure 5. FTIR map of the ketones absorption (1718 cm^{-1}) in the shelf aged liner (E0). The maximum oxidation is located in the bulk of the liner.

Different geometries showed different IR maps, as documented by the data obtained from the lower rim detailed scans. In particular, oxidation distribution in the Ø32mm liner flanged area is different in respect to the non flanged Ø28mm liner geometry. As for the line scan analysis, the FTIR detailed map of sample E0 showed a different distribution of the oxidation products compared to E1-E4 retrieved liners (Figure 5).

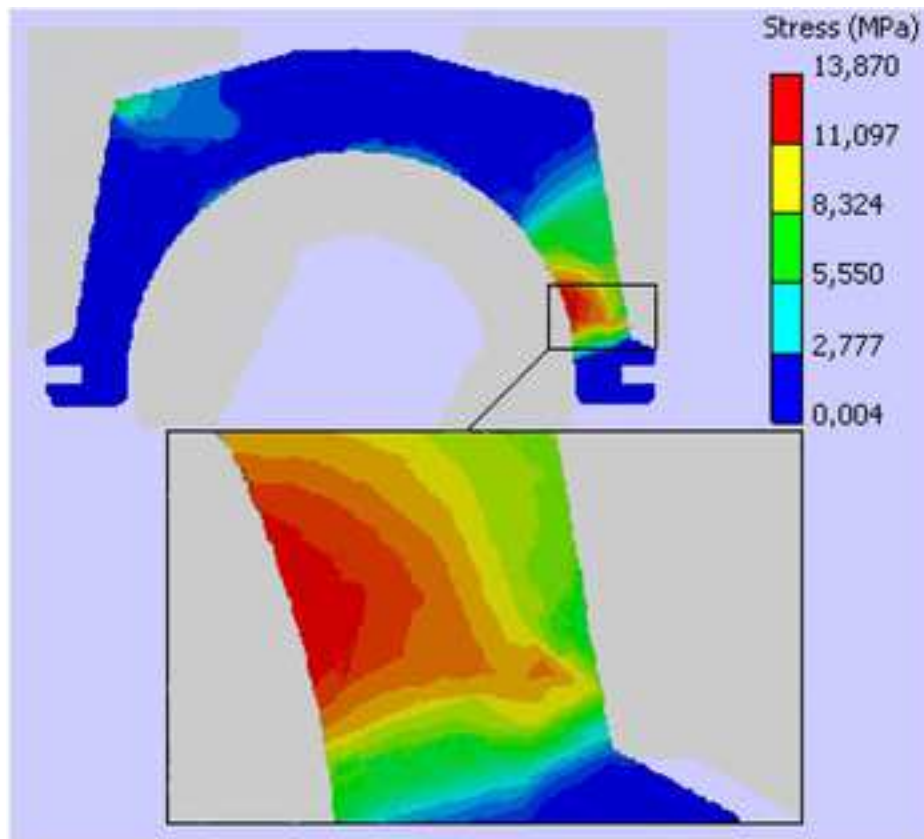
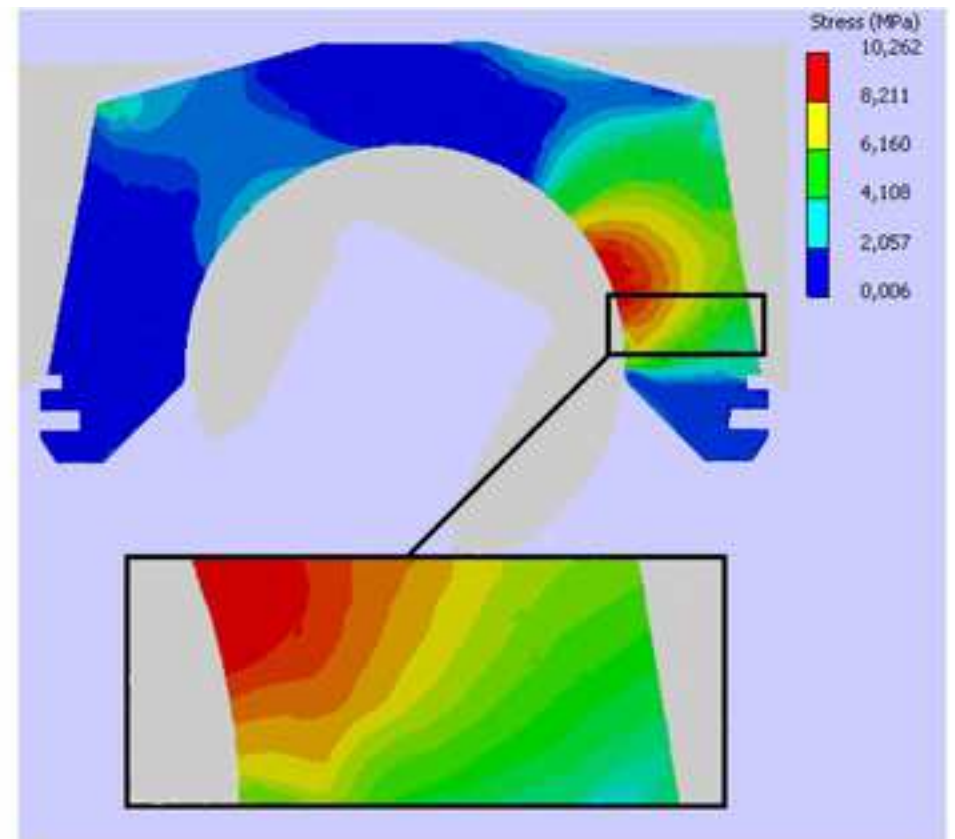
Figure 6
[Click here to download high resolution image](#)

Figure 6. FE analysis of the stress distribution in the cross-section of the liners (left $\text{Ø}32\text{ mm}$ and right $\text{Ø}28\text{ mm}$).

FE analyses revealed that the load distribution is located in the same liner cross section regions affected by oxidation (Figure 6). As for the IR maps, different geometries led to different stress fields. In fact, as expected, the flanged area affects the stress distribution in the Ø32mm liner, creating a different profile in respect to the Ø28mm non-flanged geometry. Moreover, it is observed that also the stress field range varies accordingly to the liner thickness, as for the Ø32mm liner it is more spread towards the bulk of the cross section. This is in accordance to literature data concerning the rise of stresses and applied loads for thinner and larger UHMWPE liners [37]. Stress levels, in terms of von Mises criterion, are 10.3 MPa and 13.9 MPa for the Ø28mm and Ø32mm geometries respectively. Values are in accordance with the liner geometry and thickness. Stress

field range covers the same region of the observed oxidised area for Ø28mm and Ø32mm liners, and maximum values of both von Mises stress and KI are located in the same area.
