JOURNAL OF MATERIALS SCIENCE. MATERIALS IN MEDICINE
(2014)

Correlation between in vivo stresses and oxidation of UHMWPE in total hip arthroplasty

M. Regis, P. Bracco, L. Giorgini, S. Fusi, P. Dalla Pria, L. Costa, C. Schmid

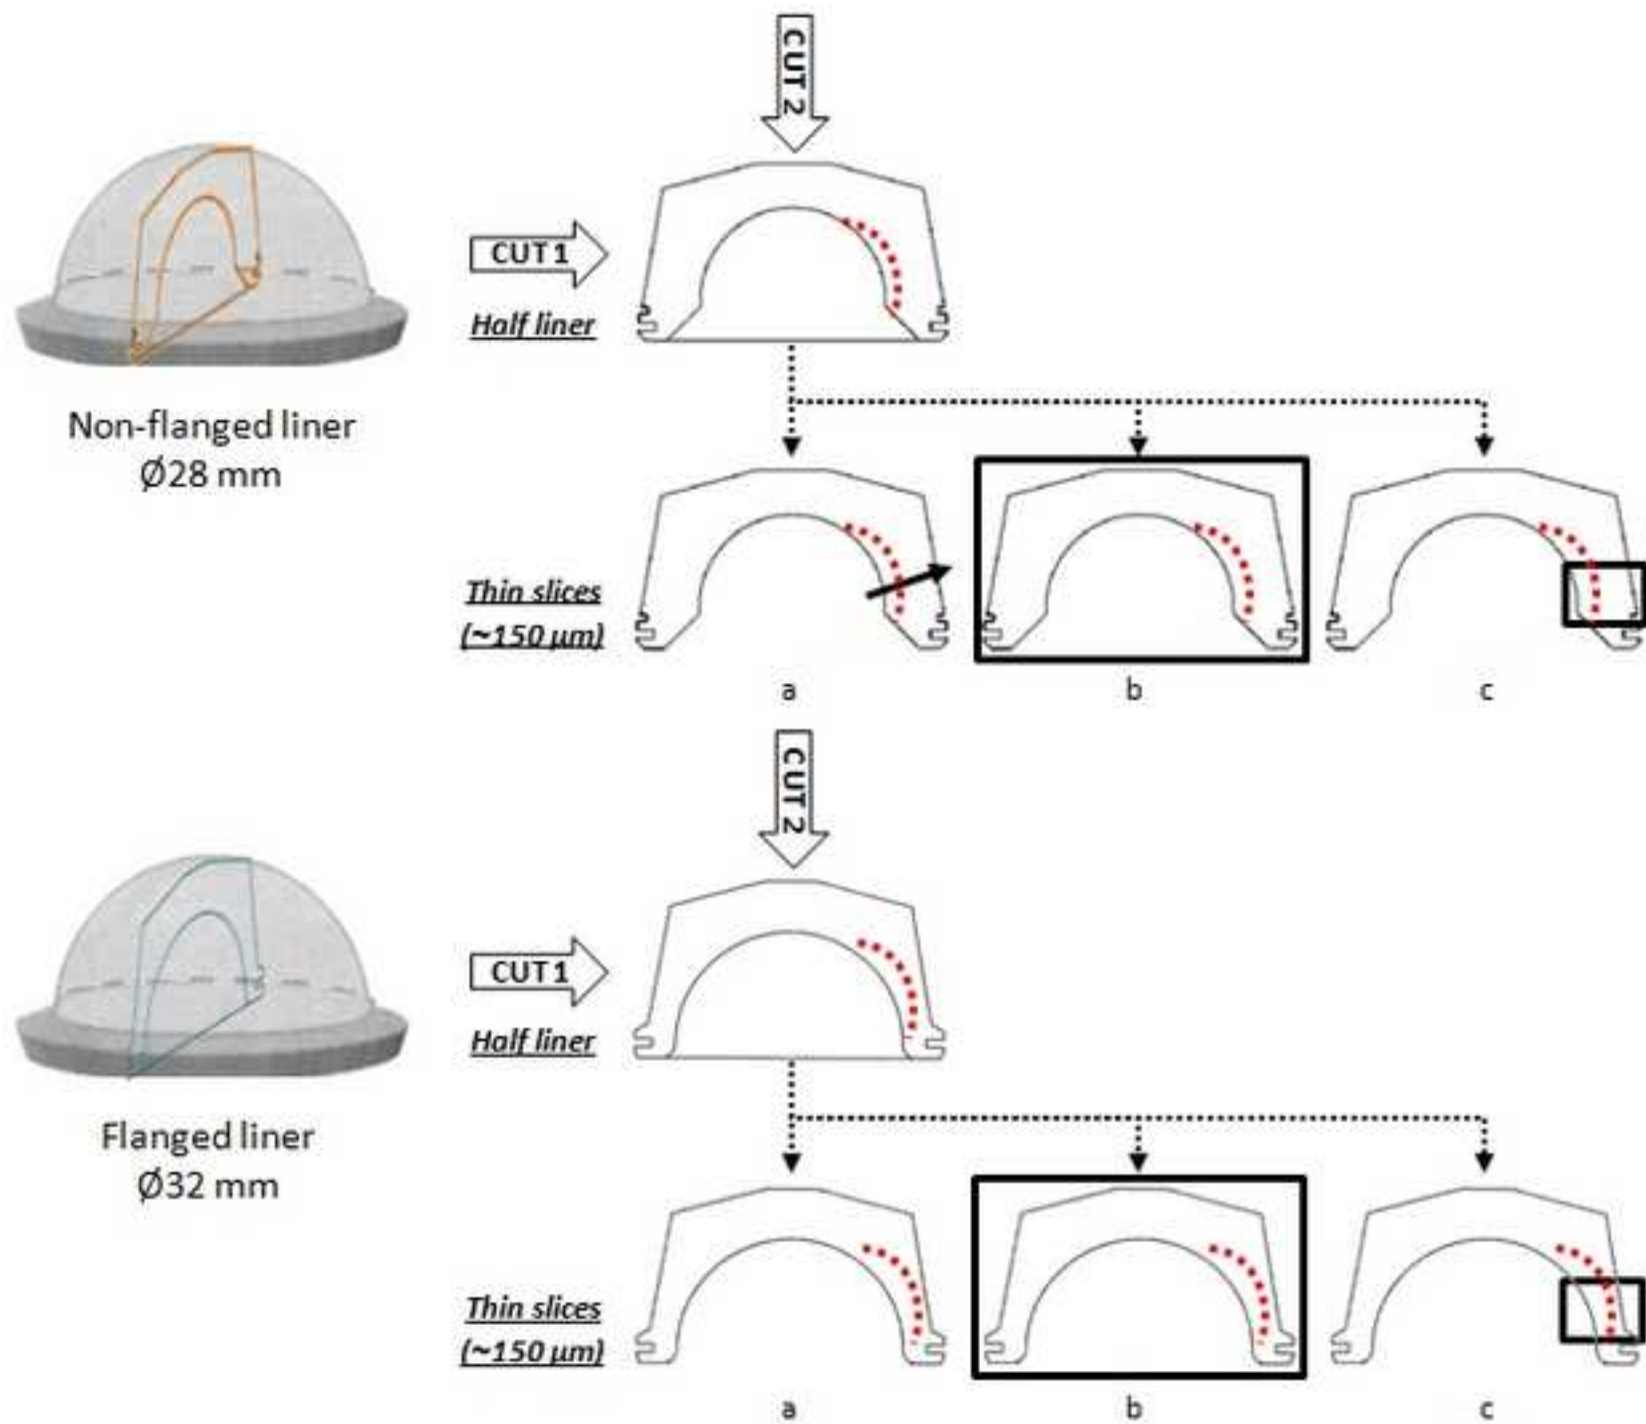
Figure 1
[Click here to download high resolution image](#)

Figure 1. Thin slices preparation of E1-E4 liners for FTIR analysis and investigated areas. From a to c, line scan path and direction (points collected every 100 μm); global IR map (surface scanned at 100x100 μm spot size); worn side detailed IR map (surface scanned at 25x25 μm spot size). Red dotted line indicates the most worn region.

After wear evaluation, liners were cut in half so that their cross-section contained both worn and unworn areas, and microtomed into thin sections (~150 µm) for FTIR analysis, using a Reichert-Jung POLYCUT S microtome (cutting speed 4 cm/s, at room temperature). The same microtoming conditions were used to obtain thin films of the reference materials. Cutting scheme and FTIR analysis for all the considered liners are summarized in Figure 1. After a cyclohexane Soxhlet extraction, performed to remove in vivo absorbed lipids, FTIR analyses were conducted using a Perkin-Elmer SPOTLIGHT microscope, to assess the oxidation level and distribution in all samples. At first, FTIR line scans (100x100 µm spot size, 16 scans at 4cm⁻¹ resolution) of E1-E4 samples were performed along the thickness of the worn cross section. The sections were scanned in 100µm deep increments from the articulating surface towards the backside (Figure 1a). E0 shelf-aged sample and the reference virgin block were also line-scanned for comparison. Then, FTIR spectral maps were collected (transmission mode, 16 scans at 4 cm⁻¹ resolution for each point, autofocus every 10th scan). Maps allowed to gain information on the oxidation level of both worn and unworn liner areas (Figure 1b and c). The spot size for the IR maps varied from 100x100 µm to 25x25 µm, depending on the size of the scanned area (the whole area or the rim area by the worn side, respectively). This determined a more accurate data acquisition in the most worn areas of the samples. All spectra were normalized at 2020 cm⁻¹, a combination band associated with the twisting of CH₂, which can be regarded as unaffected by minor changes in the polymer structure [31]. A ketone index (KI) was calculated as the peak ratio between the deconvolved carbonyl peak centered at 1718 cm⁻¹ and the reference band at 2020 cm⁻¹. Oxidation index (OI) calculation (following ASTM F2102 and F2381) was not performed, in order not to introduce measurement deviations in terms of esters presence introduced by microtoming [32].

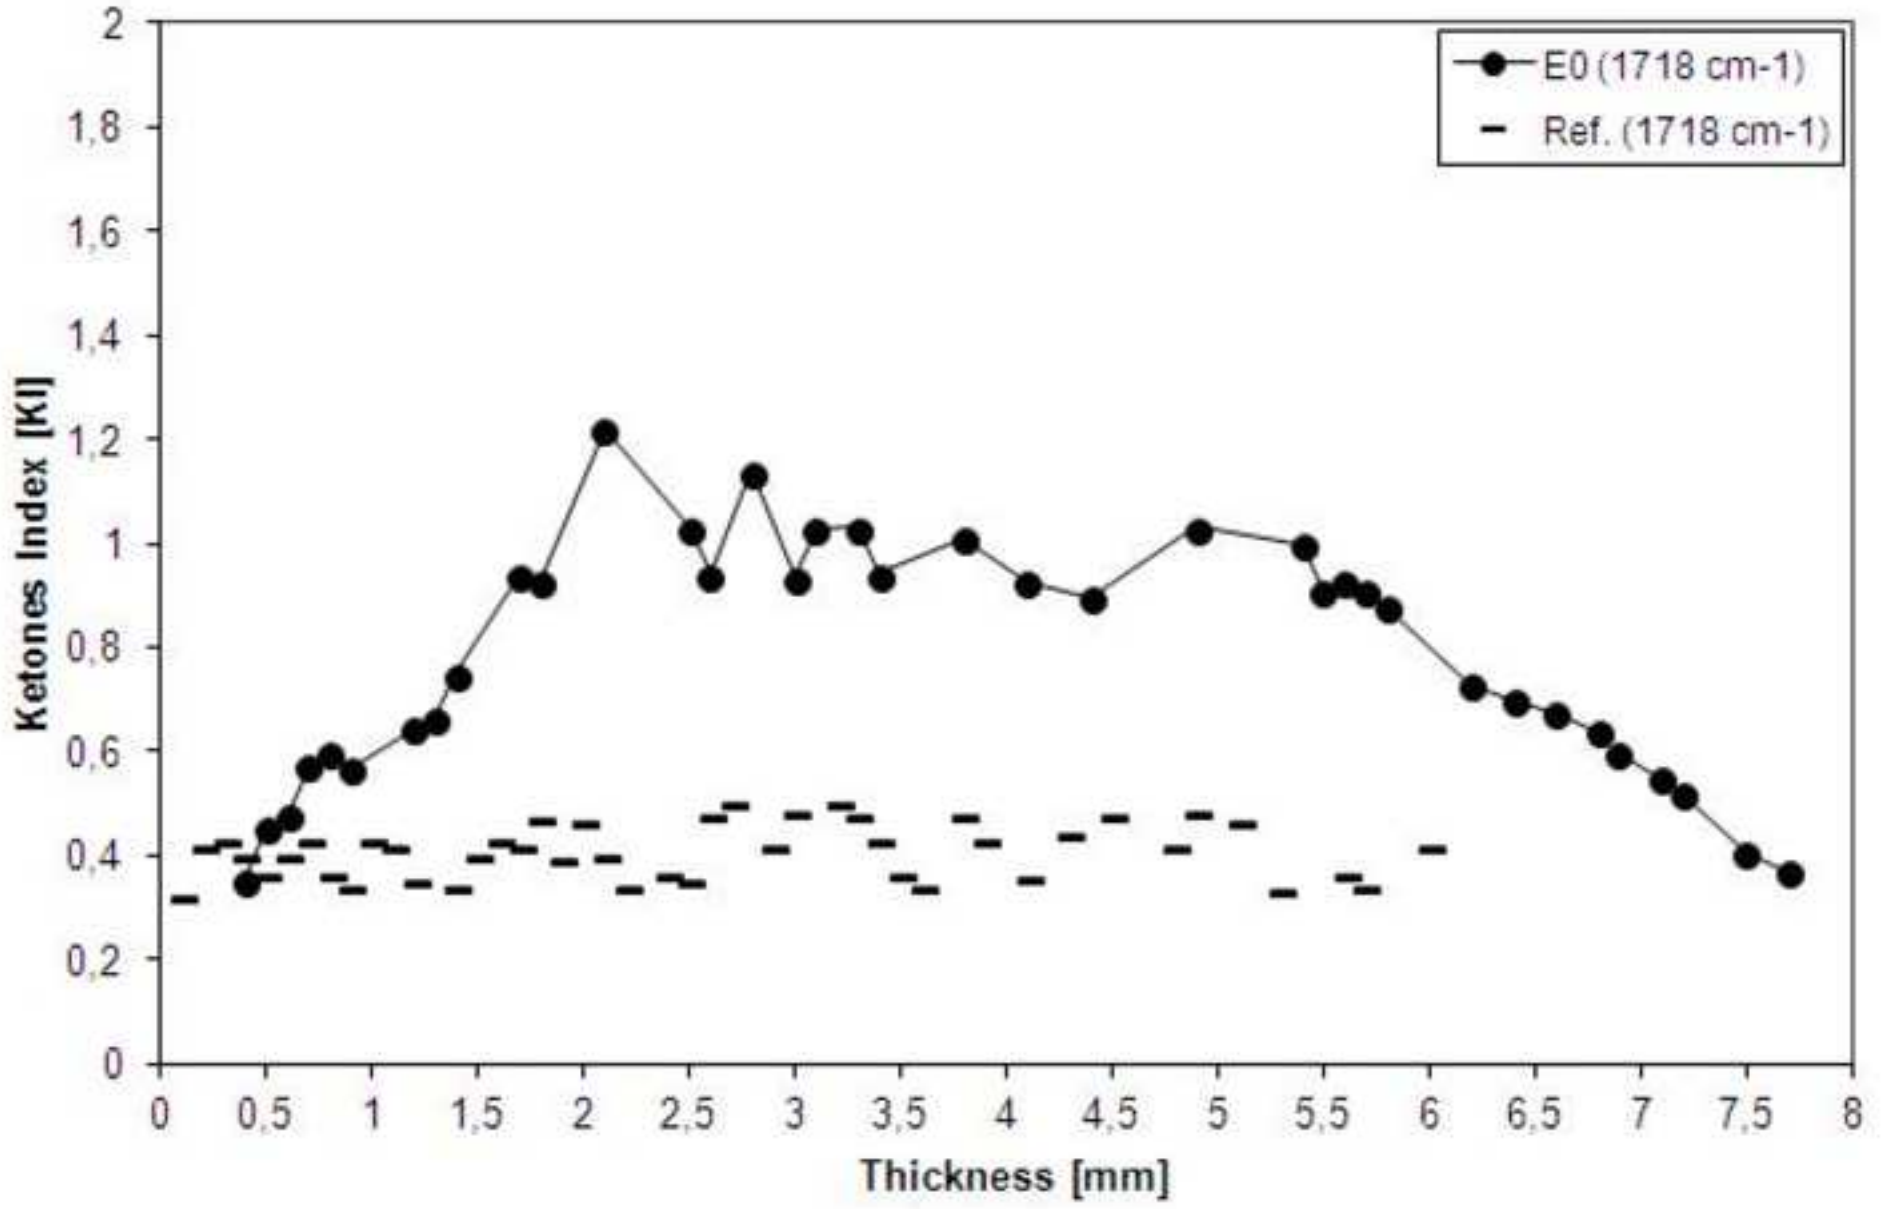
Figure 3
[Click here to download high resolution image](#)

Figure 3. Ketone index profiles across the cut section of shelf aged E0 liner, and Reference profile. The 0 depth value is located at the inner rim of the liner.

No correlation between linear wear data and oxidation could be detected. However, it is noticeable that for the highest in vivo time (E1 liner), the highest amount of oxidation products was observed. The reference UHMWPE block did not show any significant oxidation, while the shelf aged liner (E0) had a different oxidation profile, as reported in Figure 3 (note the difference in the KI trend, when compared to Figure 2). According to similar literature studies [24, 25], the oxidation profile throughout E0 cross section shows a symmetric path, with a maximum peak in the central region of the liner. When comparing the oxidation profiles of the explanted liners to that of the shelf aged one, no similarities can be found, neither in terms of KI trend, nor in terms of peak oxidation, as for the shelf aged liner the oxidation amount was lower than in the retrieved components.
