Investigation about ancient mortars and plasters in the Mondovì cathedral (Cuneo, Italy)

Key words: Mortar; Plaster; EDS Maps; Cultural Heritage; Mondovì Cathedral.

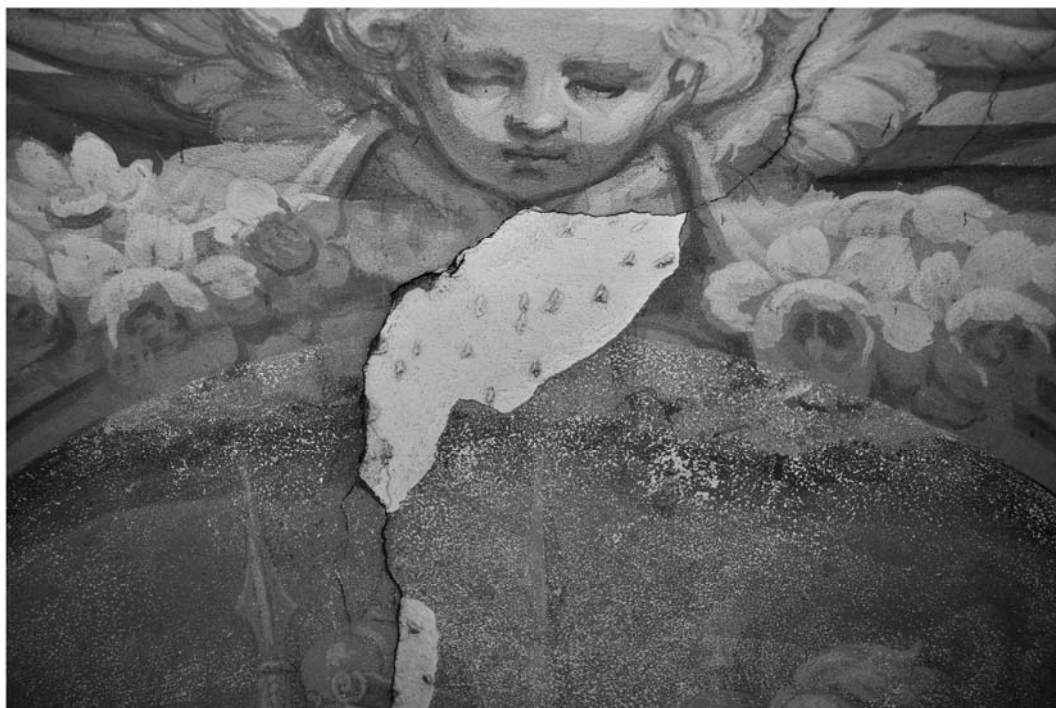
Figure 4. In the picture it is clearly observable the whitish surface of the mid '700 plaster, which was lately in mid '800 scaled with hammer to obtain a rough surface for a better adhesion of the new mortar and pictorial decoration. FOV 40 cm.

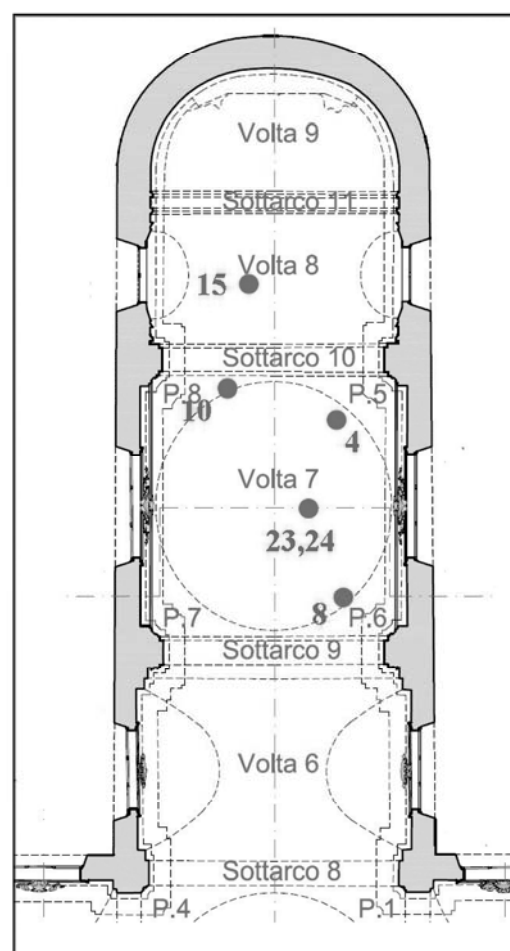
Figure 5. Sampling position in the north portion of the Church. Courtesy of GEOMAR.IT (www.geomar.it).

All the samples were picked from the northern part of the church, from the upper portion of the pictorial cycle (Figure 5; Table 1), where the restoration works are now in progress. For the investigation of pigment layers we used different techniques like SEM-EDS, FT-IR, Raman Spectroscopy and ICP-OES (Artioli, 2010), for the investigation of mortar layers -conducted extensively on resin included polished sections- we used Optical Microscopy (OM) and Scanning Electron Microscopy (SEM) supported by Energy Dispersive microprobe Spectroscopy (EDS) (Reed, 2005; Severin, 2004).

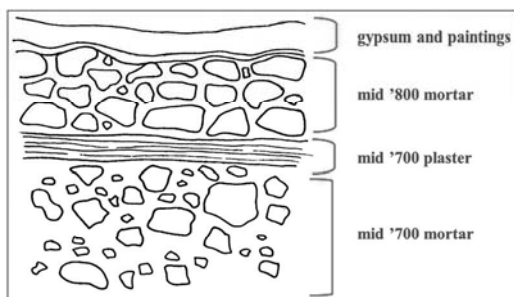
Figure 6. Schematic stratigraphy of the mortars and plaster.

The study of the sections is useful to recognize techniques and materials used in both of the different historical moments. Starting from the oldest layers findings, using Optical Microscopy we can observe (Figure 6):

- a mid-'700 mortar, with fine-grained aggregate. It is almost monomineralic and it is composed of subangular quartz grains. The binder is mainly calcic/magnesian lime (the composition was verified by EDS analysis). We will show here images and analysis of samples 10 and 24 (numeration of the samples follows the original order, in which more sample were analyzed for pigments and other characteristics);
- a mid-'700 finishing plaster, very fine grained and almost without aggregate phases, coated in many layers, with a total thickness usually below 1 mm; (sample 4, 10 and 24);

- a mid-'800 plaster, very rough, with some coarse grained aggregate, made by quartz and rare feldspar (verified lately by EDS analysis), almost equidimensional, with rounded grains; (samples 4 and 23);

- a very thin layer of gypsum probably used as a preparative ground colour (sample 3 and 4); this thin layer was observed and identified with the aim of SEM-EDS analysis.

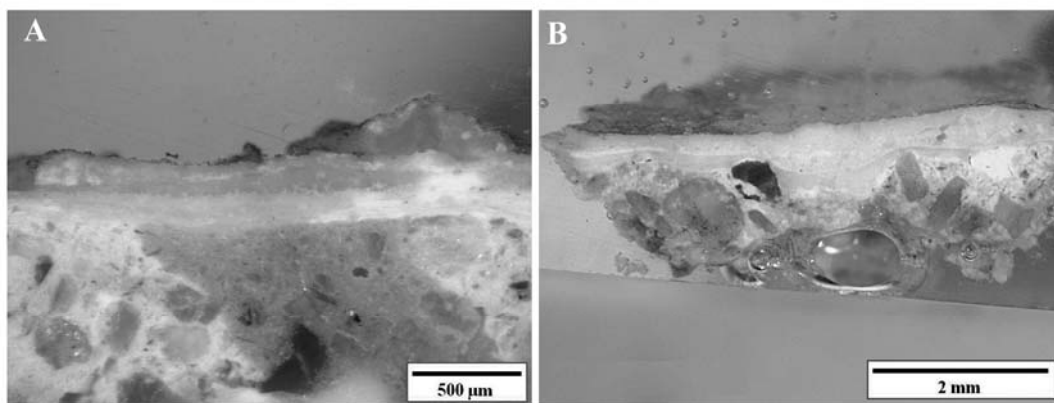
Figure 8. A) The finishing layer is composed of a very compact and homogeneous plaster, milky white, fine textured and almost without aggregate, coated in many layers (as shown in Figure 8). Sample 10 taken in OM picture; B) Another portion of the white brilliant plaster in an area of sample 24. The layer is very thin, but it follows the rough surface and in some place has a higher thickness.

A thin finishing material made of lime and magnesian lime lies on the surface of the mid '700 mortar (Figure 8A and 8B). The total thickness of this layer is usually less than 1 mm, but in this very subtle coating we can recognize up to seven different strata of variable composition (Figure 9). The layer is fine grained and, in optical microscopy observation, shows a very brilliant-white finishing. Only in one sample we noticed a blackish-gray horizon containing a little amount of charcoal. In one of the strata we also found lime lumps. This sequence was probably obtained by multiple brush application of a diluted lime suspension (whitewash).

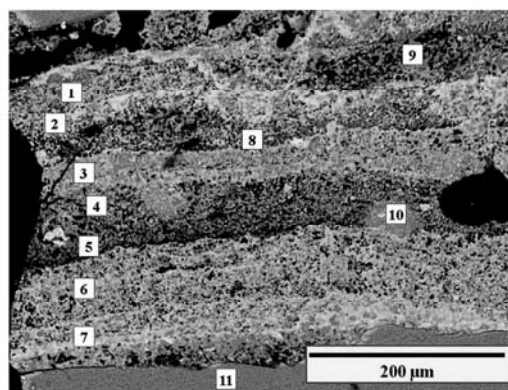
Figure 10. A false colour EDS map of the same area of Figure 9, with the analysis localizations (results are shown in Table 2). In this image Ca concentration is coded in green, Mg concentration is coded in red and silicium content is rendered in blue. We can clearly observe a silica grain at the base of the strata, but there is no silica in the magnesian lime of the plaster. Different layers have different compositions, alternating magnesium-rich lime to magnesium-poor lime.

In the picture (Figure 10) the stacking of the layers is clearly visible. False colour EDS map shows compositional differences, confirmed by EDS analysis (Table 2). All the analyses were obtained on small area to mediate the imperfection and to have a better fitting with higher count ratio. Sum of oxides is recalculated to approximate 100% total weight, despite of the presence of water and other substances not analyzed (Franzini, 1999). Strong variations in the Mg/Ca can be observed. Analysis n. 11 was performed in a quartz grain. The different distribution of magnesium in the layer rises a question: why are there so many strata in this layer? The sampled surface is around 15 m high from the church floor, a white coat periodically painted for cleaning purpose every few years is quite unconvincing. The entire layer was probably made during the same period while the wooden scaffolding was still in place. But if the work was done in the same time frame, why are

there so big differences in composition between layers? We hypothesize the presence of Mg-containing silicatic minerals, but no silicon is showed by EDS spectra.

Table 2. The EDS analysis from different areas of the EDS Map of Figure 10. Values are in weight %

Area	MgO	SiO ₂	SO ₂	CaO	MnO	FeO
1	44.8	1.2	5.5	49.2	< 0.1	< 0.1
2	33.2	1.1	7.5	57.2	0.7	0.3
3	27.3	0.8	3.4	68.1	< 0.1	0.6
4	36.2	1.0	3.7	59.3	< 0.1	0.2
5	49.0	0.3	4.7	46.3	< 0.1	< 0.1
6	29.1	0.8	3.3	67.8	< 0.1	< 0.1
7	24.6	0.4	4.2	69.6	0.3	0.9
8	54.2	1.9	4.2	38.9	0.1	0.7
9	21.6	1.2	8.2	69.9	< 0.1	< 0.1
10	60.4	< 0.1	3.6	36.0	0.4	< 0.1
11	0.0	99.6	0.3	< 0.1	< 0.1	0.1

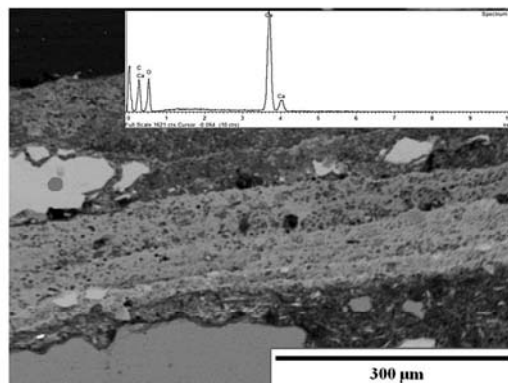
Figure 12. BSE image of some lime fragments in sample 10, mid '700 plaster horizon. The analysis made in the position of the red dot shows a composition made of pure Ca carbonate, almost without magnesium (the EDS spectra in the insert).

In Figure 12 we can observe white particles surrounded by whitish plaster. Analysis on fragments showed that these are pure calcium carbonate, with magnesium content below the

EDS detection limit (0.1%). This particle can be a grain of calcite or pure limestone deposited in the layer. The unusual size of this particle could be due to an incorrect grinding of the raw material (Kirk Othmer, 2001).

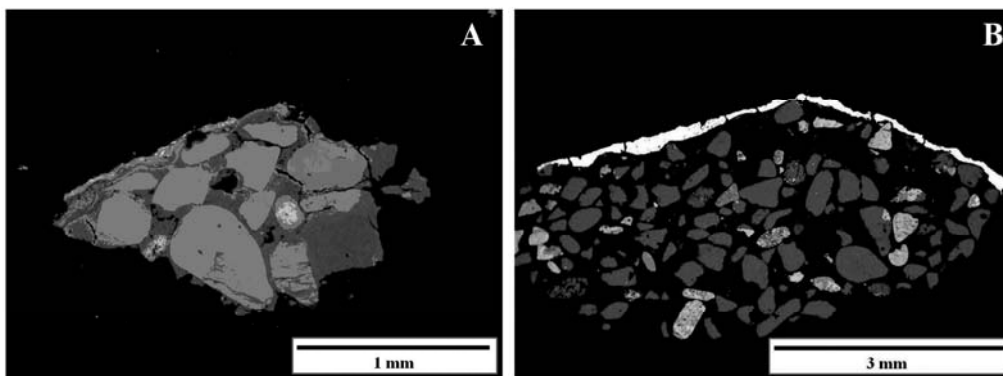
Figure 14. A) A false colour BSE image of sample 8 mid '800 mortar. Silica (quartz) granules are light blue whereas feldspars range from green to orange; B) A false colour BSE image of sample 15 mid '800 mortar. Silica (quartz) granules are light blue whereas feldspars range from green to orange.

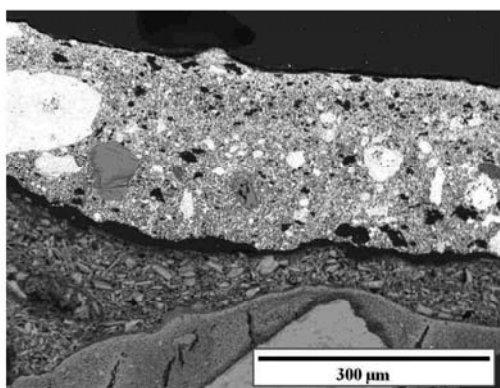
Figure 16. The gypsum layer below the pictorial layer (above) and the mortar (at the base). The texture made of tiny elongated microcrystals of gypsum is clearly pictured in the BSE-SEM image. This layer was requested by the painters as a preparative surface for the painting cycle.

This layer has been found in almost all samples. The gypsum (which nature was confirmed by EDS analysis) (Figure 16) is in a dense polycrystalline form, represented by an aggregate of minute bacillar cristallites, few micrometers long and very thin; the total thickness of the layer is usually below 100 micrometers, following the roughness and the cavities of the mortar surface

below. The reason for that could be that this layer has been painted "a secco", or with organic ligands. For these painting techniques it's necessary to prepare the wall with a layer called "imprimitura", a uniform background for paintings. Usually this is made of very fine lime, but sometimes it may be made of gypsum mixed with water, glue or milk (Forti, 1937).
