Investigation about ancient mortars and plasters in the Mondovì cathedral (Cuneo, Italy)

Key words: Mortar; Plaster; EDS Maps; Cultural Heritage; Mondovì Cathedral.

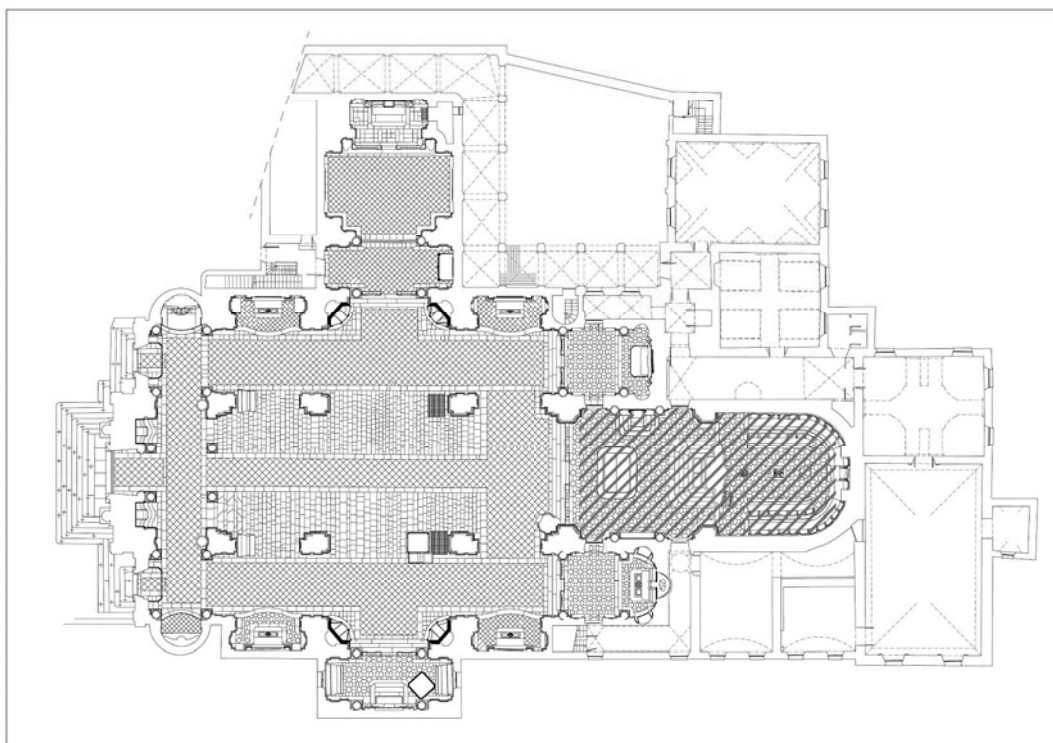
Figure 3. Plan of the Cathedral. The total length of the Church is about 56 m, whereas the width is 24 m. Courtesy of GEOMAR.IT (www.geomar.it).

The San Donato Cathedral of Mondovì (Cuneo Province, North-West Italy, Figure 1) is an 18th century building, by the great architect from Mondovì Francesco Gallo (Figure 2). Erected in 1743 on the structures of the ancient Franciscan church (Grassi, 1789; Casalis, 1842), the building works lasted for decades and were followed by important architects such as Bernardo Antonio Vittone and the first architect of the king, Benedetto Alfieri. The façade was built in 1777 by master builder Quadrone with structural stone from Vico, following faithfully the design of architect Gallo. The building is an impressive church, it has a three naves structure, with lateral chapels and a large transept where two lateral chapels are situated on the side of the presbytery and two large chapels at the heads. It is of a considerable length of 56 meters and a width of 24 meters, and a wide dome on corbels is located at the crossing of the ribs (Figure 3).

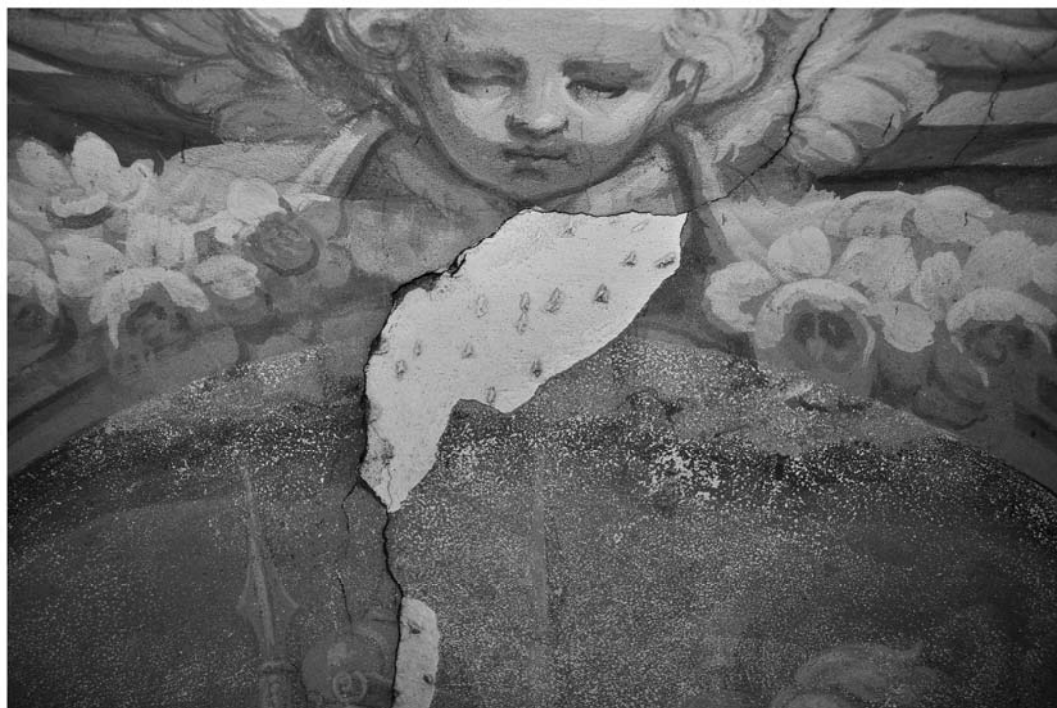
Figure 4. In the picture it is clearly observable the whitish surface of the mid '700 plaster, which was lately in mid '800 scaled with hammer to obtain a rough surface for a better adhesion of the new mortar and pictorial decoration. FOV 40 cm.

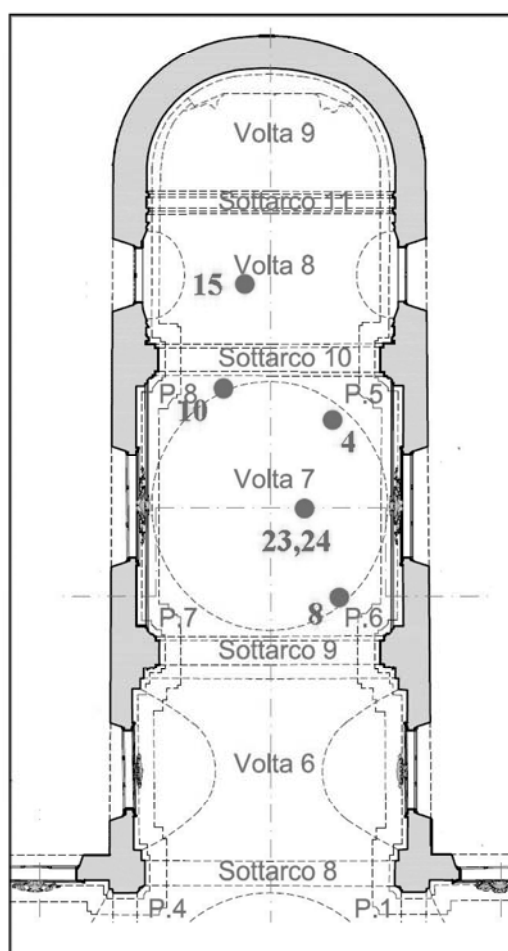
Figure 5. Sampling position in the north portion of the Church. Courtesy of GEOMAR.IT (www.geomar.it).

All the samples were picked from the northern part of the church, from the upper portion of the pictorial cycle (Figure 5; Table 1), where the restoration works are now in progress. For the investigation of pigment layers we used different techniques like SEM-EDS, FT-IR, Raman Spectroscopy and ICP-OES (Artioli, 2010), for the investigation of mortar layers -conducted extensively on resin included polished sections- we used Optical Microscopy (OM) and Scanning Electron Microscopy (SEM) supported by Energy Dispersive microprobe Spectroscopy (EDS) (Reed, 2005; Severin, 2004).

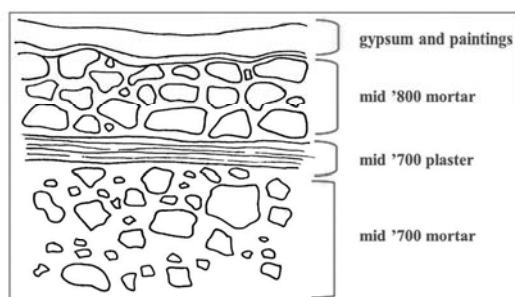
Figure 6. Schematic stratigraphy of the mortars and plaster.

The study of the sections is useful to recognize techniques and materials used in both of the different historical moments. Starting from the oldest layers findings, using Optical Microscopy we can observe (Figure 6):

- a mid-'700 mortar, with fine-grained aggregate. It is almost monomineralic and it is composed of subangular quartz grains. The binder is mainly calcic/magnesian lime (the composition was verified by EDS analysis). We will show here images and analysis of samples 10 and 24 (numeration of the samples follows the original order, in which more sample were analyzed for pigments and other characteristics);
- a mid-'700 finishing plaster, very fine grained and almost without aggregate phases, coated in many layers, with a total thickness usually below 1 mm; (sample 4, 10 and 24);

- a mid-'800 plaster, very rough, with some coarse grained aggregate, made by quartz and rare feldspar (verified lately by EDS analysis), almost equidimensional, with rounded grains; (samples 4 and 23);

- a very thin layer of gypsum probably used as a preparative ground colour (sample 3 and 4); this thin layer was observed and identified with the aim of SEM-EDS analysis.

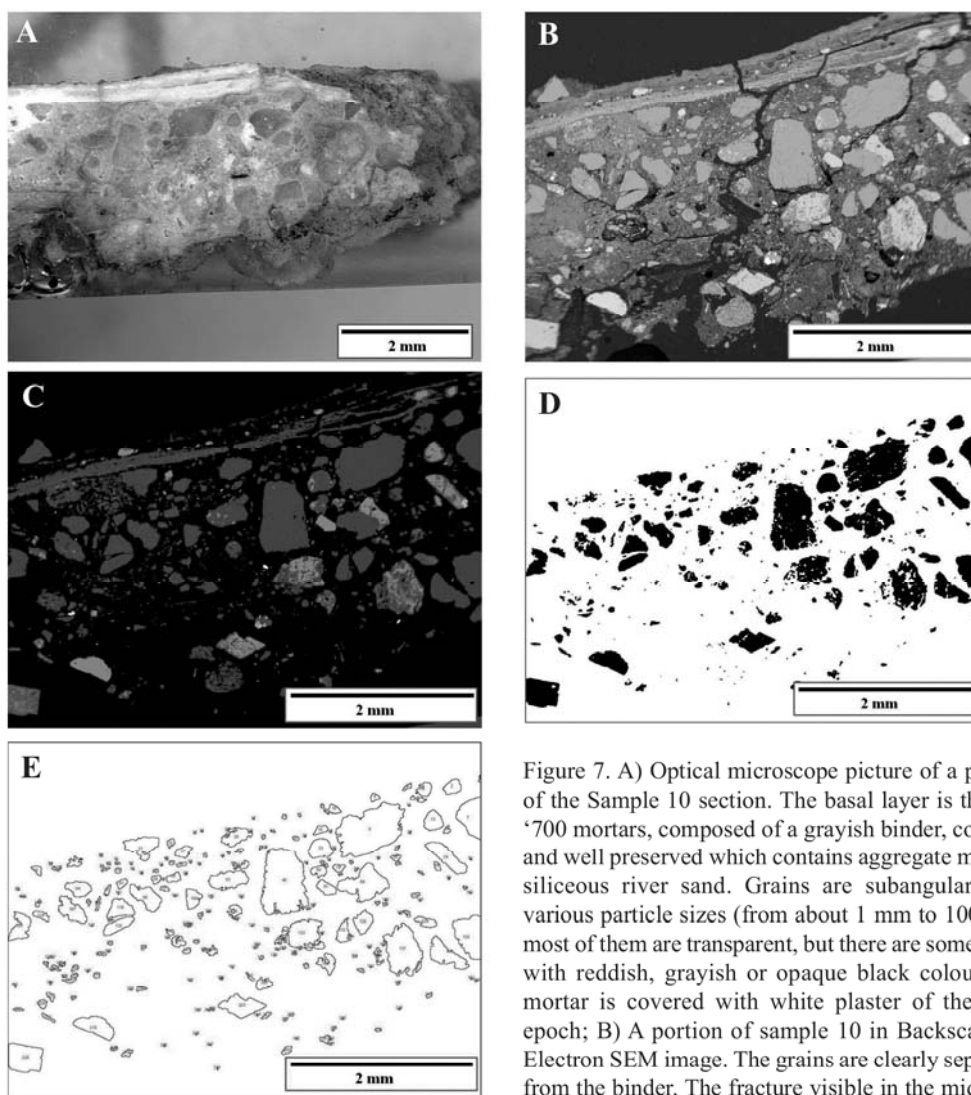
Figure 7. A) Optical microscope picture of a portion of the Sample 10 section. The basal layer is the mid '700 mortars, composed of a grayish binder, compact and well preserved which contains aggregate made of siliceous river sand. Grains are subangular, with various particle sizes (from about 1 mm to 100 μ m); most of them are transparent, but there are some clasts with reddish, grayish or opaque black colour. The mortar is covered with white plaster of the same epoch; B) A portion of sample 10 in Backscattered Electron SEM image. The grains are clearly separated from the binder. The fracture visible in the middle of the section is a consequence of the preparation and was not in the original mortar sample; C) The false colour BSE image could enhance the subtle difference between similar gray levels. It is possible, in this way, to distinguish between quartz (deep blue) and feldspar (light blue). The biggest portion of the mineral phase is represented by quartz; D) An opportune treatment and thresholding of the gray levels with the ImageJ software permit to isolate the grain contour in the mortar; E) The ImageJ software made the automatic count of the particles and sum their total area.

We can describe sample 10, one of the mid '700 mortar. It is characterized by a rough layer of mortar with quartz sand, made of subangular grains, not well sorted and sized normally below 1 mm (Wentworth, 1922). The binder is a whitish-greyish magnesian lime (as showed by

EDS analysis), with no or very little amount of sulphates (Figure 7A). Observing the section in electron microscopy, using backscattered electron mode (BSE), position, size and shape of quartz grains (Figure 7B, confirmed as quartz in EDS spectra) became immediately visible. We also found rare grains of mineral others than quartz, such as feldspar, clearly visible in the elaborated image (obtained ascribing false colours to different gray levels) (Figure 7C). The different gray levels of SEM-BSE image are also very useful for image analysis, carried out with software Image-J. Gray levels are used to identify the pixels with a determinate tonal value, e.g. the quartz is light gray and the binder mass is dark gray (Carò, 2008; Miriello, 2006). Thereafter the software made some calculation regarding the amount of pixels and their total area, the number of grains, the shape and roundness of the aggregate particle (Figure 7D and 7E). The program was used to determine the ratio between binder and aggregate. The results showed that the aggregate is roughly 20% of the volume, a very scarce value. This probably represents a low original content of aggregate in the mortar.

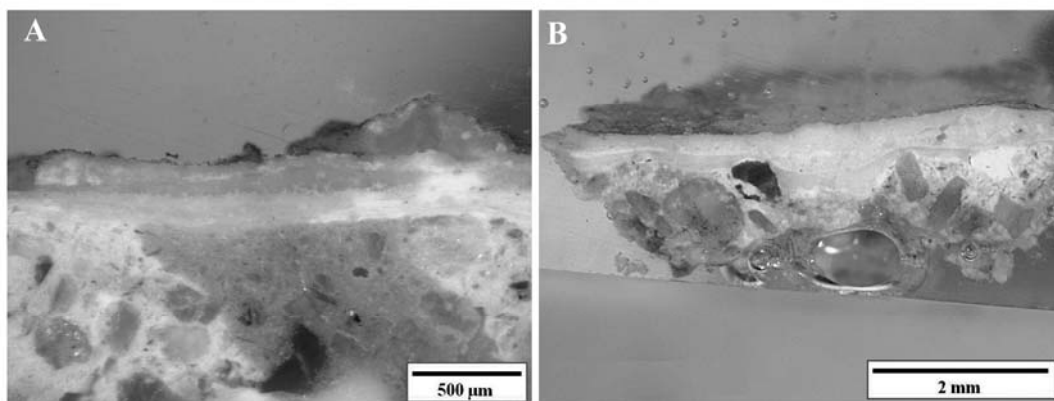
Figure 8. A) The finishing layer is composed of a very compact and homogeneous plaster, milky white, fine textured and almost without aggregate, coated in many layers (as shown in Figure 8). Sample 10 taken in OM picture; B) Another portion of the white brilliant plaster in an area of sample 24. The layer is very thin, but it follows the rough surface and in some place has a higher thickness.

A thin finishing material made of lime and magnesian lime lies on the surface of the mid '700 mortar (Figure 8A and 8B). The total thickness of this layer is usually less than 1 mm, but in this very subtle coating we can recognize up to seven different strata of variable composition (Figure 9). The layer is fine grained and, in optical microscopy observation, shows a very brilliant-white finishing. Only in one sample we noticed a blackish-gray horizon containing a little amount of charcoal. In one of the strata we also found lime lumps. This sequence was probably obtained by multiple brush application of a diluted lime suspension (whitewash).

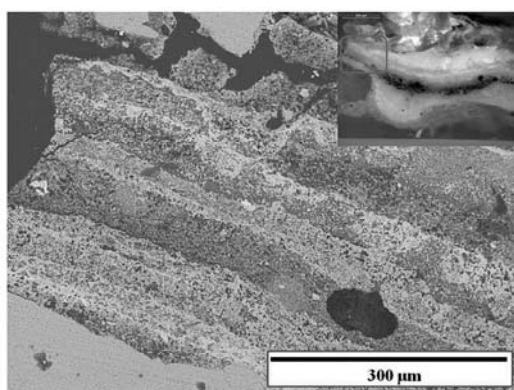
Figure 9. The white mid '700 plaster observed in BSE image shows its nature composed by multiple layer (the small insert is the same area in OM picture). Light gray levels are calcium rich, whereas darker levels are magnesium-rich. Up to seven different layers could be identified in this high resolution image.

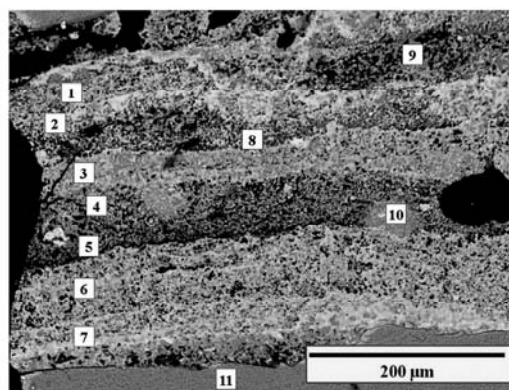
Figure 10. A false colour EDS map of the same area of Figure 9, with the analysis localizations (results are shown in Table 2). In this image Ca concentration is coded in green, Mg concentration is coded in red and silicon content is rendered in blue. We can clearly observe a silica grain at the base of the strata, but there is no silica in the magnesian lime of the plaster. Different layers have different compositions, alternating magnesium-rich lime to magnesium-poor lime.

In the picture (Figure 10) the stacking of the layers is clearly visible. False colour EDS map shows compositional differences, confirmed by EDS analysis (Table 2). All the analyses were obtained on small area to mediate the imperfection and to have a better fitting with higher count ratio. Sum of oxides is recalculated to approximate 100% total weight, despite of the presence of water and other substances not analyzed (Franzini, 1999). Strong variations in the Mg/Ca can be observed. Analysis n. 11 was performed in a quartz grain. The different distribution of magnesium in the layer rises a question: why are there so many strata in this layer? The sampled surface is around 15 m high from the church floor, a white coat periodically painted for cleaning purpose every few years is quite unconvincing. The entire layer was probably made during the same period while the wooden scaffolding was still in place. But if the work was done in the same time frame, why are

there so big differences in composition between layers? We hypothesize the presence of Mg-containing silicatic minerals, but no silicon is showed by EDS spectra.

Table 2. The EDS analysis from different areas of the EDS Map of Figure 10. Values are in weight %

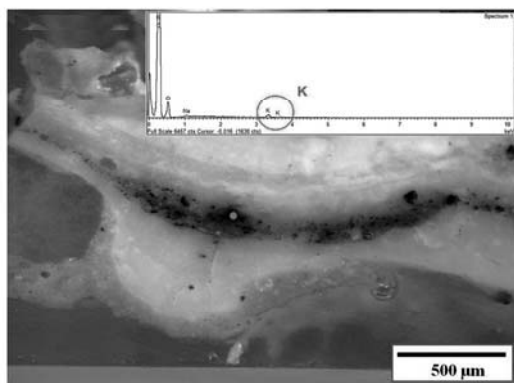
Figure 11. In the OM image the black level of charcoal lumps is visible in a portion of sample 4, mid '700 plaster. The red dot shows the position of the analyses which spectrum is reported in the insert. The red circle evidence the small peak of potassium, typical of carbon from vegetal material.

In the picture (Figure 11) it is clearly visible a small portion of the '700 plaster containing some charcoal fragments, shaped as blackish dots and lumps. EDS analysis reported a small quantity of

potassium inside the otherwise very pure coal; this suggests the nature of the coal as charcoal, obtained by the combustion of vegetal matter. We found it only in one sample, and we suspect a contamination of coal from lime furnace, rather than a charcoal pencil sign (Rinaldi, 1986; Bevilacqua, 2010).

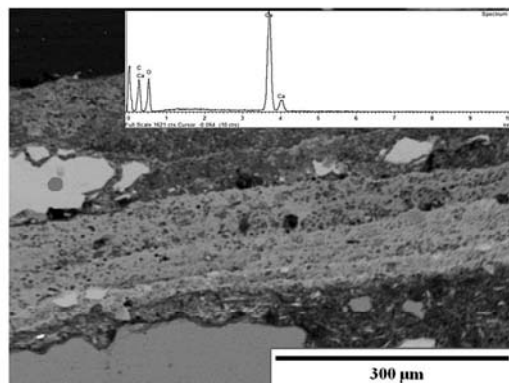
Figure 12. BSE image of some lime fragments in sample 10, mid '700 plaster horizon. The analysis made in the position of the red dot shows a composition made of pure Ca carbonate, almost without magnesium (the EDS spectra in the insert).

In Figure 12 we can observe white particles surrounded by whitish plaster. Analysis on fragments showed that these are pure calcium carbonate, with magnesium content below the

EDS detection limit (0.1%). This particle can be a grain of calcite or pure limestone deposited in the layer. The unusual size of this particle could be due to an incorrect grinding of the raw material (Kirk Othmer, 2001).

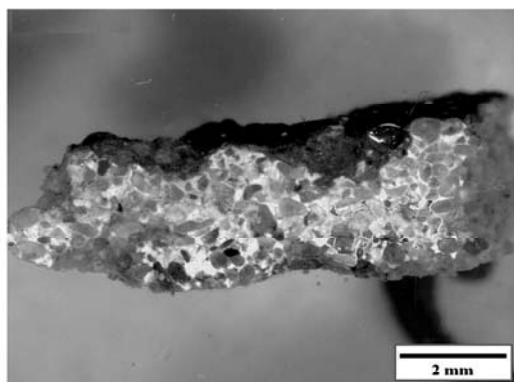
Figure 13. An OM picture of sample 23 showing the very rough mid '800 mortar, quartz rich.

The mid '800 mortar is more coarse than the previous century's one (Figure 13); quartz grains are the main aggregate phase, by comparison with the '700 mortar, the mean dimension of the grains is bigger and the ratio aggregate/binder is highest. The binder is magnesian lime, with variable content of magnesium, from 5 to 30% expressed as MgO. In Figure 14A and 14B, we can observe the structure of the mortar, sampled from different sites of the church dome. Although there are some differences in the samples, the prevalence of quartz and the low content of binder are immediately noticeable.

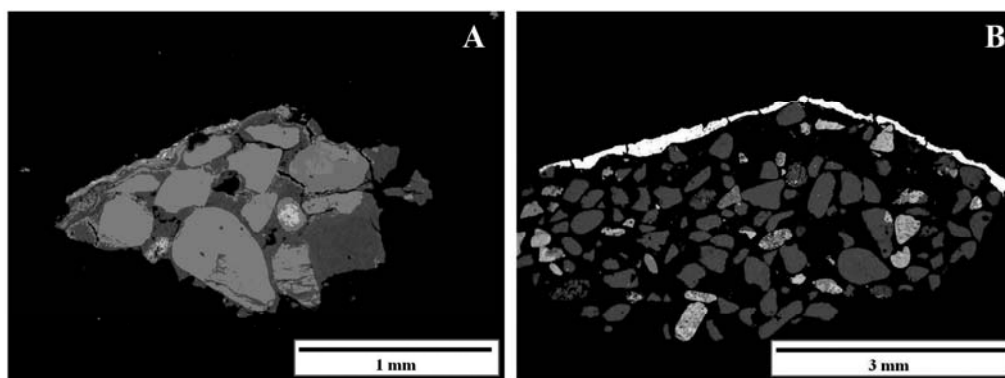
Figure 14. A) A false colour BSE image of sample 8 mid '800 mortar. Silica (quartz) granules are light blue whereas feldspars range from green to orange; B) A false colour BSE image of sample 15 mid '800 mortar. Silica (quartz) granules are light blue whereas feldspars range from green to orange.

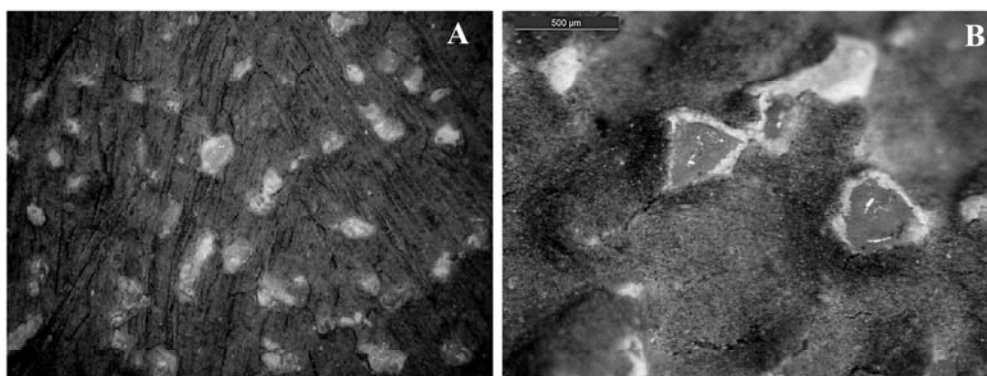
Figure 15. A) A micro-camera image of a pictorial surface with the whitish tiny dots due to detach of the paint layer in correspondence of the quartz grain; B) Magnification of the previous area. The quartz grain protrudes from the surface causing a loss of pictorial layer. The white thin gypsum layer is also visible between the quartz and the paint film.

Macrophotography of the surface and SEM imaging proved that the distribution of the white dots on the pigment layers matches with the protrusion of quartz particles from the mortar: the adhesion between quartz and the pictorial layer was not strong enough to ensure the grasping of the paint for about 150 years (Figure 15A and 15B).

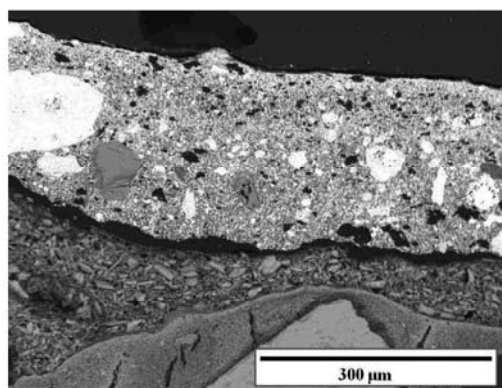
Figure 16. The gypsum layer below the pictorial layer (above) and the mortar (at the base). The texture made of tiny elongated microcrystals of gypsum is clearly pictured in the BSE-SEM image. This layer was requested by the painters as a preparative surface for the painting cycle.

This layer has been found in almost all samples. The gypsum (which nature was confirmed by EDS analysis) (Figure 16) is in a dense polycrystalline form, represented by an aggregate of minute bacillar cristallites, few micrometers long and very thin; the total thickness of the layer is usually below 100 micrometers, following the roughness and the cavities of the mortar surface
