CASE REPORT

Focused tight dressing does not prevent cochlear implant magnet migration under 1.5 Tesla MRI

Acta Otorhinolaryngol Ital 2013;33:133-136

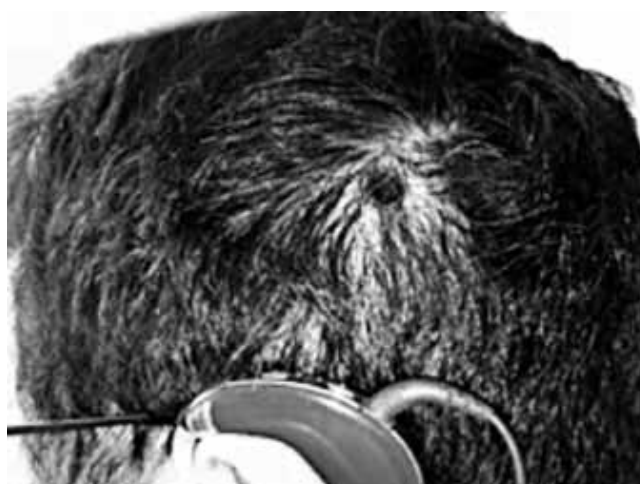
Fig. 2. Focal skin-crust lesion on left side, at the centre of the external coil position.

MRI examination was performed without complications. However, the day after the patient reported a deep pain and heating of the skin above the device on left side. The skin appearance seemed normal and the patient continued to wear his speech processor. The pain continued over 24 hours. A local skin alteration became gradually more evident in subsequent days. The patient did not complain of fever or tenderness. One week later, medical examination was required. A local, crusty, skin lesion was observed under the patient's left external coil at its centre (Fig. 2). At local palpation, the internal magnet did not appear to be displaced from its normal location. The external coil was worn normally. The magnet was found attached to the skin with more strength than usual. He scored 85% on an open set, disyllabic words test; this is consistent with the test session preceding the MRI exam. Electrode impedances were also unremarkable.
