World Multidisciplinary Civil Engineering-Architecture-Urban Planning Symposium 2016,
WMCAUS 2016

Buildings Under the Rocks: An Interdisciplinary Approach for A Safe Conservation

Eva Coïsson^{a,*}, Andrea Segalini^a, Sabrina Maria Rita Bonetto^b

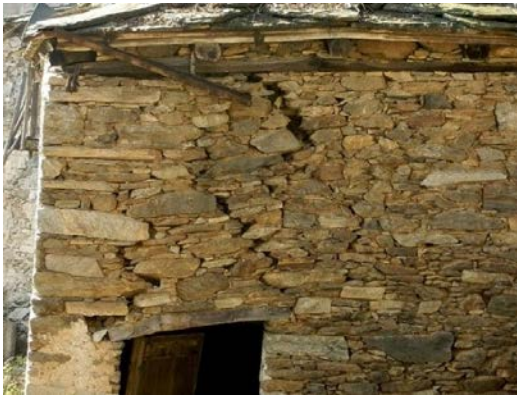
Fig. 3. The main crack pattern is caused by a differential soil settlement.

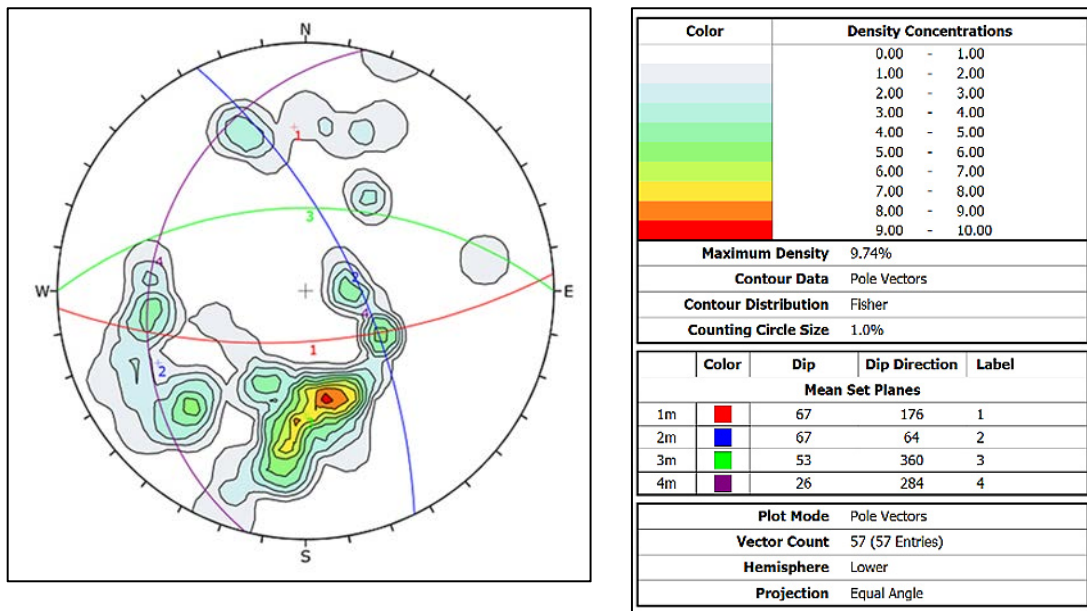
Fig. 5: Equiareal projections of the surveyed discontinuities [7]. Four main discontinuity systems were highlighted (Tab. 1).

The adopted methodology consisted both in a subjective survey of the main discontinuities playing an important role on the face stability and an objective survey with scanlines nearly perpendicular to the main discontinuities on four different orientation of the rock face (50/140; 80/120; 70/88; 70/110) in order to define the values of the averages spacing for each set of fractures. A statistical analysis was performed and data were processed using a plotting patterns (Figure 5).
