Dismemberment by a tamping machine: An unusual case of work-related accidental decapitation

Key Words: occupational accident, decapitation, ballast cleaning machine.

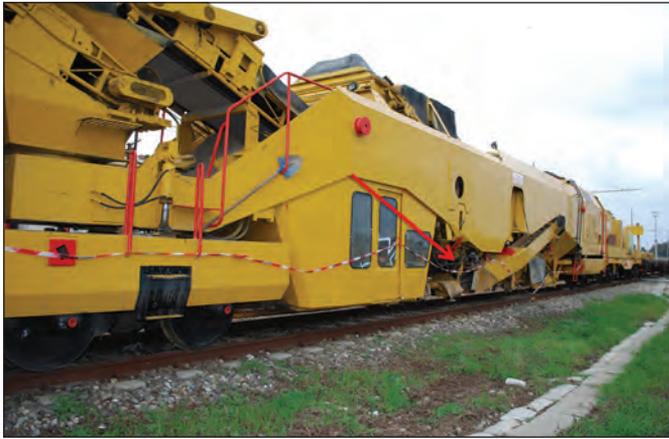
appropriate safety equipment (a helmet, headset and reflective vest). The ballast machine (Fig. 1) was driven by another worker, while two other men were located on the opposite site of the railway track.

Figure 1. View of the Ballast Cleaning Machine. The arrow indicates the place where the head was found.

He was probably bent near the chain and slipped on the uneven ground, when the teeth of the chain must have caught him by the helmet or the jacket and carried him to the right arm of the BCM. Passing through the BCM, too small (45 centimeters high and 40 centimeters wide) to allow the passage of the whole body, his head was sliced from his body. The worker's colleagues saw him only when he was already decapitated.

At the workplace investigation the victim's head was found inside the right arm of the machine, while the right arm and the remains of the body were lying on the rail. There were traces of blood on the chain, inside the arm of the BCM, and on the railway.

In the context of the risks associated to maintenance activities on the railways, this case illustrates a unique case of decapitation in an occupational accident. Investigation of the scene demonstrated that the man had been working beside a BCM. This machinery consists of a tamping unit and a lifting/lowering hydraulic cylinder that packs ballast underneath railway tracks. An operator oversees these processes from the control cabin. One of the functions of the Ballast Cleaning Machine (BCM) is to collect ballast from underneath and around the sleepers using cutter blades. A conveyor belt then transfers this material to the on-board cleaning equipment. The machine then goes into reverse and the blades rotate anti-clockwise.
