# Combining Multiband Imaging, Photogrammetric Techniques, and FOSS GIS for Affordable Degradation Mapping of Stone Monuments

**Citation:** Adamopoulos, E.; Rinaudo, F. Combining Multiband Imaging, Photogrammetric Techniques, and FOSS GIS for Affordable Degradation Mapping of Stone Monuments. *Buildings* **2021**, *11*, 304. <https://doi.org/10.3390/buildings11070304>

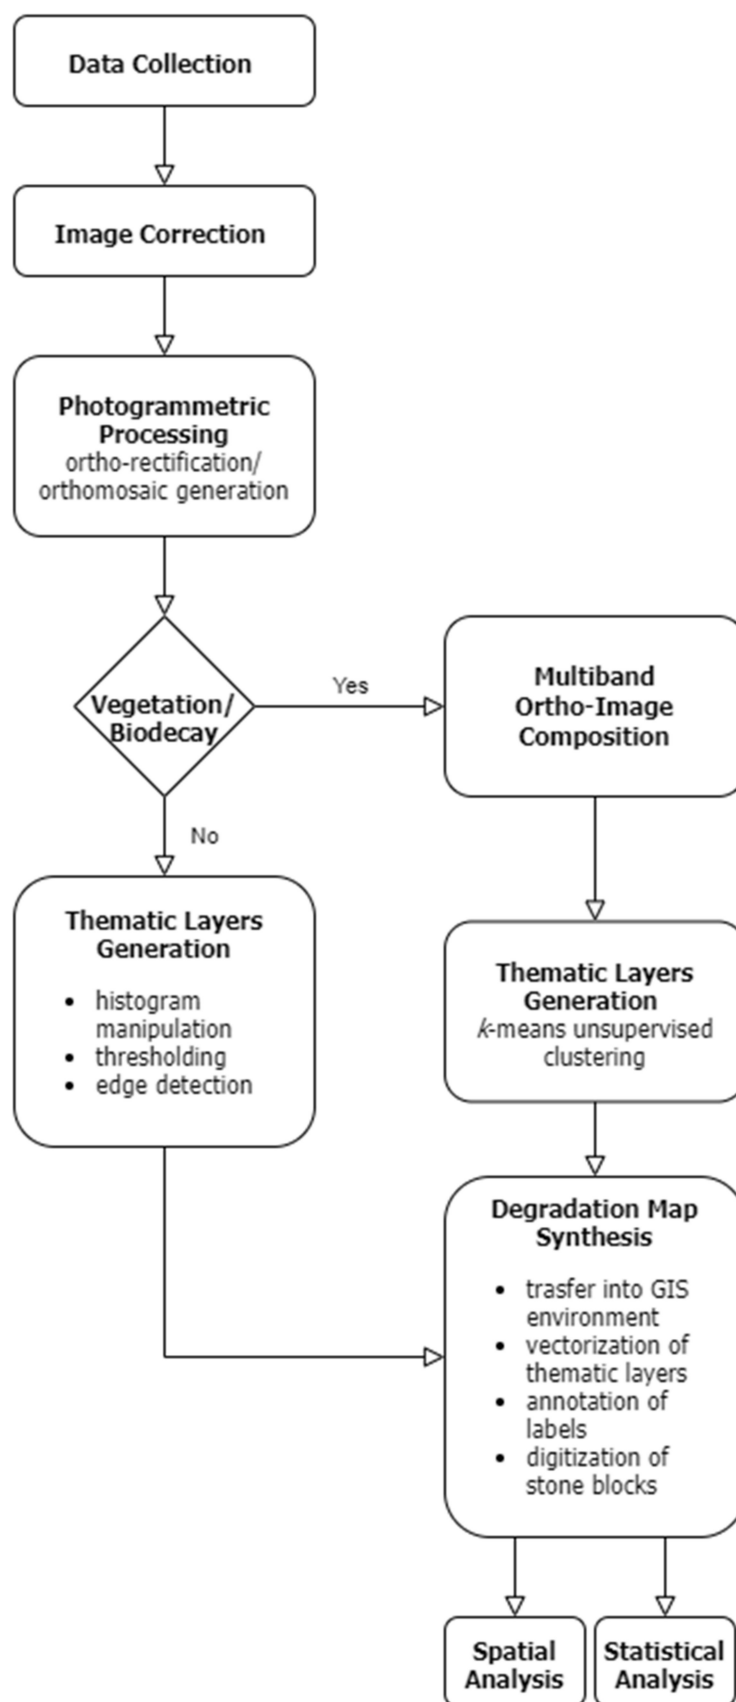
Figure 1. Schematic representation of the methodological workflow.

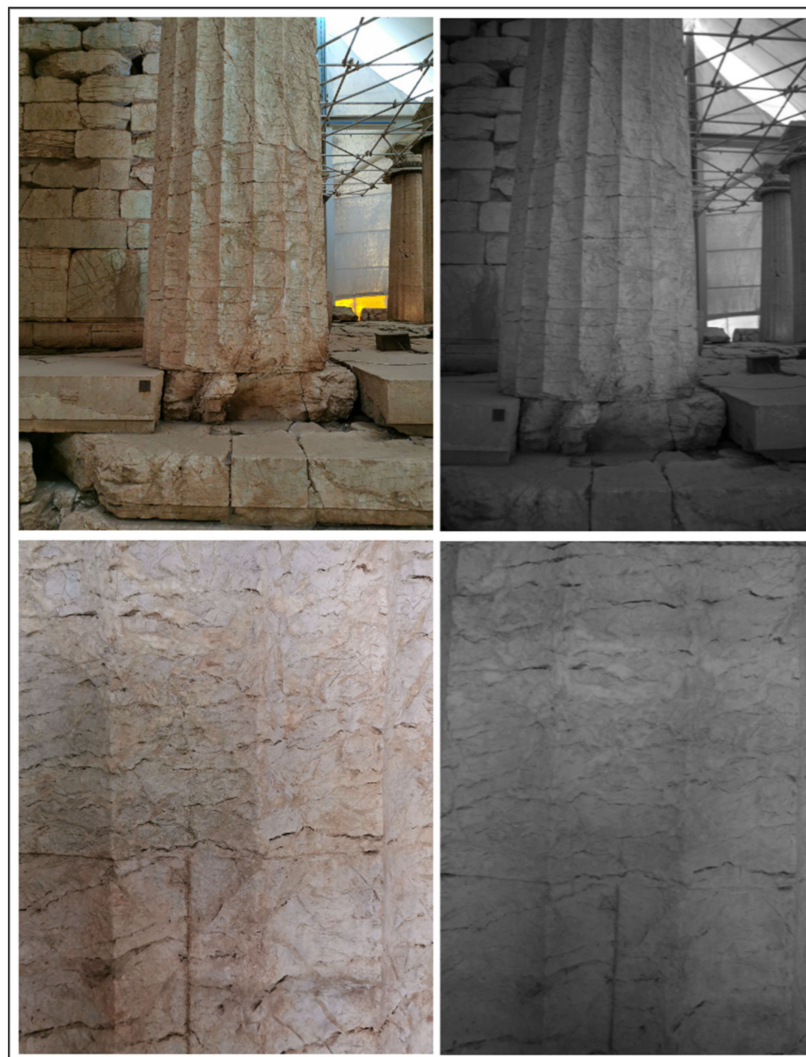
**Figure 4.** Color (**left**) and near-infrared reflectance (**right**) images of the same column captured at the Temple of Apollo Epikourios at Bassae, from further and closer range.

The thematic data about characteristic surfaces at the Temple of Apollo Epikourios were produced by digitally manipulating NIR reflectance images. These images presented more homogeneous radiometry, which was extremely important in order to extract suitable thematic information. In particular, the original and restoration materials that had been previously used presented more similar reflectance characteristics in the near-infrared than in the visible spectrum. Thus, by using NIR reflectance images, the misinterpretation of other degradation forms could be avoided (Figure 4). The architectural surfaces had been mostly cleaned, and therefore, the observable categories of degradation were only loss of material, cracks, and in certain places discoloration. After the NIR images had been corrected and rectified, binary images representing these different categories were produced. Thresholding was applied for identifying discoloration after flat-field correction, which eliminated any remaining inhomogeneous illumination problems. Edge detection and afterward binarization was performed on the first principal component of the images to detect cracks. Finally, histogram equalization and thresholding were performed to identify the loss of material. Figure 5 presents the generation of the binarized category-specific degradation images for an architectural surface and the production of thematic layers in the FOSS GIS environment. The thematic maps produced for investigated characteristic surfaces are presented in Figures 6 and 7.

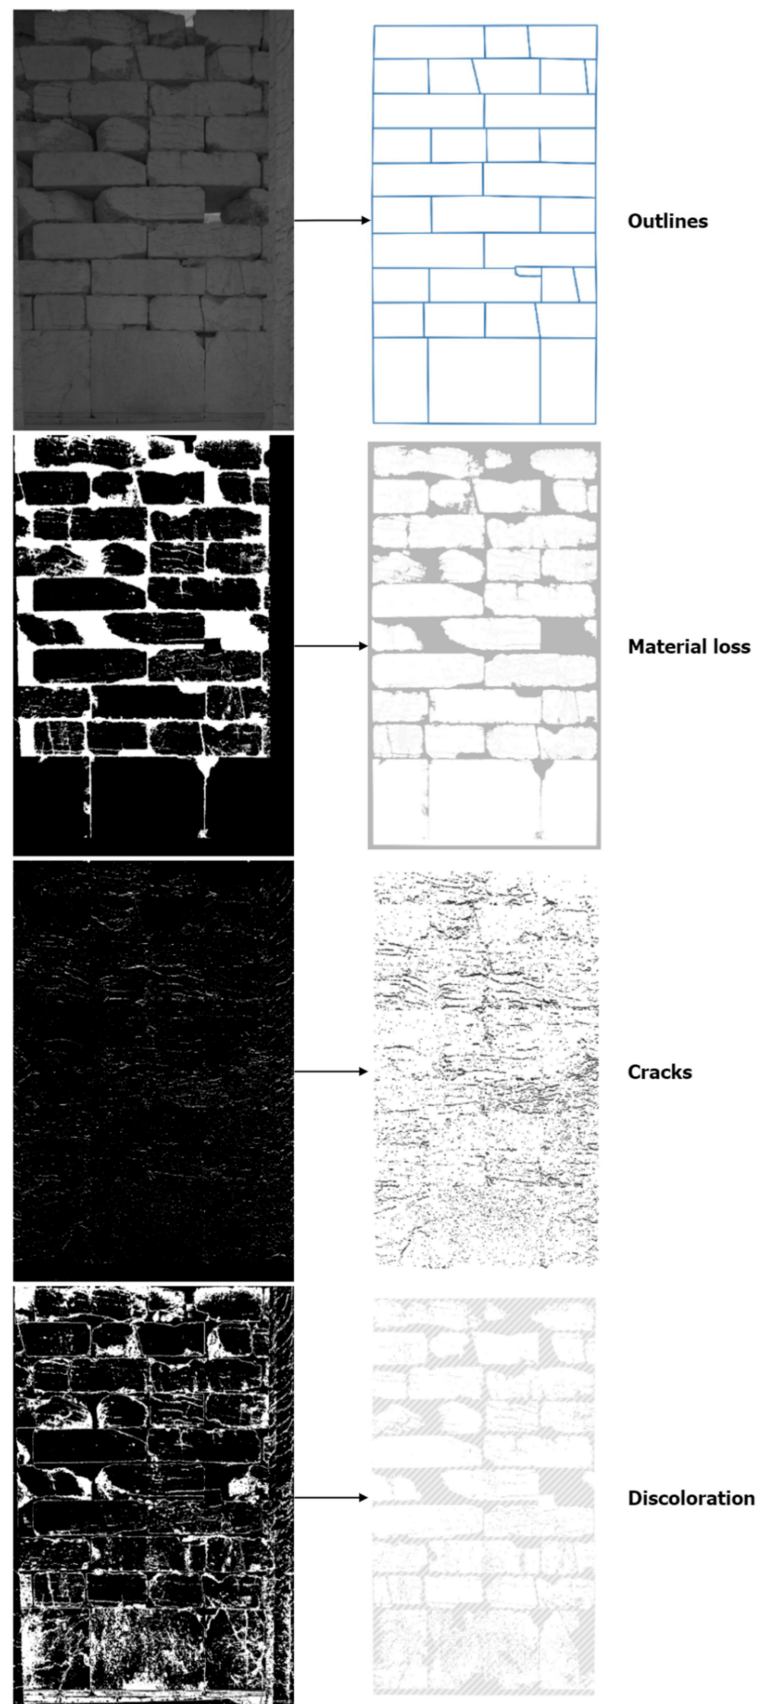
Figure 5. Generation of thematic map layers (right) in QGIS using features extracted from rectified near-infrared reflectance images (left) for the Temple of Apollo Epikourios.

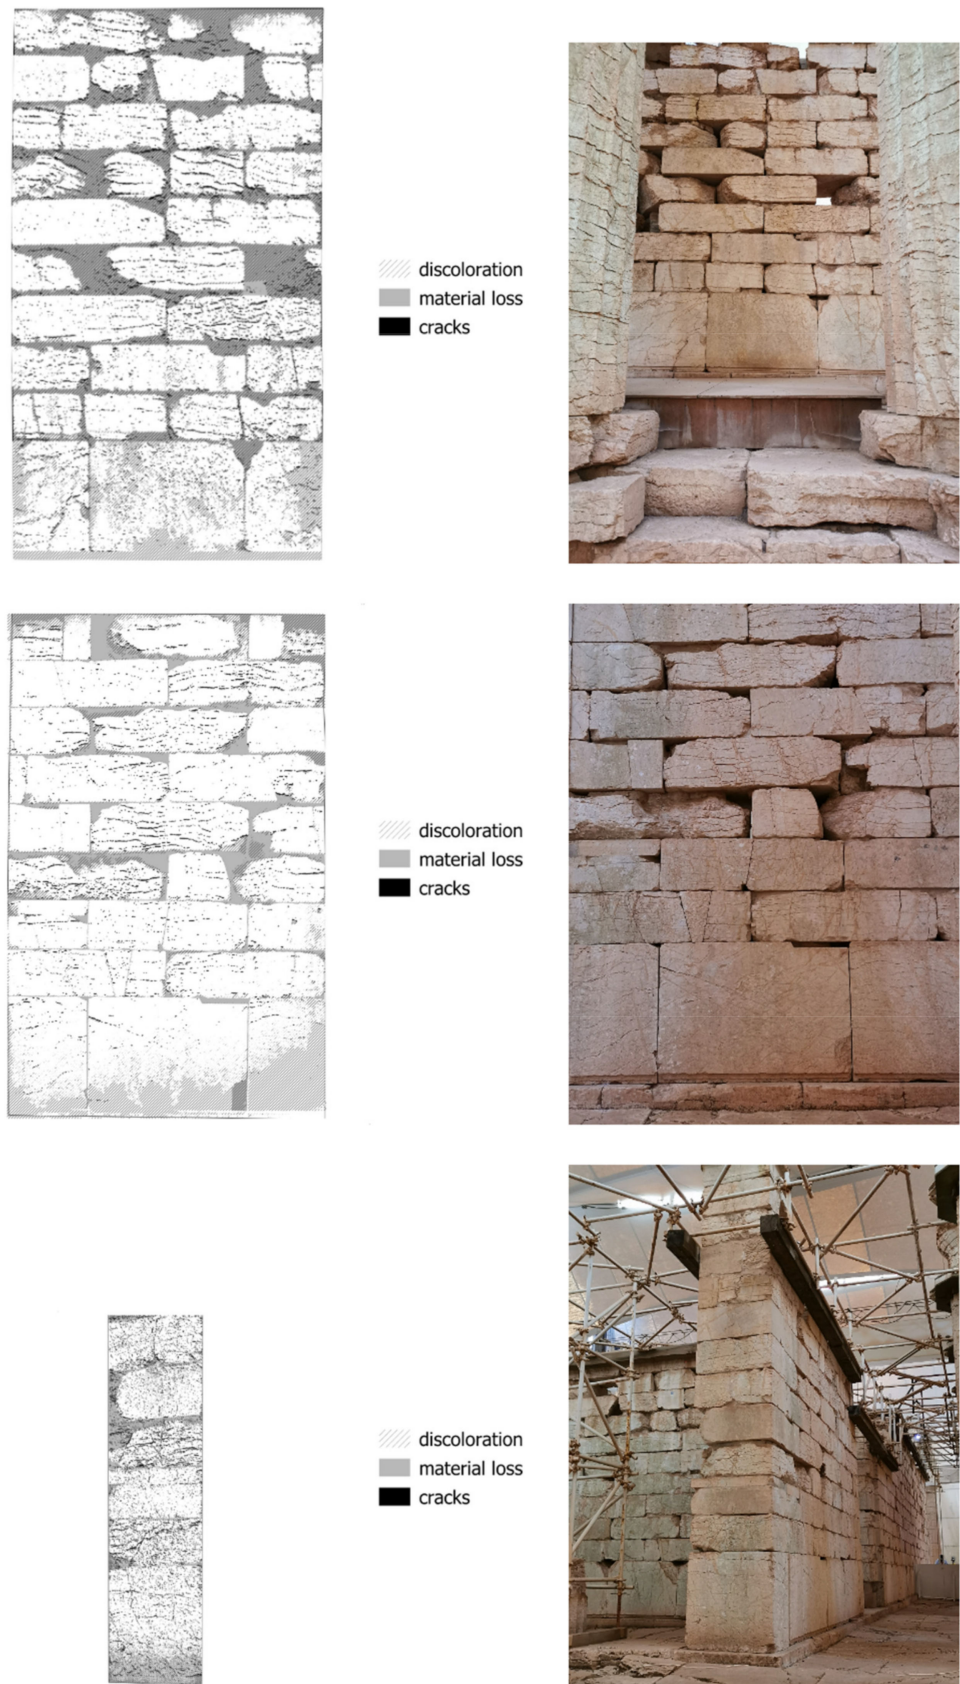
**Figure 6.** Degradation maps and corresponding images for characteristic areas of walls at the Temple of Apollo Epikourios.

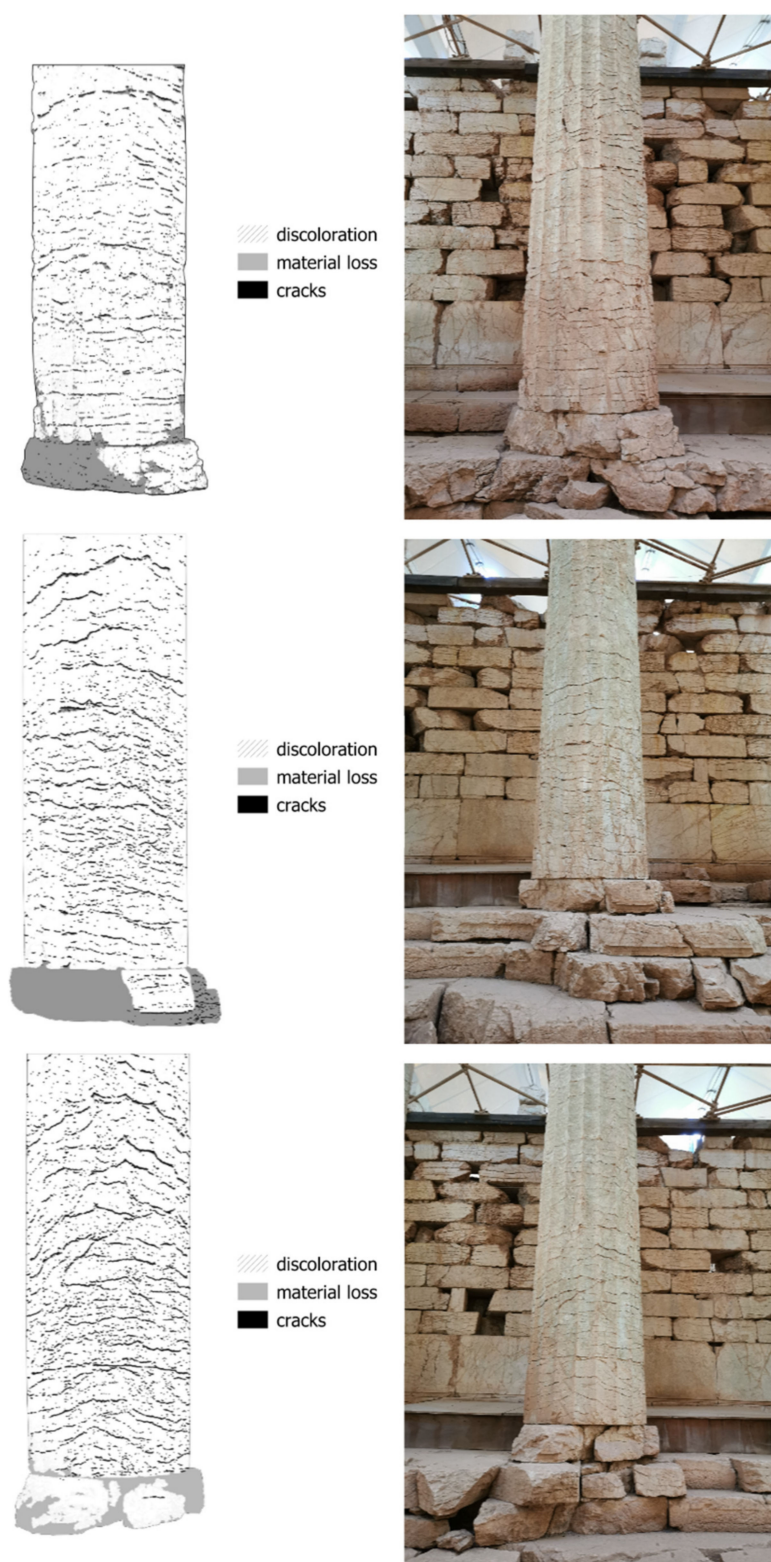
**Figure 7.** Degradation maps and corresponding images for characteristic areas of columns at the Temple of Apollo Epikourios.

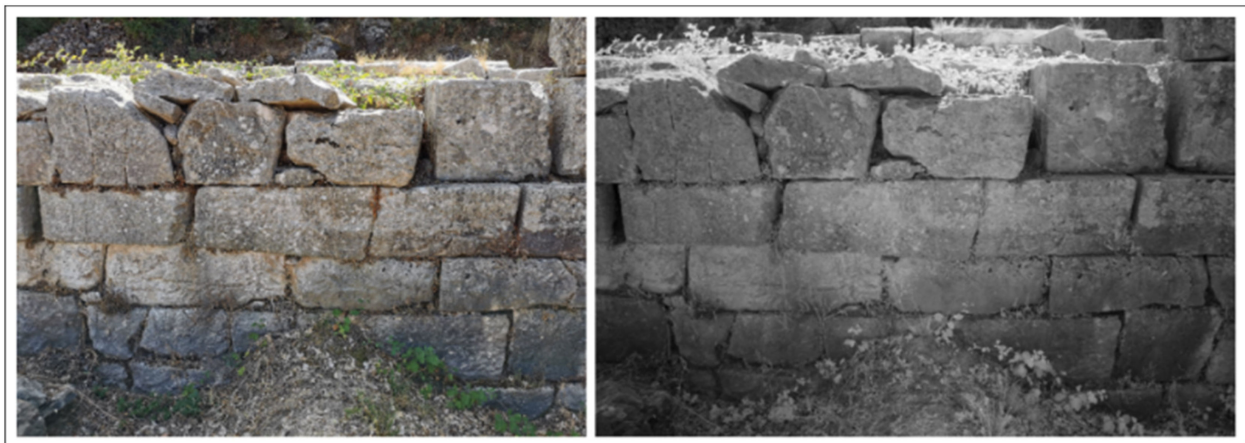
**Figure 9.** Color and near-infrared images captured at the Temple of Athena and Zeus Sotiros.

For this case study, the use of both visible and NIR-spectrum images was opted due to the existence of biological colonization (moss, lichens, biogenic crusts, vegetation), benefiting from the dissimilar reflectance characteristics that it presents at different wavelengths (Figure 9). Using a photogrammetric approach, orthoimage mosaics were generated for parts of the cella and the cubic stone pedestal with the RGB and NIR-reflectance images. Then, they were blended to create pseudo-color orthoimage mosaics (using the Green, Red, and NIR bands) in the HyperCube software. Next, the resulting base maps were segmented to the areas presenting different degradation forms following a *k*-means unsupervised clustering approach with centroids initialized using the *k*-means++ algorithm. Finally, the classified images were digitized, and the degradation was semantically annotated in QGIS to the corresponding thematic layers (Figures 10–14). A map of damage categories regarding the Temple of Athena and Zeus Sotiros remains could also be produced. Figure 15 additionally provides statistics of the coverage of the historical stone surfaces by various degradation forms. Both investigated surfaces were in their entirety covered by biogenic material or discolored.

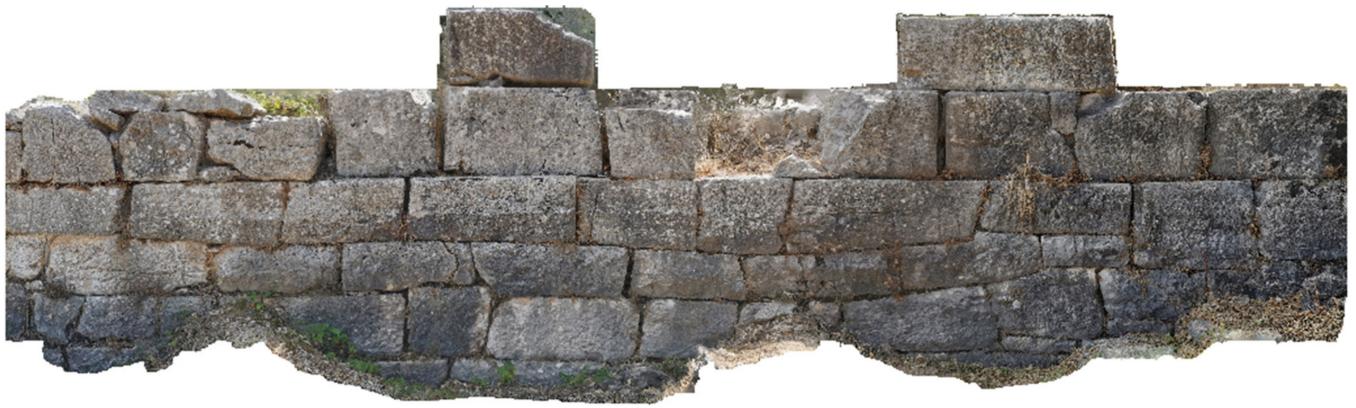
Figure 10. Orthoimage mosaic, cella wall remains at the Temple of Athena and Zeus Sotiros.

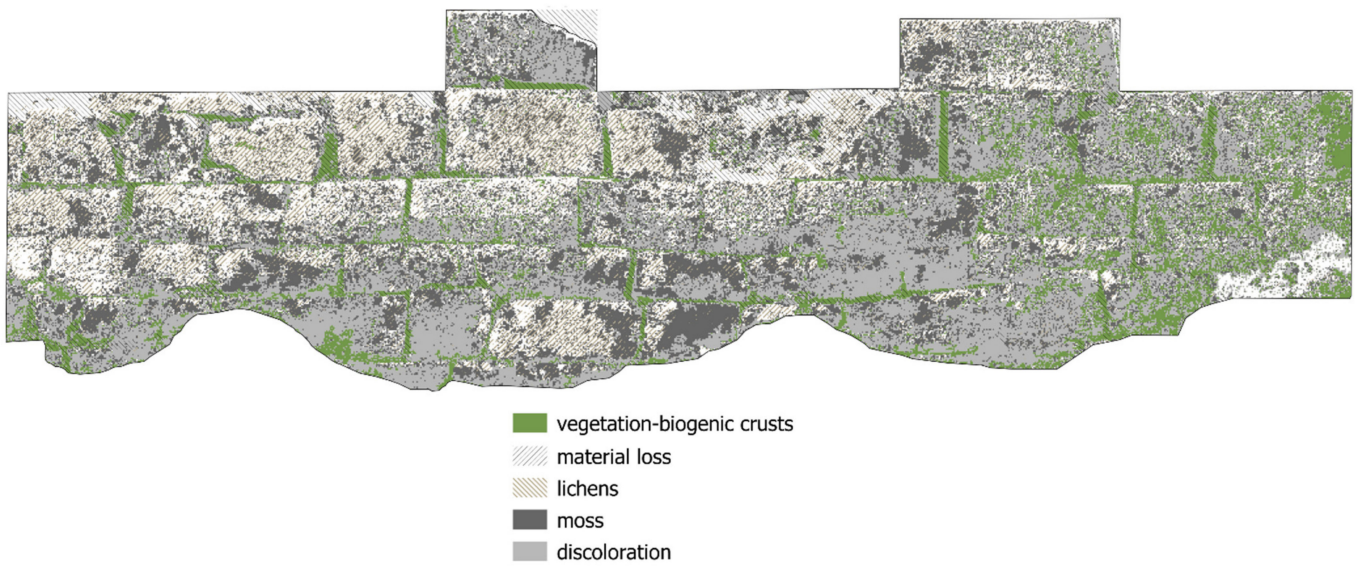
Figure 11. Degradation map, cella wall remains at the Temple of Athena and Zeus Sotiros.

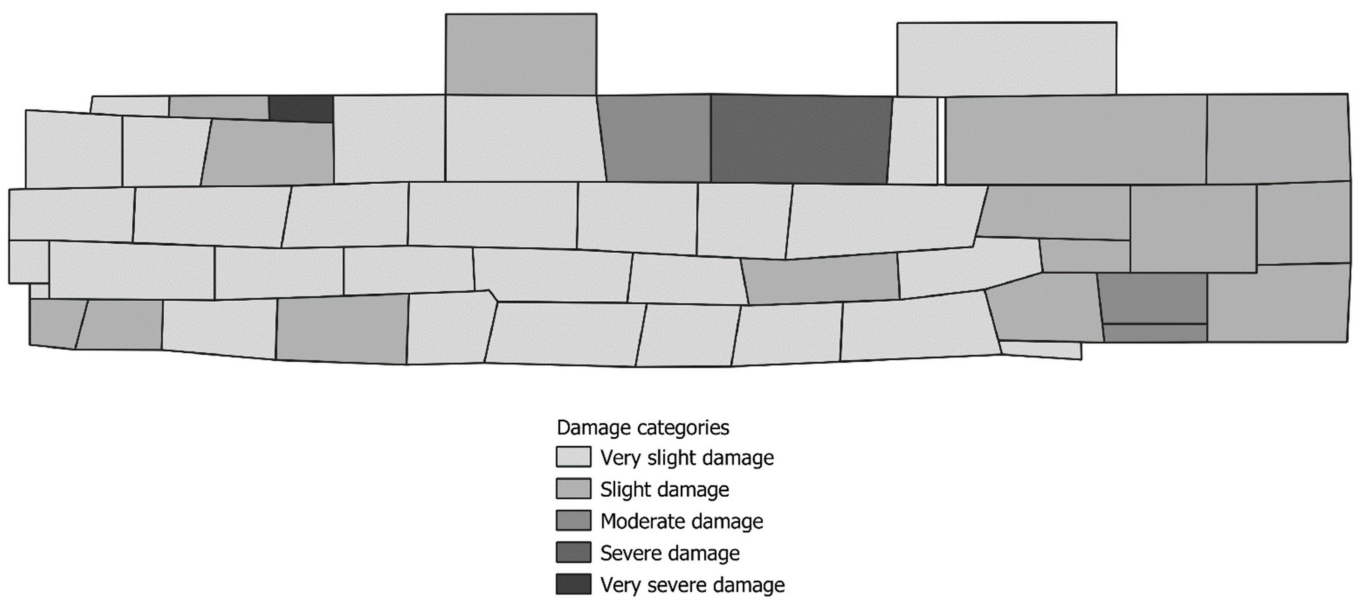
Figure 12. Damage index map, cella wall remains at the Temple of Athena and Zeus Sotiros.

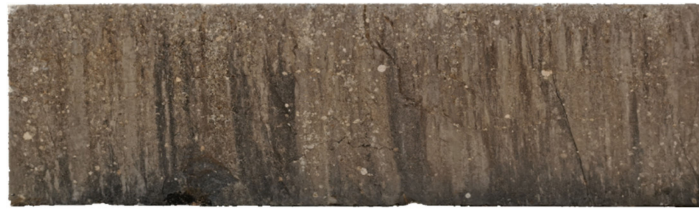
Figure 13. Orthoimage mosaic, cubic stone pedestal at the Temple of Athena and Zeus Sotiros.

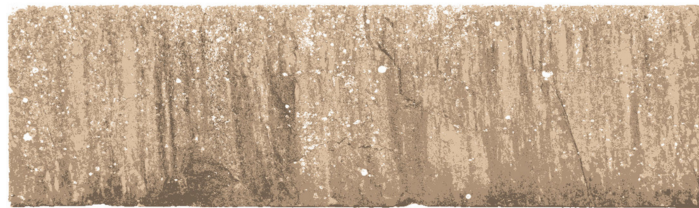
Figure 14. Degradation map, cubic stone pedestal at the Temple of Athena and Zeus Sotiros.

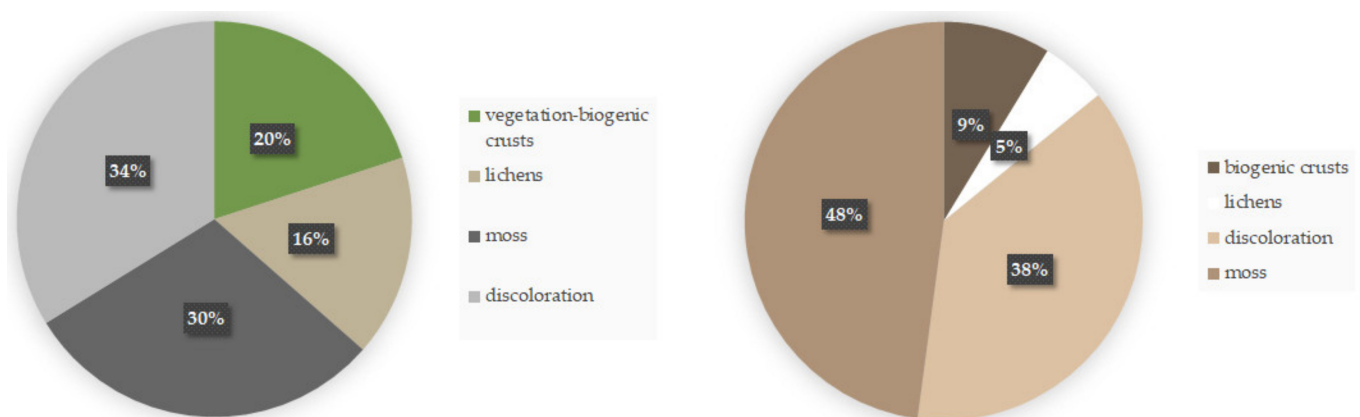
Figure 15. Degradation pattern statistics for the investigated surfaces at the remains of the Temple of Athena and Zeus Sotiros; cella wall (left) and cubic stone pedestal (right).

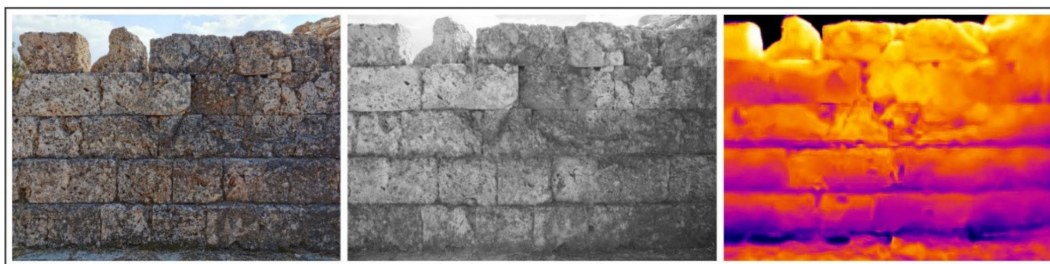
**Figure 17.** Reflectance images captured at the archaeological site of Lepreum: (from left to right) visible-spectrum, near-infrared, and a thermal-infrared image.

For this case study, photogrammetric approaches were followed using multiband datasets (examples of reflectance images shown in Figure 17), as described in Section 3.2, to generate the necessary base maps for the mapping process. The thermal orthoimage mosaic was produced following a hybrid approach exploiting both the visible and thermal images captured by the FLIR One Pro camera [58] (Figure 18). The false-color multiband image mosaic composed of three single-band mosaics (RGB, NIR, and TIR) was classified to create the thematic map (true-color image shown in Figure 19 and final degradation pam in Figure 20). Statistics were again calculated for the coverage of the historic surface by various degradation forms (Figure 21), while the damage map (Figure 22) considered the presence of vegetation, moss, and biocolonization. Additionally, in this case study, the historical surface was almost entirely covered by biogenic material or discolored.

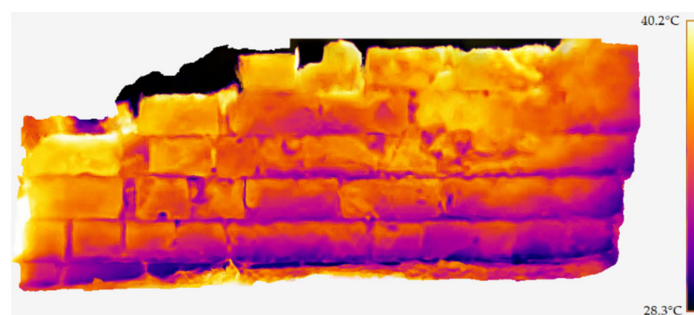
**Figure 18.** Thermal orthomosaic of an ancient wall at the archaeological site of Lepreum.

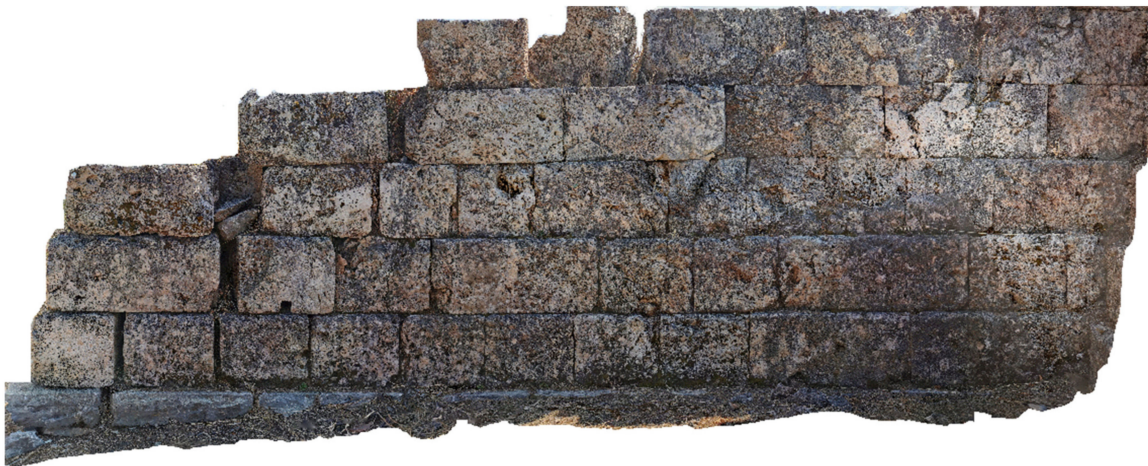
Figure 19. Orthomosaic of an ancient wall at the archaeological site of Lepreum.

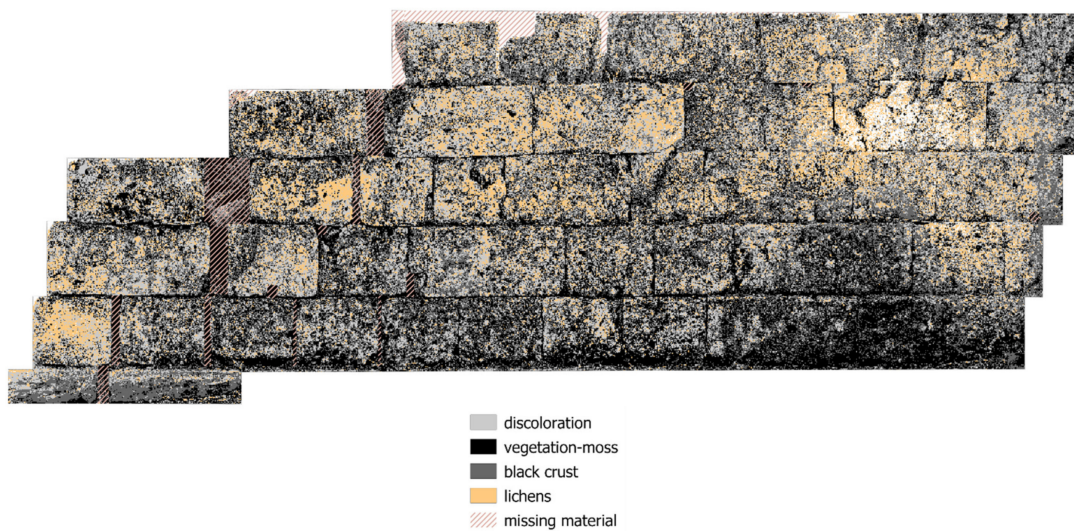
Figure 20. Degradation map of an ancient wall at the archaeological site of Lepreum.

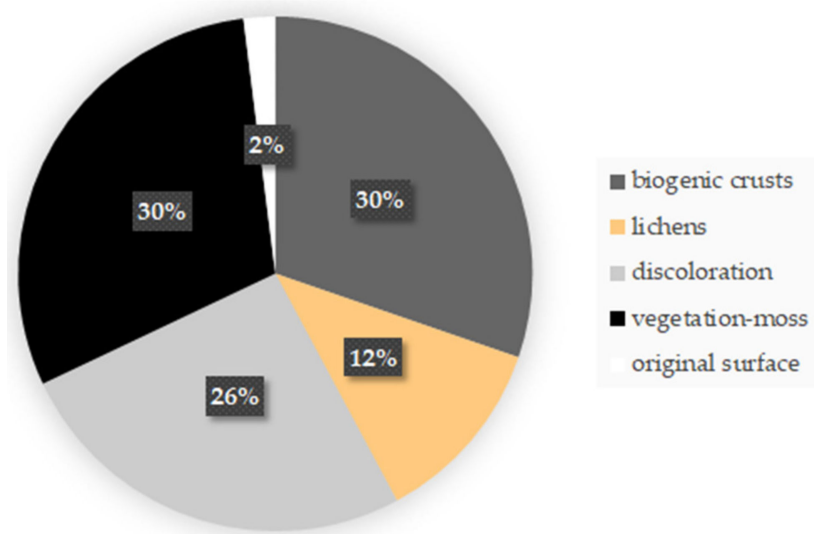
Figure 21. Degradation pattern statistics for the investigated surface of the wall at the archaeological site of Lepreum.

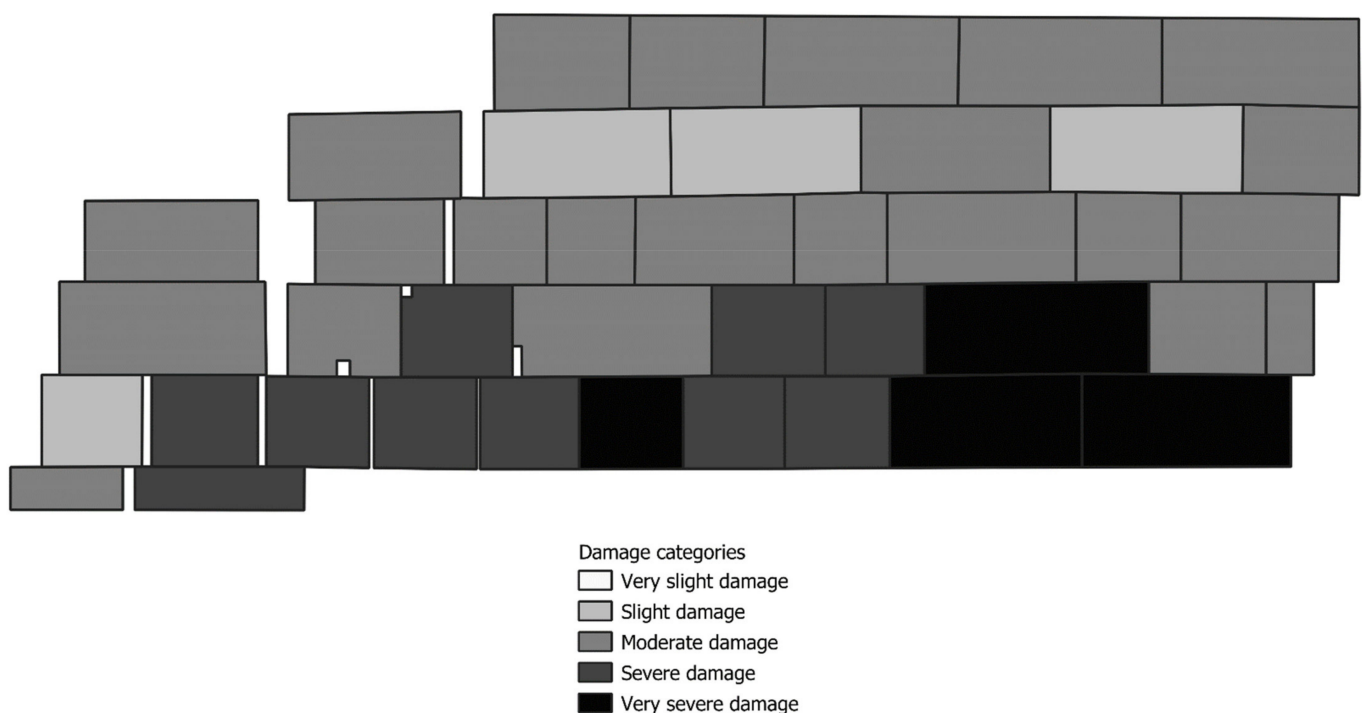
**Figure 22.** Damage index map, of an ancient wall at the archaeological site of Lepreum.
