Block toppling stability in the case of rock blocks with rounded edges

Manuscript number	ENGEO_2017_1239_R1
Title	Block toppling stability in the case of rock blocks with rounded edges
Article type	Research Paper

Leandro R. Alejano¹, Carlota Sánchez–Alonso^{1,4}, Ignacio Pérez–Rey¹, Javier Arzúa¹, E. Alonso¹, Javier González^{1,3}, Luisa Beltramone⁴ & Anna María Ferrero⁴

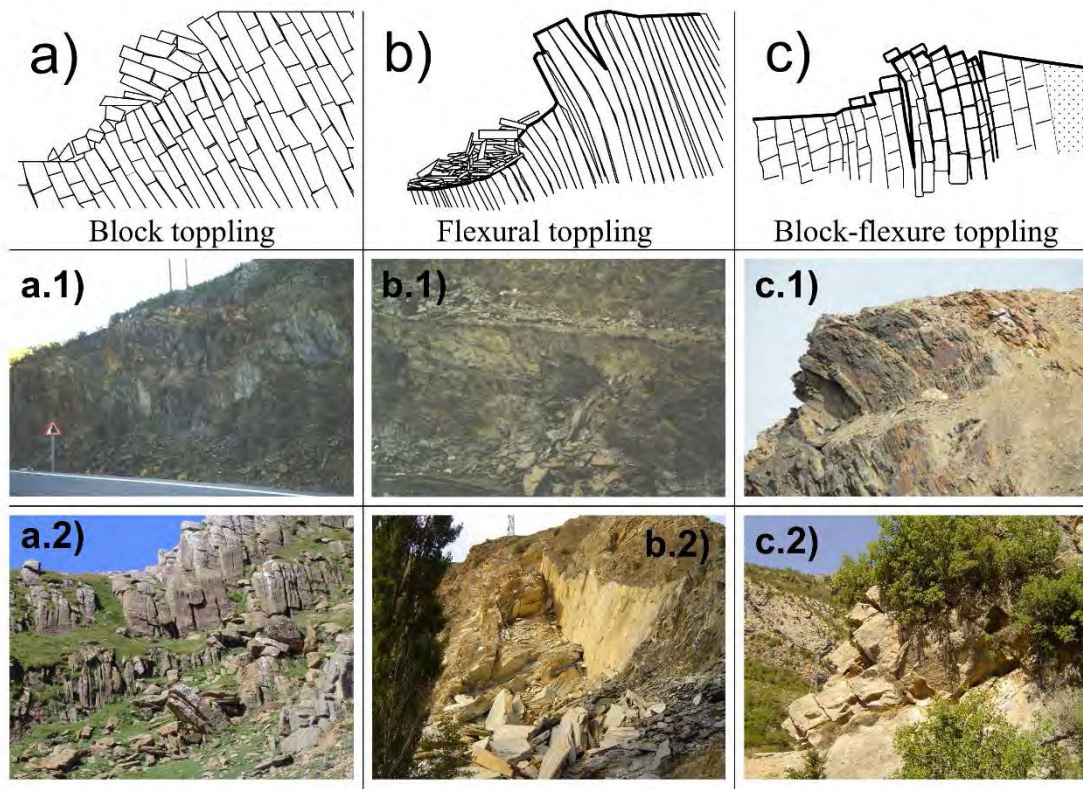
Figure 2. Common toppling failures as described by Willye and Mah (2004). a) Block toppling of slabs of rock with widely spaced normal joints: a.1) block toppling on a road in Salamanca (Spain); a.2) block toppling in the Pyrenees (Spain). b) Flexural toppling of slabs of rock dipping steeply into face: b.1) flexural toppling in a bench of the Tharsis copper open-pit mine in Huelva (Spain); b.2) flexural toppling near a riverbank in Sort near the Pyrenees (Spain). c) Block-flexural toppling characterized by pseudo-continuous flexure of long slabs through accumulated motions along various cross joints: c.1) block flexural toppling in a slate quarry in La Cabrera in León (Spain); c.2) block flexural toppling in a riverbank near Gerri de la Sal in Lleida (Spain).

Block toppling takes place in hard rock when individual blocks or columns are formed by two orthogonal joint sets, when the main set strikes parallel to the slope crest and dips steeply into the face. The upper blocks tend to topple and push forward on the short columns in the slope toe. Flexural toppling typically occurs in thinly bedded slate in which orthogonal jointing is not well developed; consequently, the basal plane is not as well defined as in block toppling. The general condition for flexural toppling is therefore when continuous columns of rock dipping steeply towards the slope break in flexure and tilt forward. Finally, block-flexural toppling is a complex mechanism characterized by pseudo-continuous flexure along long blocks that are divided by a number of cross-joints.

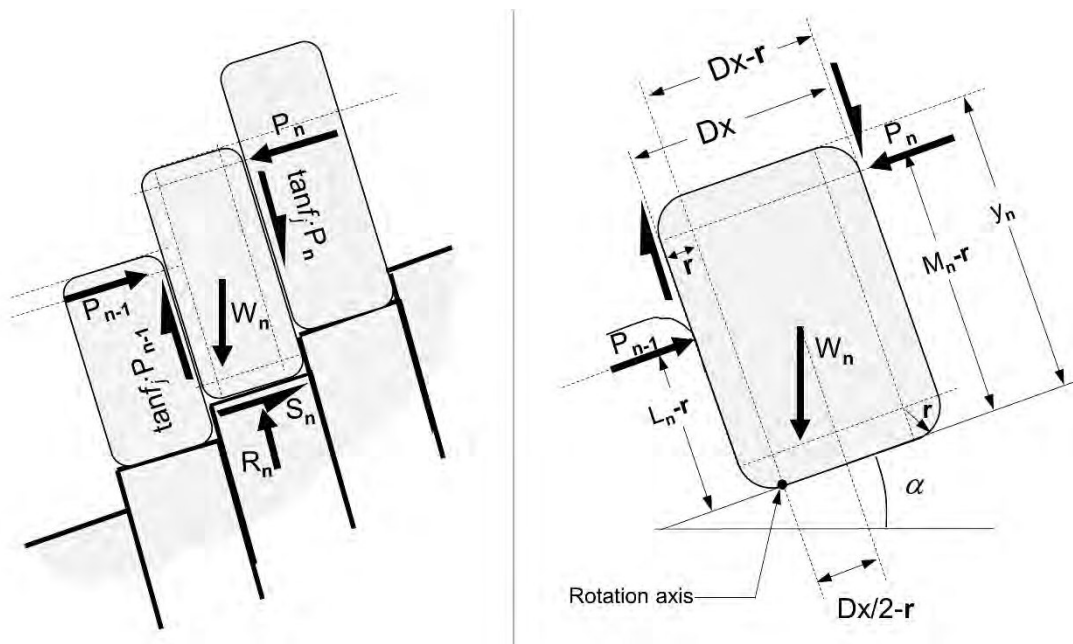
Since rounded edges in blocks may appear in rock blocks in slopes prone to toppling, we propose an analytical approach to calculating the corresponding FoS based on first revisiting the limit equilibrium equations described in Goodman and Bray (1976). The analysis of a single block demonstrated that the impact of rounded corners on sliding mechanisms is negligible (Alejano et al, 2015). However, as illustrated in Figure 4, the rotation axis is displaced in toppling blocks.

Figure 4. Geometry and forces acting on a block with rounded edges.

Proposed here is a modification of the equation used to calculate the force necessary to prevent a block from toppling, in which the moments are calculated taking into account the rounding of block edges. To simplify calculations, circular curvature of the edges is suggested as a hypothesis. The modified equation (Eq. 3) — used in further calculations for blocks with rounded edges — is as follows:

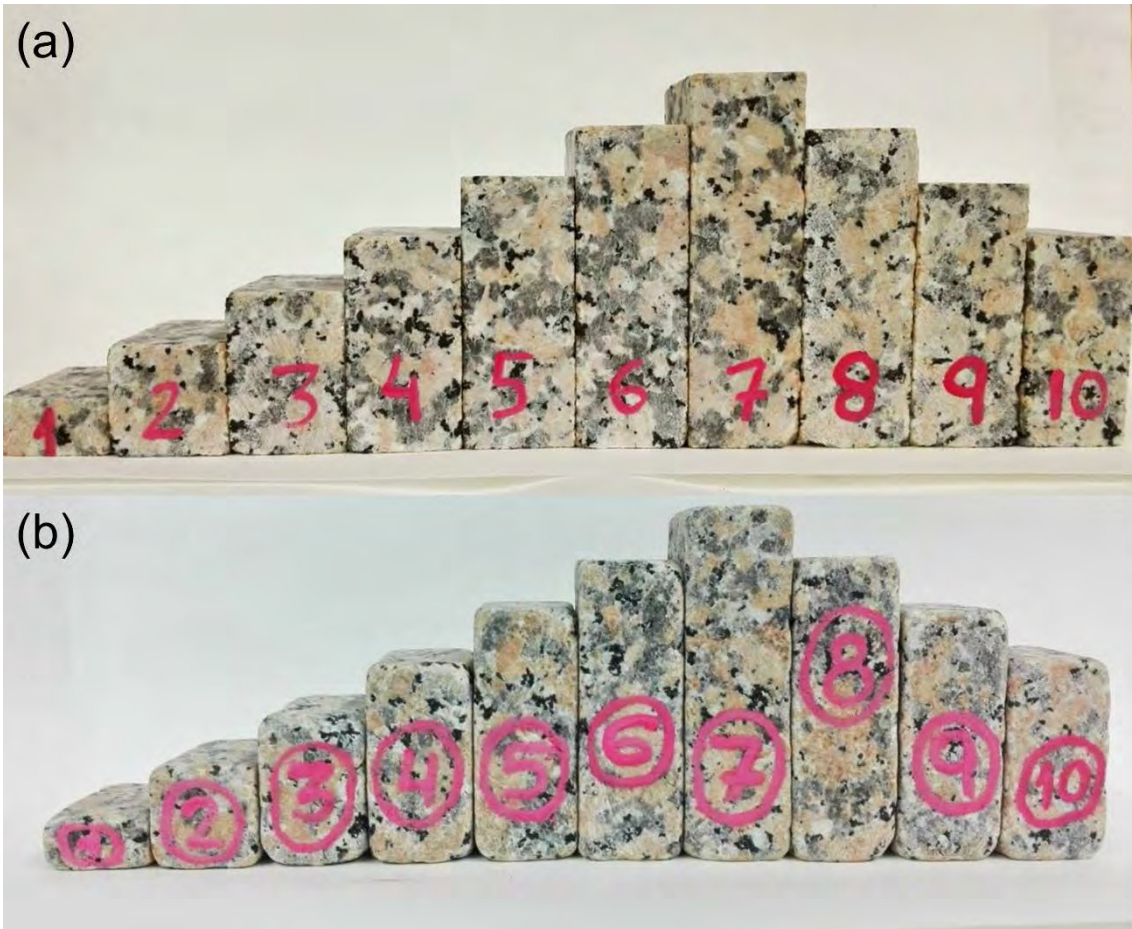
Taking the modified Eq. (3) into consideration, the block toppling mechanism was reproduced in the laboratory using two 10-block saw-cut Rosa Porriño granite models as illustrated in Figure 8. The models were cut from a 31-mm wide granite specimen, roughly finished on one side and polished on the other side. Two sets of 48.5-mm wide blocks were cut to heights of 15, 30, 45, 60, 75, 90, 105, 90, 75 and 60 mm. One set was left with saw-cut sharp edges and the other underwent 12 hours of mechanical weathering in a slake durability machine to obtain rounded edges.

Figure 7. Two sets of 10 blocks, with sharp edges (a) and with rounded edges (b).

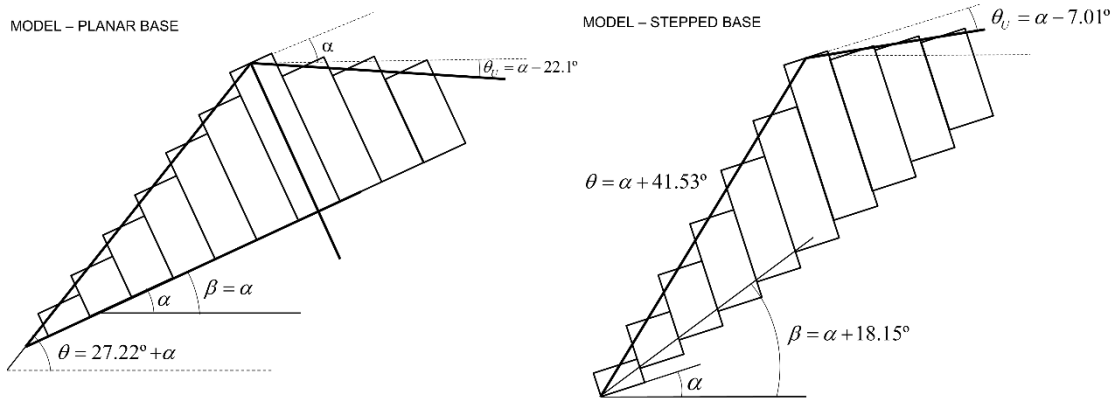
Figure 8. Geometrical parameters for the flat and stepped bases.

From the measurement data it was possible to calculate the failure angle and predict the inclination of the tilt table, α , at failure in order to compare theoretical and laboratory results. The geometrical parameters used in the calculations are shown in Figure 8 (above).

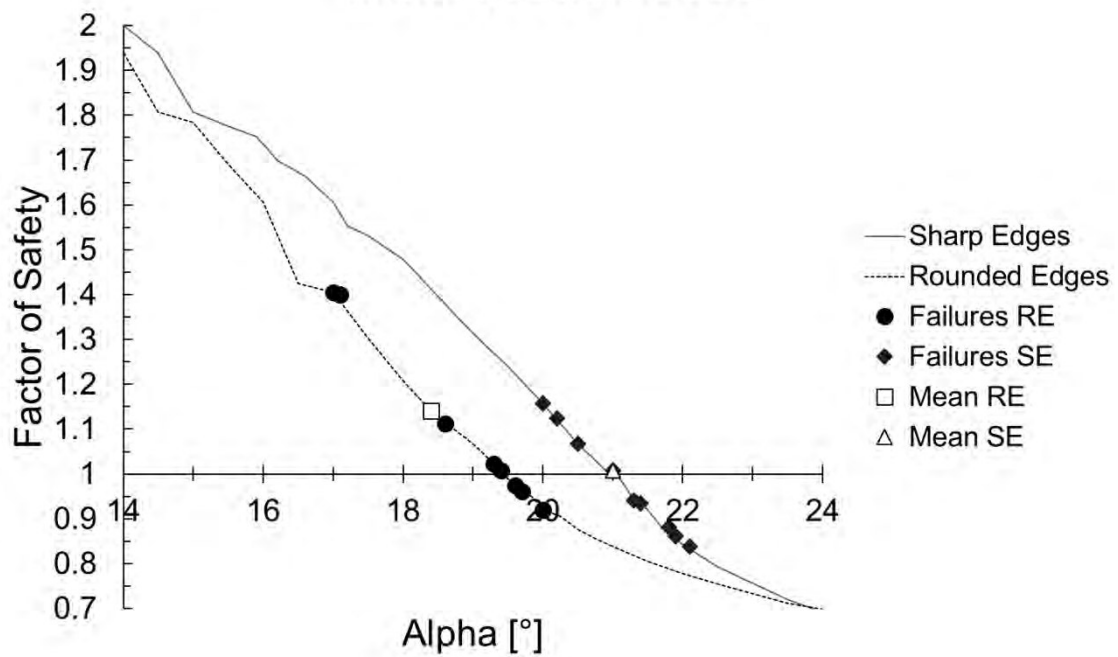
Figures 9-12 graphically compare the predicted behaviour and laboratory results obtained for the sharp-edge models (SE, continuous lines) and rounded-edge models (RE, broken lines) for each of the four bases, depicting the predicted variation in the FoS against the inclination of the base (α). Individual observations are indicated by black circles and triangles and the mean of the two medians obtained for each set is indicated by a white circle or triangle. The FoS values were computed in an Excel spreadsheet application (created by Carranza-Torres) that calculated slope FoS against toppling taking into account the rounding of rock block edges.

Figure 9. Model behaviour for the flat wooden base.

It can be observed that results varied widely depending on the model and the base. The greatest variability occurred in the tests carried out on the polished base (standard deviation of around 1.5^0), indicating that in occasion, the model failed when the overall computed FoS was right off 1.5.

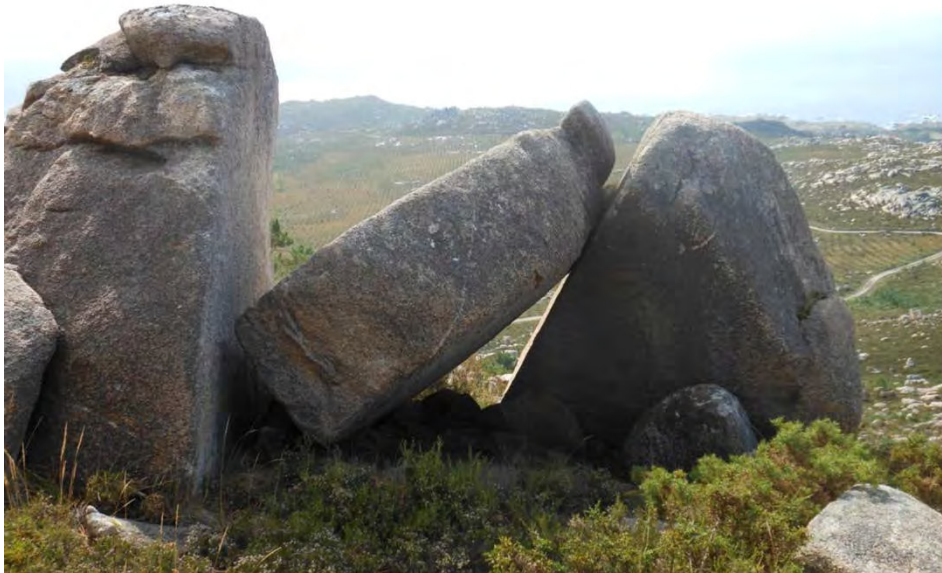
Figure 14. Toppled single block on Monte Pindo (A Coruña, NW Spain).

The Monte Pindo area has a large number of weathered boulders, including toppled specimens, mostly single blocks (e.g., Figure 14), but also sets of blocks that had apparently experienced toppling failure (e.g., Figure 15).

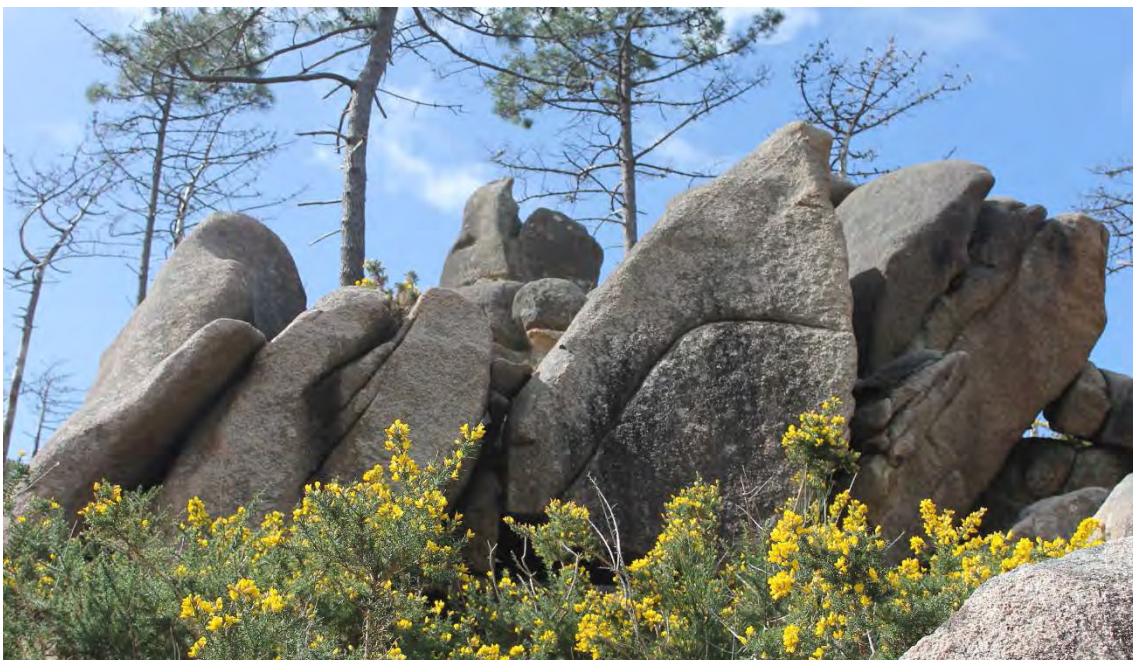
Figure 15. Apparently toppled series of blocks showing rounded corners on Monte Pindo (A Coruña, NW Spain).

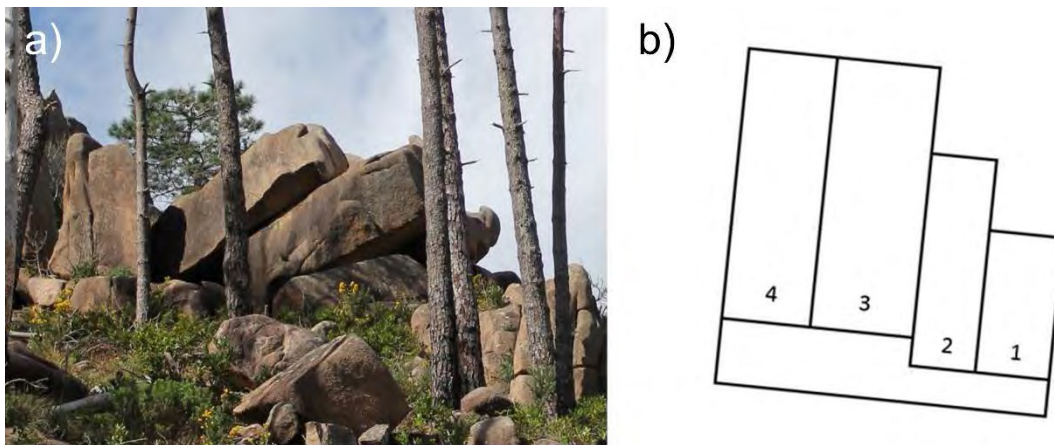
The first case study referred to a set of four blocks (Figure 16). As found, two blocks were already toppled, but another rock was preventing them from falling to the ground, and yet another block lay on the ground. The possibility of a fifth block that had already fallen down the hill was also taken into account in calculations, although the likelihood of just four blocks produced more coherent results.

Figure 16. Set of four blocks analysed in case study 1: picture on site (a) and simplified cross-cut view (b).

To analyse the role of the rounded edges in the failure of the set, Goodman and Bray (1976) calculations were performed to obtain the FoS for both rounded and sharp edges. Set geometry (summarized in Table 8) was measured in the field using measuring tape for block dimensions, a set-square for corner rounding, a compass with inclinometer to orientate rock contacts and standard rock mechanics field equipment. Note that the geometry measurements were simplified to make calculations more straightforward, so the results must be taken as an overall estimate.

Other relevant geometrical parameters were base inclination $\alpha=12^{\circ}$, assumed friction angles of the contacts $\phi_b=35^{\circ}$ and $\phi_j=30^{\circ}$, and rock specific weight $\gamma=25.5 \text{ kN/m}^3$. The height of the step separating the base of the block 1 and 2 from that of blocks 3 and 4 was 40 cm. By using these parameters for the calculations, the FoS values for blocks with sharp edges and rounded edges were found to be 2.71 and 0.93, respectively, thereby justifying the present state of the slope.

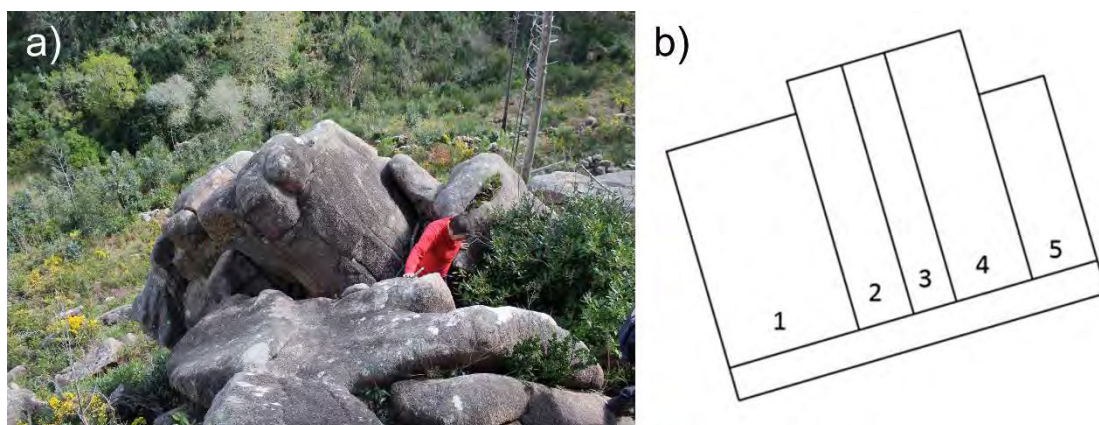
Downhill from the location of the first analysed set of blocks was another set of toppled blocks, stable because a block at the end was preventing further toppling (Figure 17).

Figure 17. Set of five blocks analysed in case study 2: picture on site (a) and simplified cross-cut view (b).

This second set of five blocks with different thicknesses and sizes was measured for the same parameters as the first set of blocks (Table 9). Specific weight and friction angles were assumed to be the same since they would be typical values for granitic rocks in this location. The base inclination was $\alpha=10^{\circ}$ and the base where all the blocks rested was assumed to be planar. The FoS values for blocks with sharp edges and rounded edges were found to be 3.27 and 0.91, respectively, again justifying the present state of the slope and a clear indicator of how rounded corners affected the stability of this natural slope.

The numeric analysis of the two block sets observed in the field revealed a considerable reduction in the FoS after weathering when compared to the FoS before weathering. In the first case, the FoS dropped from 2.71, indicating stability, to 0.93, indicating instability. Similar results were obtained for the second case, in which the initial FoS of 3.27 fell to 0.91 when edge rounding was taken into account.
