Learning-based classification of multispectral images for deterioration mapping of historic structures

Efstathios Adamopoulos¹

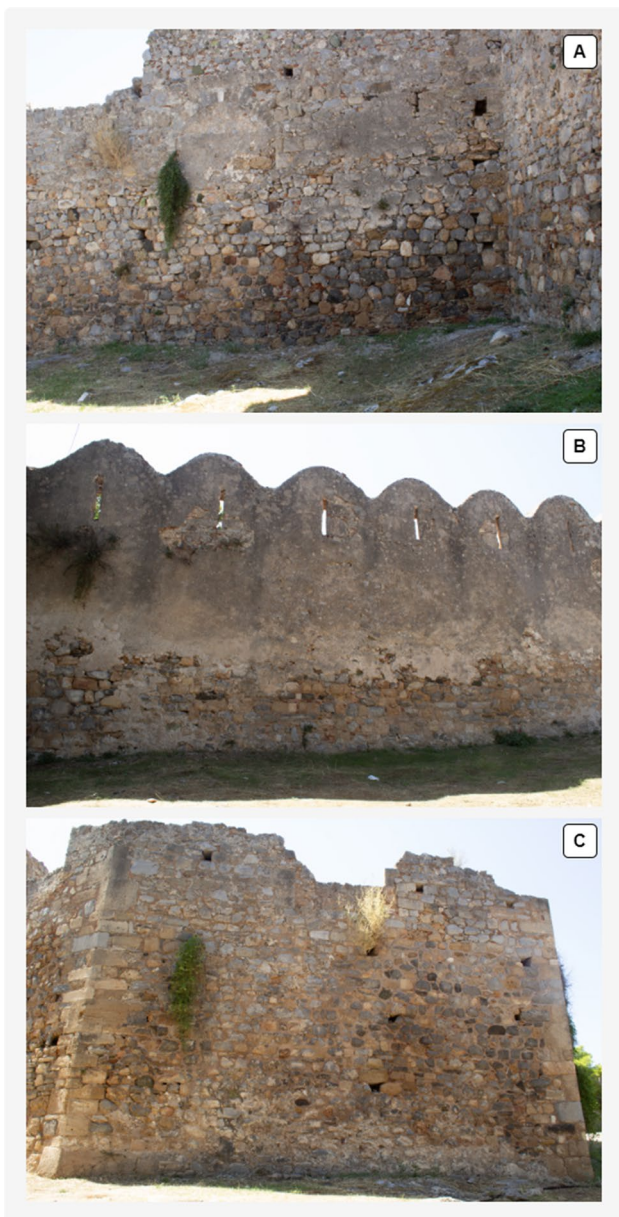
Fig. 3 Fort of Karababa north side, façades selected for evaluating the mapping methodology; from top to bottom: **A** (westernmost), **B**, and **C** (easternmost)

masonry surfaces selected for evaluating the methodology are presented in Fig. 3. They are on the north side, and for abbreviation purposes, they have been named A, B, and C, starting with the westernmost (on the north bastion).

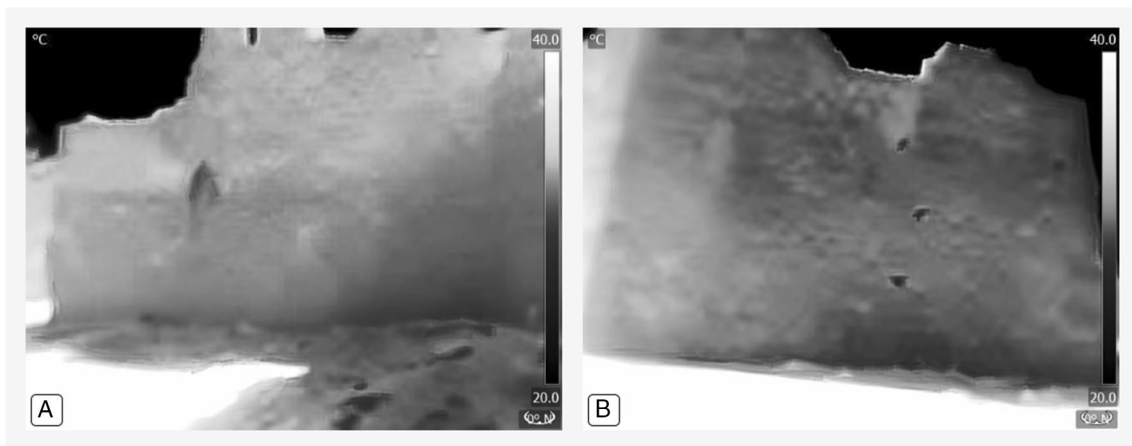
Fig. 6 Thermograms of façades A (left), and B (right)

The inclusion of the NIR spectral band fairly improved the classification results for all deterioration forms. The segmentation of a NIR-R-G multispectral image and the Fast Random Forest classifier proved to be the most consistent solution overall ($79 \leq$ overall accuracy%). Figure 5 presents a comparison between the reference maps and the NIR-R-G composites segmented with the Fast Random Forest. Using NUV reflectance data generally did not provide any improvement to the quality of the classifications. Including the TIR band also did not improve the deterioration patterns' classification. Furthermore, the fusion of visible with thermal data significantly decreased the accuracy of detecting deterioration when dampness was present, which contradicts that thermal images are helpful in detecting moisture on historic masonry, as evident by Fig. 6.
