Geomorphological evolution and present-day processes in the Dessie Graben (Wollo, Ethiopia)

This paper presents a detailed geomorphological overview of the landforms and processes characterizing the Dessie basin, a small graben located on the western Afar Margin (Ethiopia), which is a physiographic province characterized by small, closed basins and mountain ranges produced by regional extension. Large-scale geomorphological survey and mapping of the basin allowed to point out the noteworthy morphodynamic role of the present-day slope processes, including numerous landslides of different typology and size. These processes heavily interact with the built-up area of Dessie town, one of the most important cities of Ethiopia with ca. 200,000 inhabitants, which occupies a large part of the basin floor. The potential incidence of landslides of different typology in the basin and their possible impact on the urban settlement are put in relation with the distribution of the different landform units which make up the basin surface.

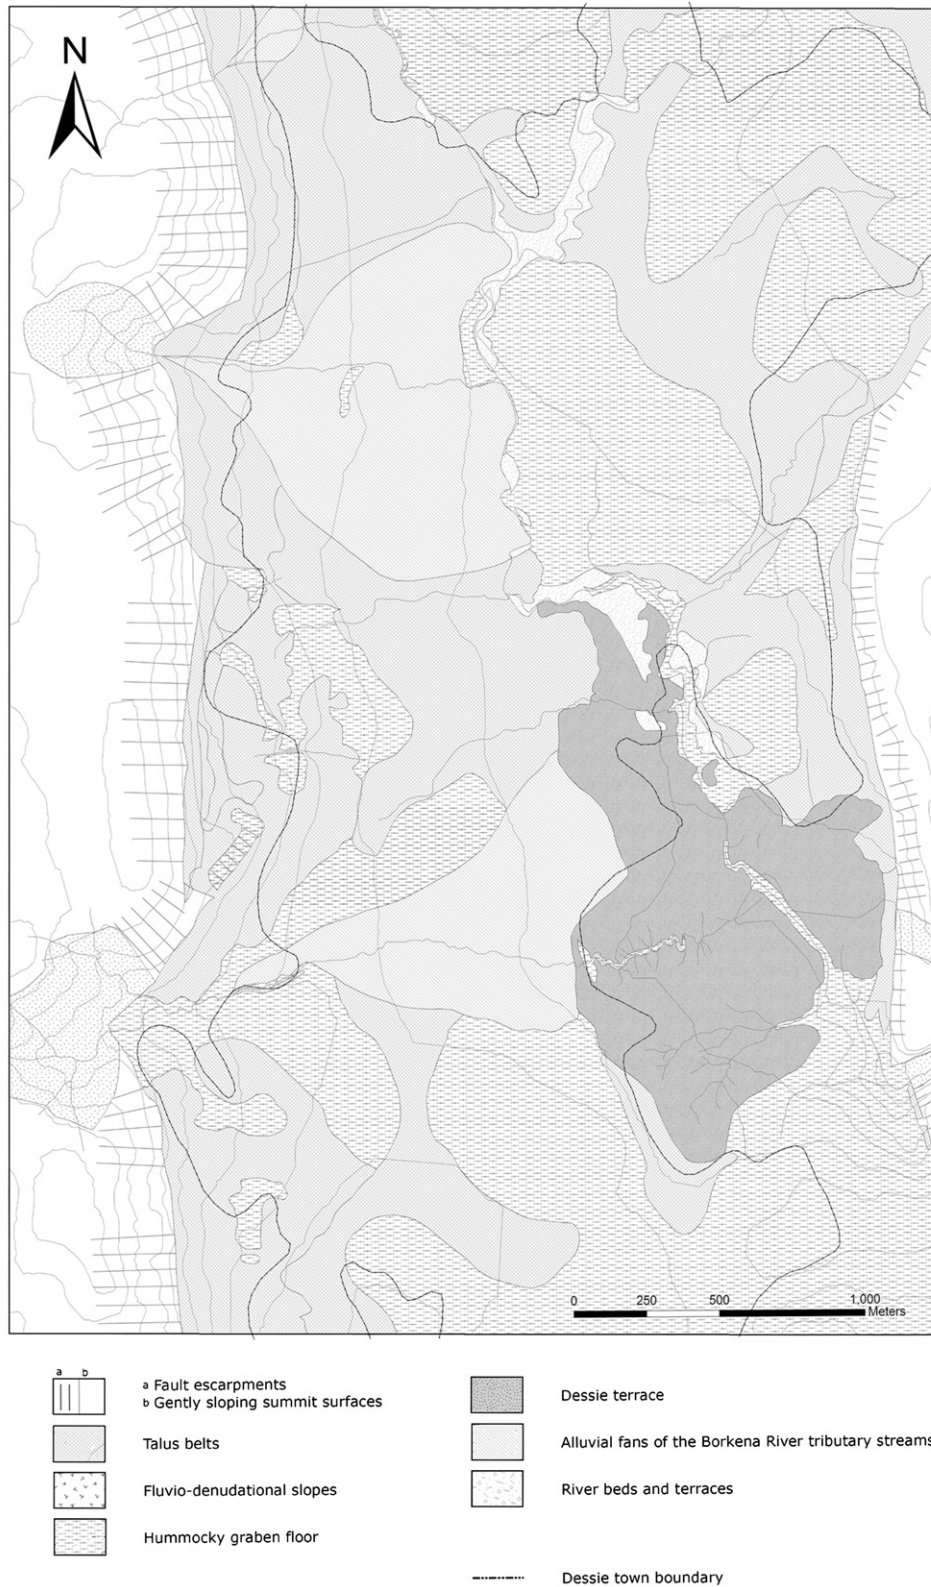
Fig. 6. Main landform units of the Dessie Basin.

From the geomorphological point of view, the Dessie graben can be divided into seven different landform units: 1) the fault escarpments and gently sloping summit surfaces; 2) the talus belts; 3) the fluvio-denudational slopes; 4) the hummocky graben floor; 5) the alluvial fans of the Borkena River tributary streams; 6) the Dessie terrace; 7) the river beds and terraces (Fig. 6).

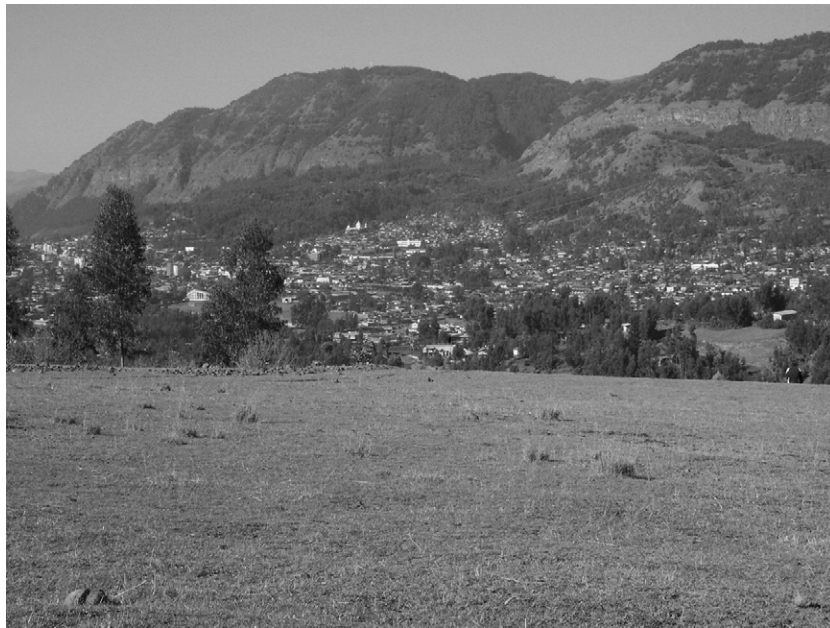
Fig. 7. Tossa fault escarpment and alluvial fan where Dessie city center is located.

The main N–S fault escarpments form imposing rocky walls over which the basalts and ignimbrites of the continental flood basalt outcrop. The Tossa fault escarpment (Fig. 7) is up to 400 m high and up to 80° steep. It follows a rectilinear trend being only interrupted by the upper catchments of the two western tributaries of the Borkena River. The Azwa Gedel scarp is lower (ca. 200 m) and has a more rectilinear trend, without major stream incision. The two N–S bordering escarpments are topped by gently sloping surfaces, whose maximum elevation is ca. 2950 m on the Tossa side and 2720 m a.s.l. on the opposite Azwa Gedel side. It is probable that these surfaces were fragments of the ancient depositional top of the trap volcanics before the opening of the Dessie graben.

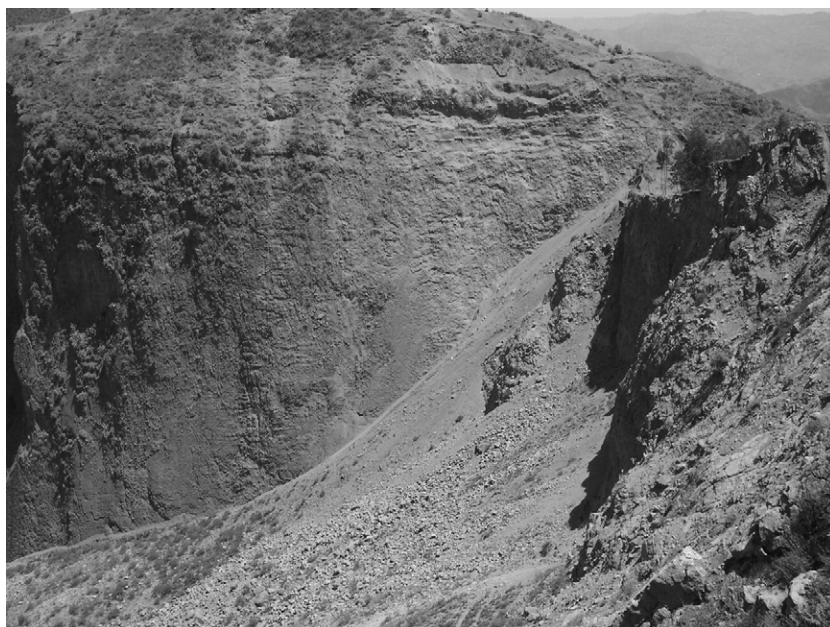
Fig. 8. Rock slide/avalanche on the Doro Mezleya right slope: the landslide scarp is about 100 m wide and 25 m high.

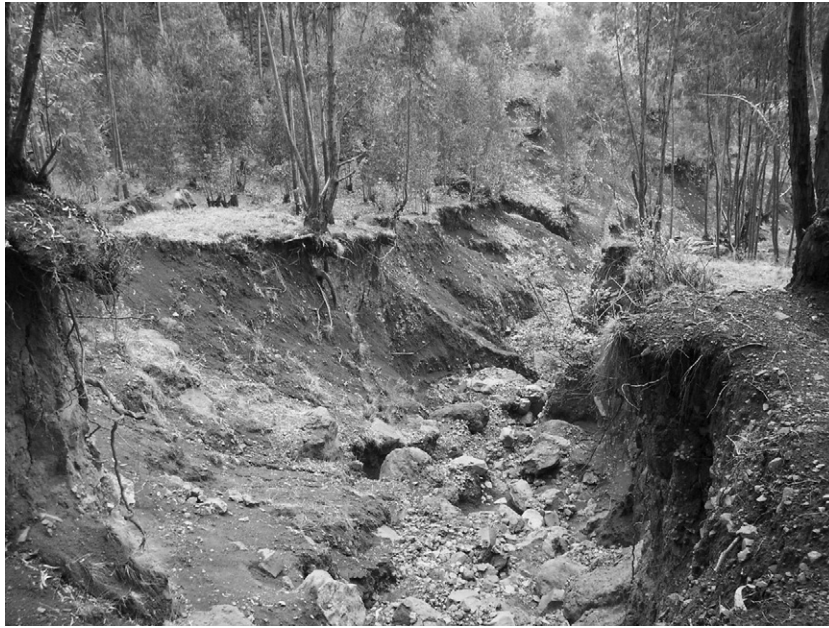
Fig. 9. Tossa talus belt with a landslide trench.

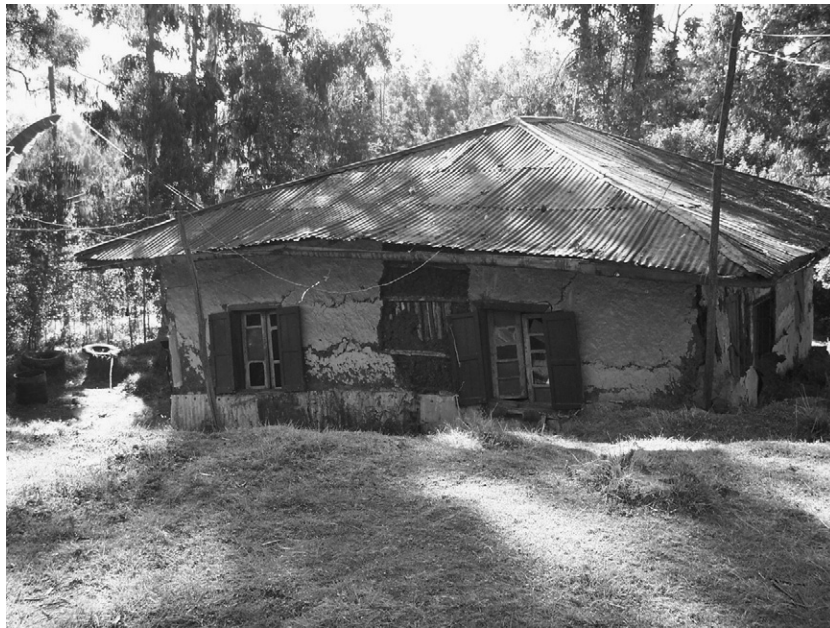
Fig. 11. House tilted by a slow moving landslide since 1994.

The active geomorphic processes which affect the study area heavily impact on the Dessie town interacting with people, settlements, infrastructures and farmlands. In particular, a large number of landslide events have repeatedly struck the urban area since long time ago, causing the loss of life and property (Ethiopian Institute of Geological Surveys, 1995; Ministry of Works and Urban Development, in press; Kefialew, 2001; Tenalem and Barbieri, 2005). In 1977, two people were killed by a seismically induced landslide (Gouin, 1979) and in 1994, landslides triggered by heavy rainfall blocked a segment of the Main Dessie–Mekelle highway, destroyed a bridge and buckled the foundations of several houses (Fig. 11).
