JOURNAL OF MATERIALS SCIENCE. MATERIALS IN MEDICINE  
(2014)

## **Correlation between in vivo stresses and oxidation of UHMWPE in total hip arthroplasty**

M. Regis, P. Bracco, L. Giorgini, S. Fusi, P. Dalla Pria, L. Costa, C. Schmid

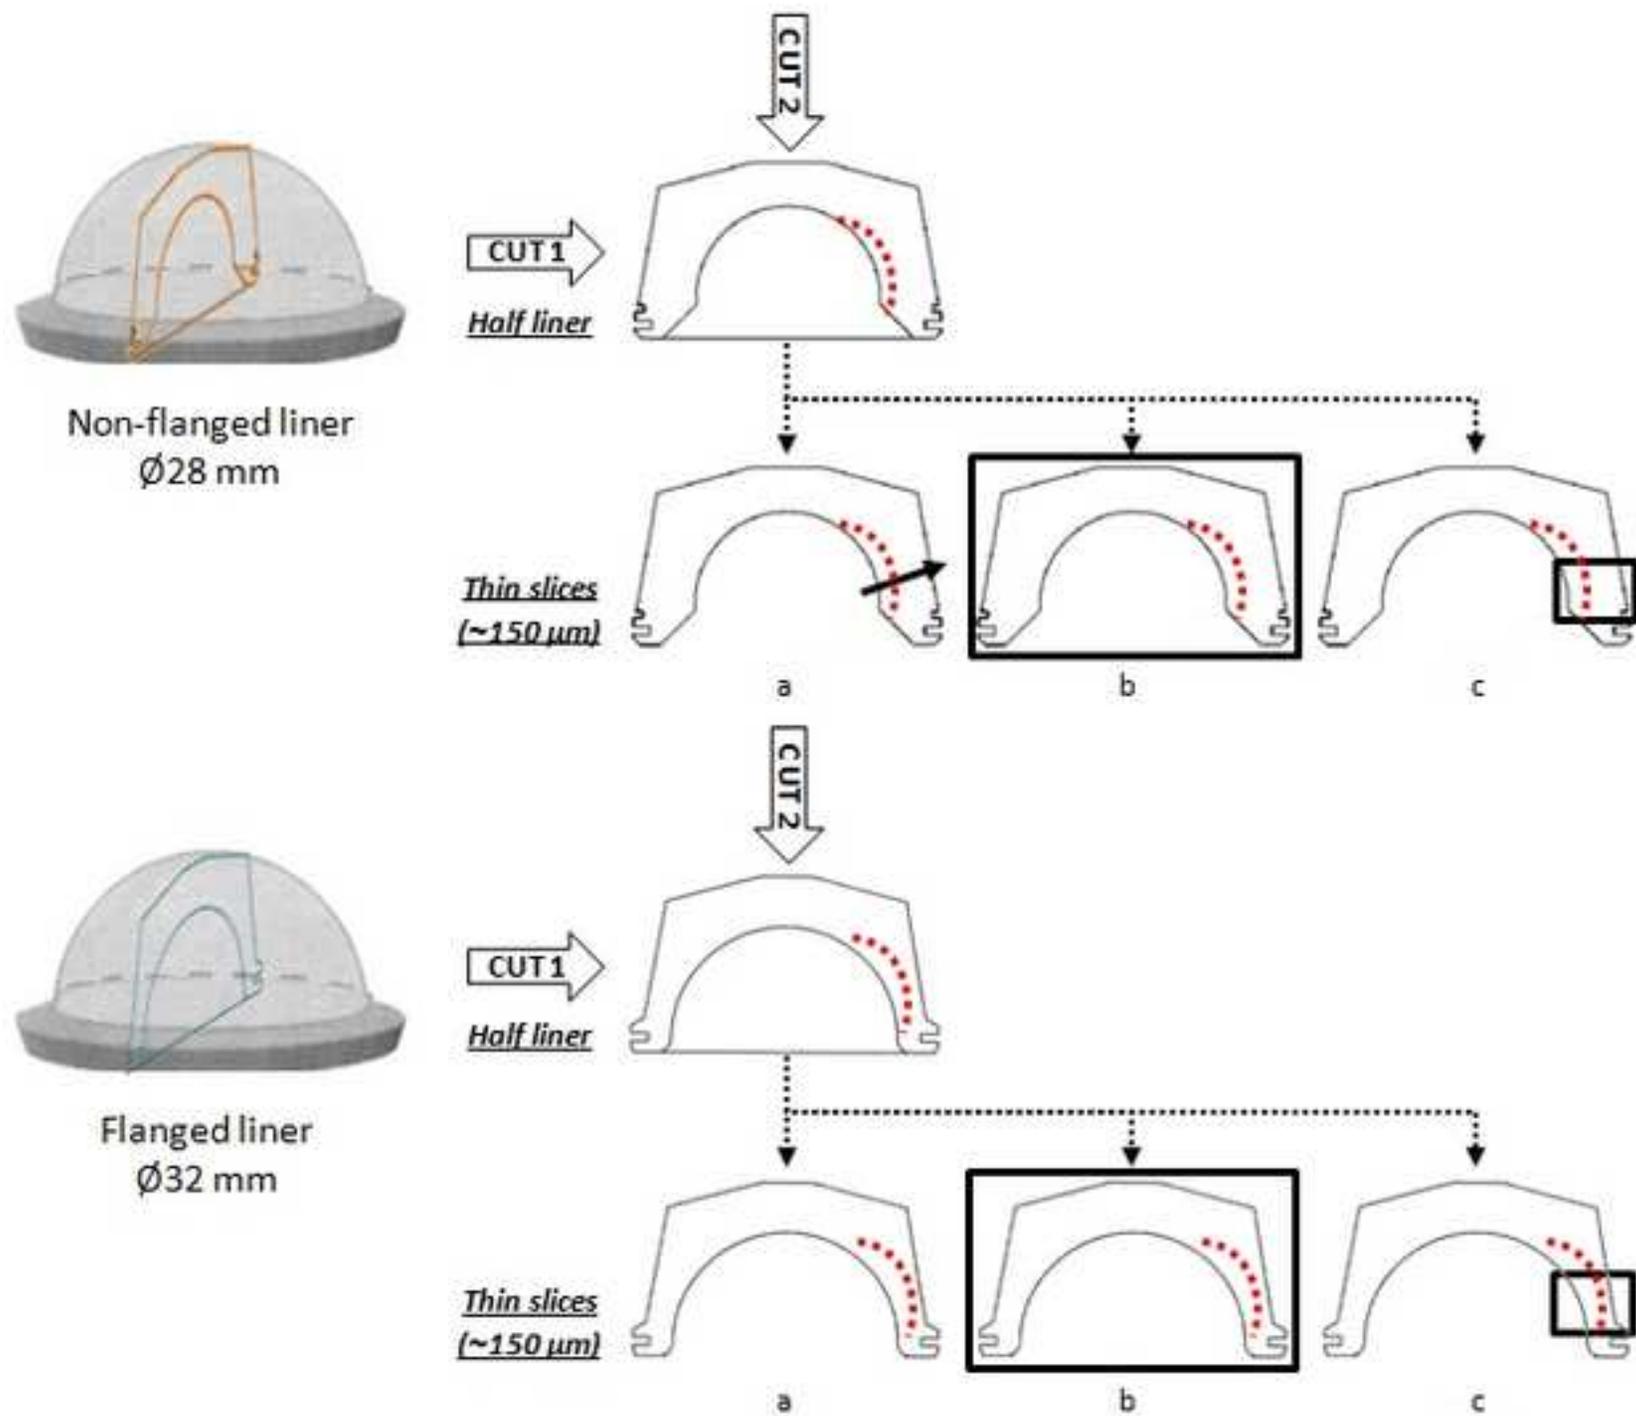
Figure 1  
[Click here to download high resolution image](#)

Figure 1. Thin slices preparation of E1-E4 liners for FTIR analysis and investigated areas. From a to c, line scan path and direction (points collected every 100  $\mu\text{m}$ ); global IR map (surface scanned at 100x100  $\mu\text{m}$  spot size); worn side detailed IR map (surface scanned at 25x25  $\mu\text{m}$  spot size). Red dotted line indicates the most worn region.

After wear evaluation, liners were cut in half so that their cross-section contained both worn and unworn areas, and microtomed into thin sections (~150 µm) for FTIR analysis, using a Reichert-Jung POLYCUT S microtome (cutting speed 4 cm/s, at room temperature). The same microtoming conditions were used to obtain thin films of the reference materials. Cutting scheme and FTIR analysis for all the considered liners are summarized in Figure 1. After a cyclohexane Soxhlet extraction, performed to remove in vivo absorbed lipids, FTIR analyses were conducted using a Perkin-Elmer SPOTLIGHT microscope, to assess the oxidation level and distribution in all samples. At first, FTIR line scans (100x100 µm spot size, 16 scans at 4cm<sup>-1</sup> resolution) of E1-E4 samples were performed along the thickness of the worn cross section. The sections were scanned in 100µm deep increments from the articulating surface towards the backside (Figure 1a). E0 shelf-aged sample and the reference virgin block were also line-scanned for comparison. Then, FTIR spectral maps were collected (transmission mode, 16 scans at 4 cm<sup>-1</sup> resolution for each point, autofocus every 10th scan). Maps allowed to gain information on the oxidation level of both worn and unworn liner areas (Figure 1b and c). The spot size for the IR maps varied from 100x100 µm to 25x25 µm, depending on the size of the scanned area (the whole area or the rim area by the worn side, respectively). This determined a more accurate data acquisition in the most worn areas of the samples. All spectra were normalized at 2020 cm<sup>-1</sup>, a combination band associated with the twisting of CH<sub>2</sub>, which can be regarded as unaffected by minor changes in the polymer structure [31]. A ketone index (KI) was calculated as the peak ratio between the deconvolved carbonyl peak centered at 1718 cm<sup>-1</sup> and the reference band at 2020 cm<sup>-1</sup>. Oxidation index (OI) calculation (following ASTM F2102 and F2381) was not performed, in order not to introduce measurement deviations in terms of esters presence introduced by microtoming [32].

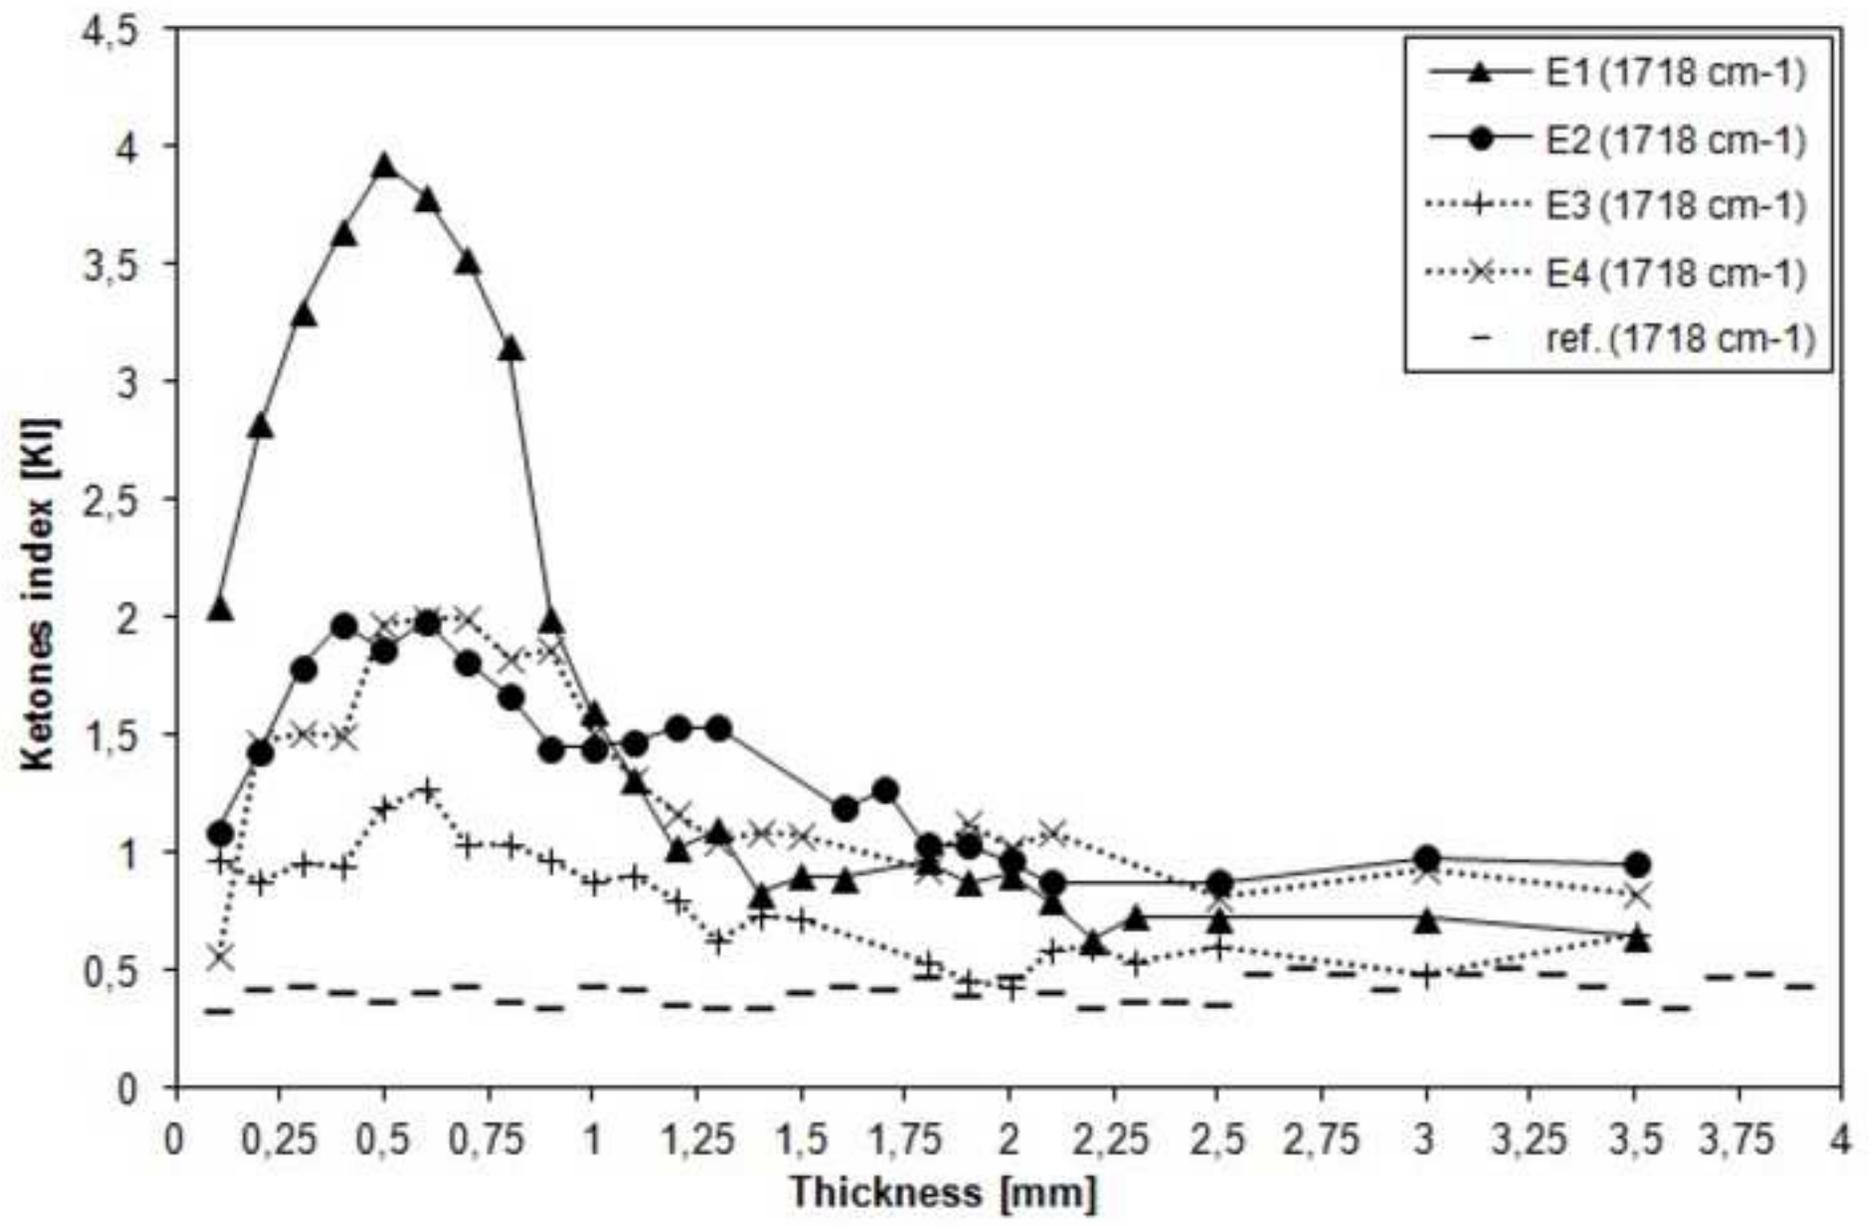
Figure 2  
[Click here to download high resolution image](#)

Figure 2. Ketone index profiles across the most worn section of E1-E4 and Reference profile. The 0 depth value is located at the inner rim of the liner.

Figure 2 reports the oxidation profile (in terms of KI) at the worn side of samples E1-E4 throughout the liners cross section (first 4mm from the bearing surface), along with that of the reference UHMWPE block, obtained from the line scan analyses. All the explanted samples show the same oxidation distribution across the liner thickness, having a maximum peak either at the inner bearing surface or in the first subsurface region. The strongest oxidation was observed in sample E1, with a

peak KI index of 3.92 at 0.5-0.6 mm depth. The amount of oxidation then decreases moving towards the bulk and the backside of the liner. The KI trend across the liner section seems not to follow any diffusive law, since the highest amount of oxidation was observed in the subsurface areas.

Moreover, the oxidation throughout the explanted liners cross-section is limited to the surface and first subsurface region of the inner worn side of the liner (Figure 2 and 4). In all the other scanned areas, the oxidation level was equal or lower than that of the reference material. Therefore, oxidation seems to be strongly localized in the ball and socket coupling area, in which the sliding motion between femoral head and liner occurs and where physiological load is applied. As well as for the linear wear data, it can be hypothesized that differences in patient weight, activity and other external factors have influenced the results.

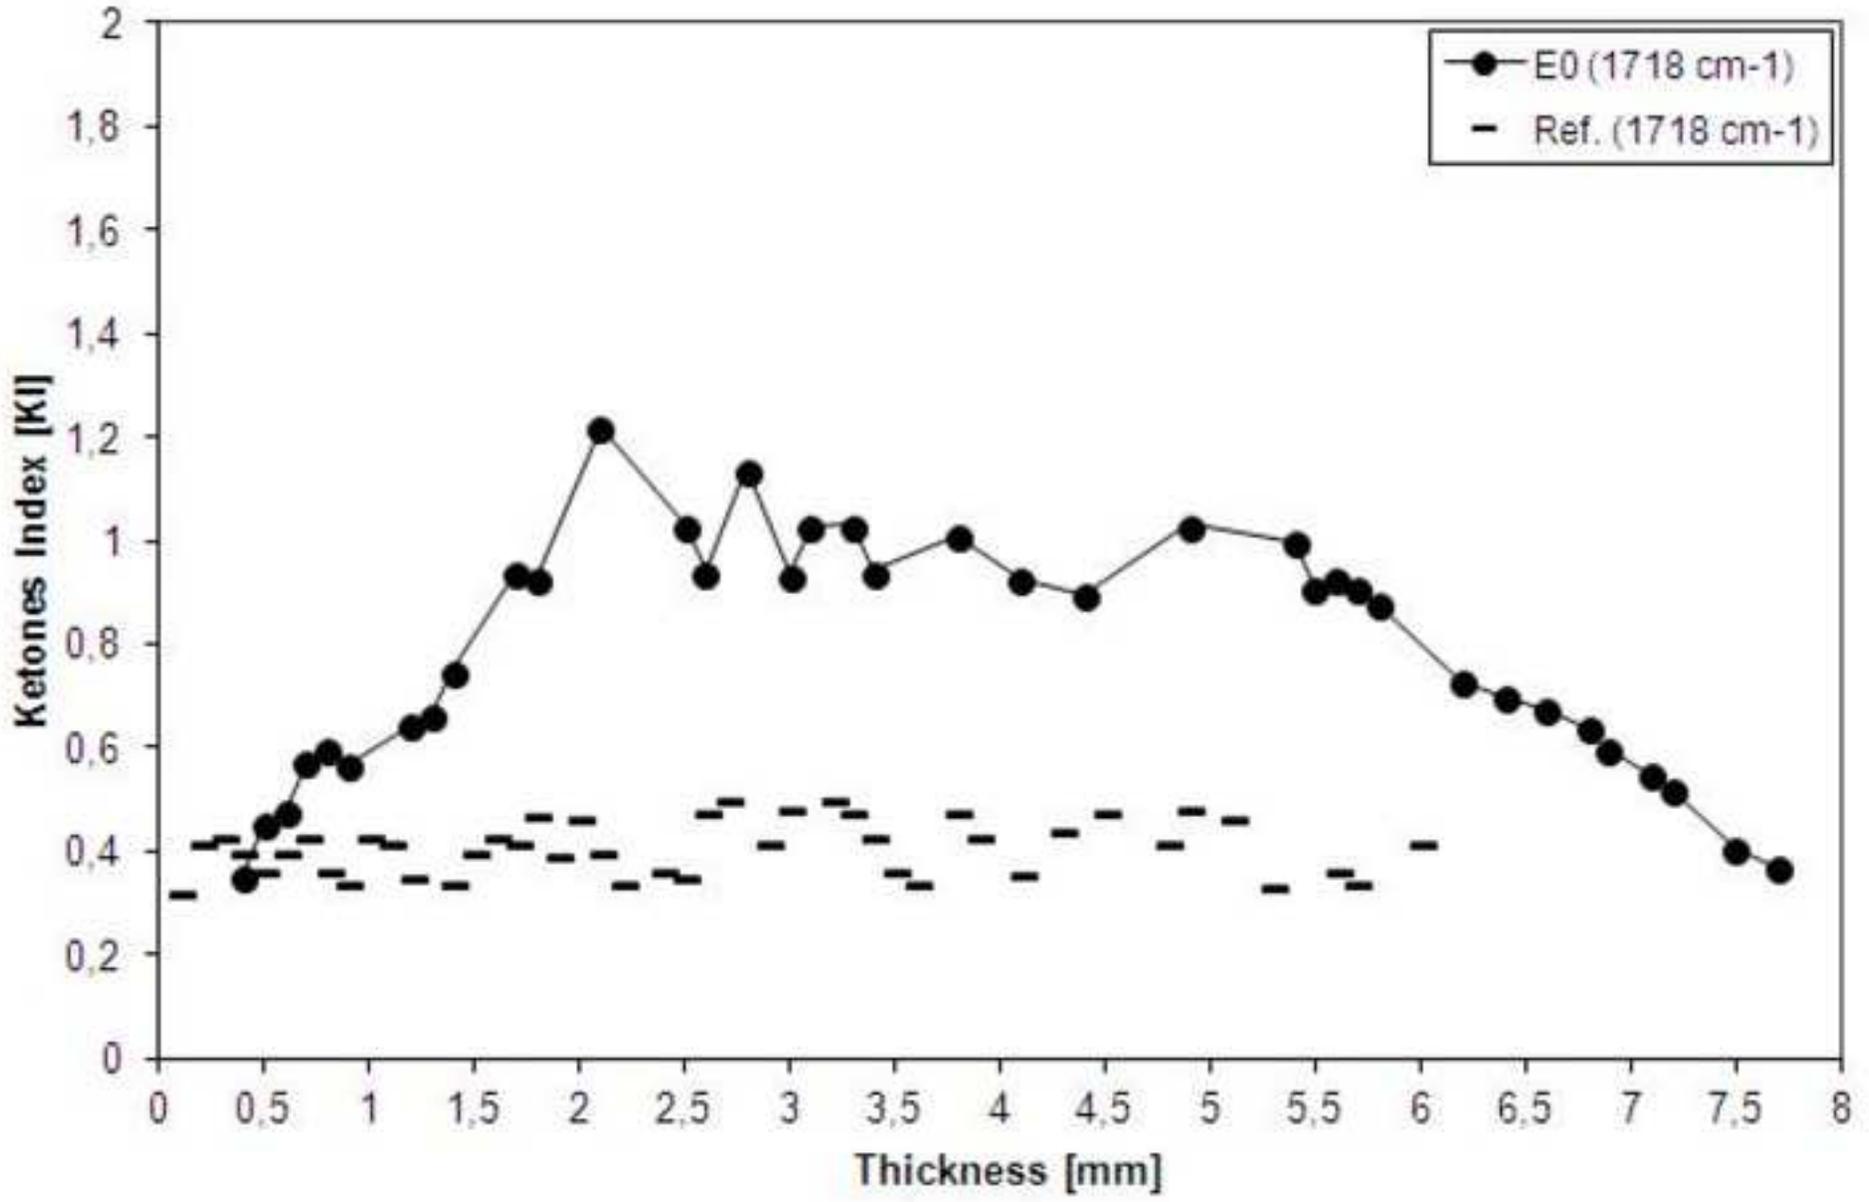
Figure 3  
[Click here to download high resolution image](#)

Figure 3. Ketone index profiles across the cut section of shelf aged E0 liner, and Reference profile. The 0 depth value is located at the inner rim of the liner.

No correlation between linear wear data and oxidation could be detected. However, it is noticeable that for the highest in vivo time (E1 liner), the highest amount of oxidation products was observed. The reference UHMWPE block did not show any significant oxidation, while the shelf aged liner (E0) had a different oxidation profile, as reported in Figure 3 (note the difference in the KI trend, when compared to Figure 2). According to similar literature studies [24, 25], the oxidation profile throughout E0 cross section shows a symmetric path, with a maximum peak in the central region of the liner. When comparing the oxidation profiles of the explanted liners to that of the shelf aged one, no similarities can be found, neither in terms of KI trend, nor in terms of peak oxidation, as for the shelf aged liner the oxidation amount was lower than in the retrieved components.

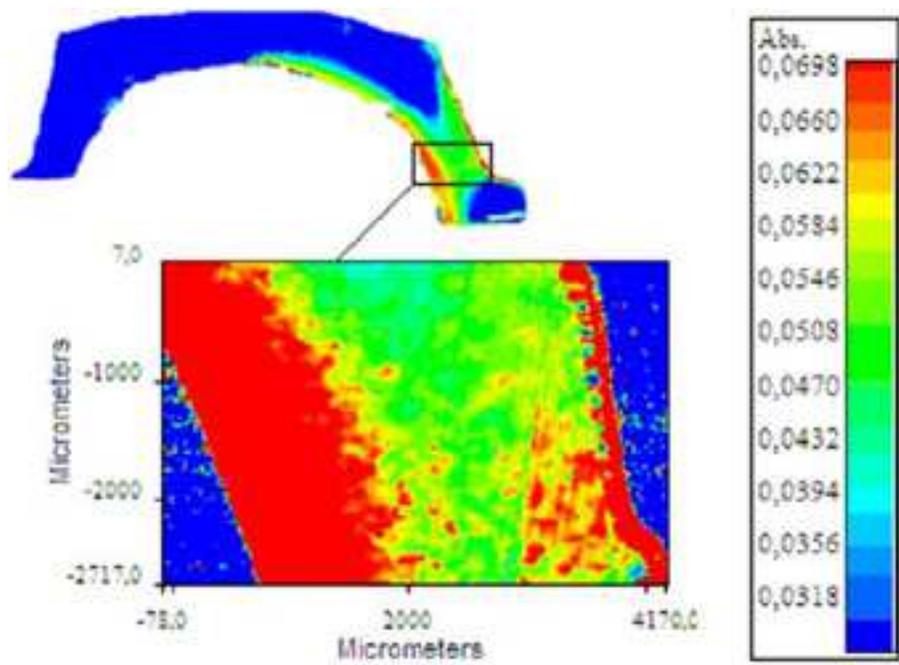
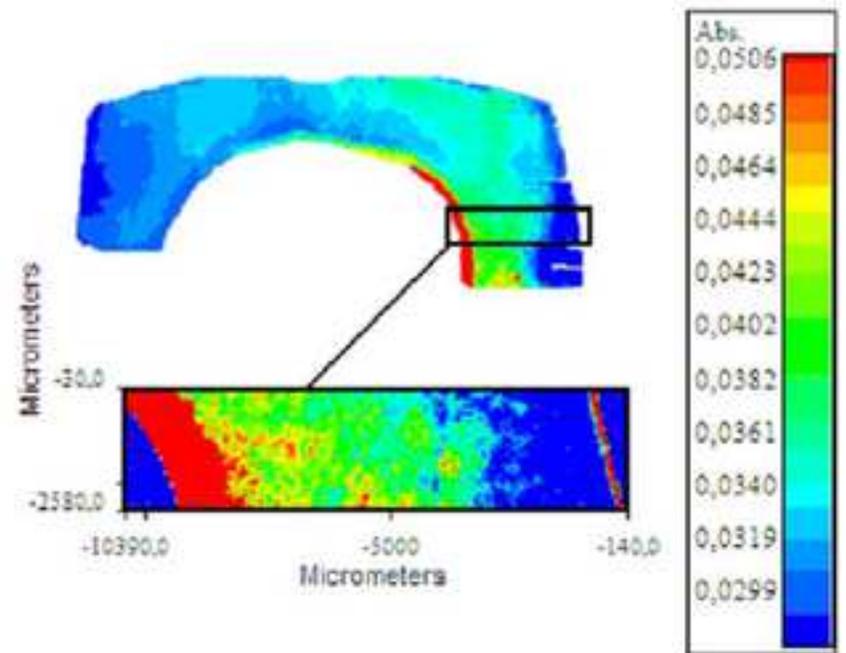
Figure 4  
[Click here to download high resolution image](#)

Figure 4. FTIR maps of the ketones absorption ( $1718\text{ cm}^{-1}$ ) in the retrieved liners (left sample E3, right sample E2). The distribution of the oxidation products is asymmetric, with the highest concentrations in correspondence of the worn area. On the opposite side of the section, no relevant oxidation was retrieved.

Figure 4 shows the FTIR maps obtained from the whole area scan of E3 and E2 with the detail of the most worn area for each liner. Oxidation distribution is asymmetric and strongly localized, and significant presence of ketones was found in the worn areas only. No traces of oxidation were found at the opposite region of the liners cross section, indicating that oxidation occurred in correspondence of the loaded areas, that is where the contact between femoral head and liner occurred and, consequently, where the majority of wear concentrated.

Comparing the IR maps to the FEA results (Figure 4 vs. 6), there is an evident correlation between the concentration of oxidation products and the stress distribution for both liners geometries. The asymmetric stress and oxidation maps reveal that these phenomena are related to the joint compliance, strongly depending upon the head and cup positioning. These data confirm that lifetime

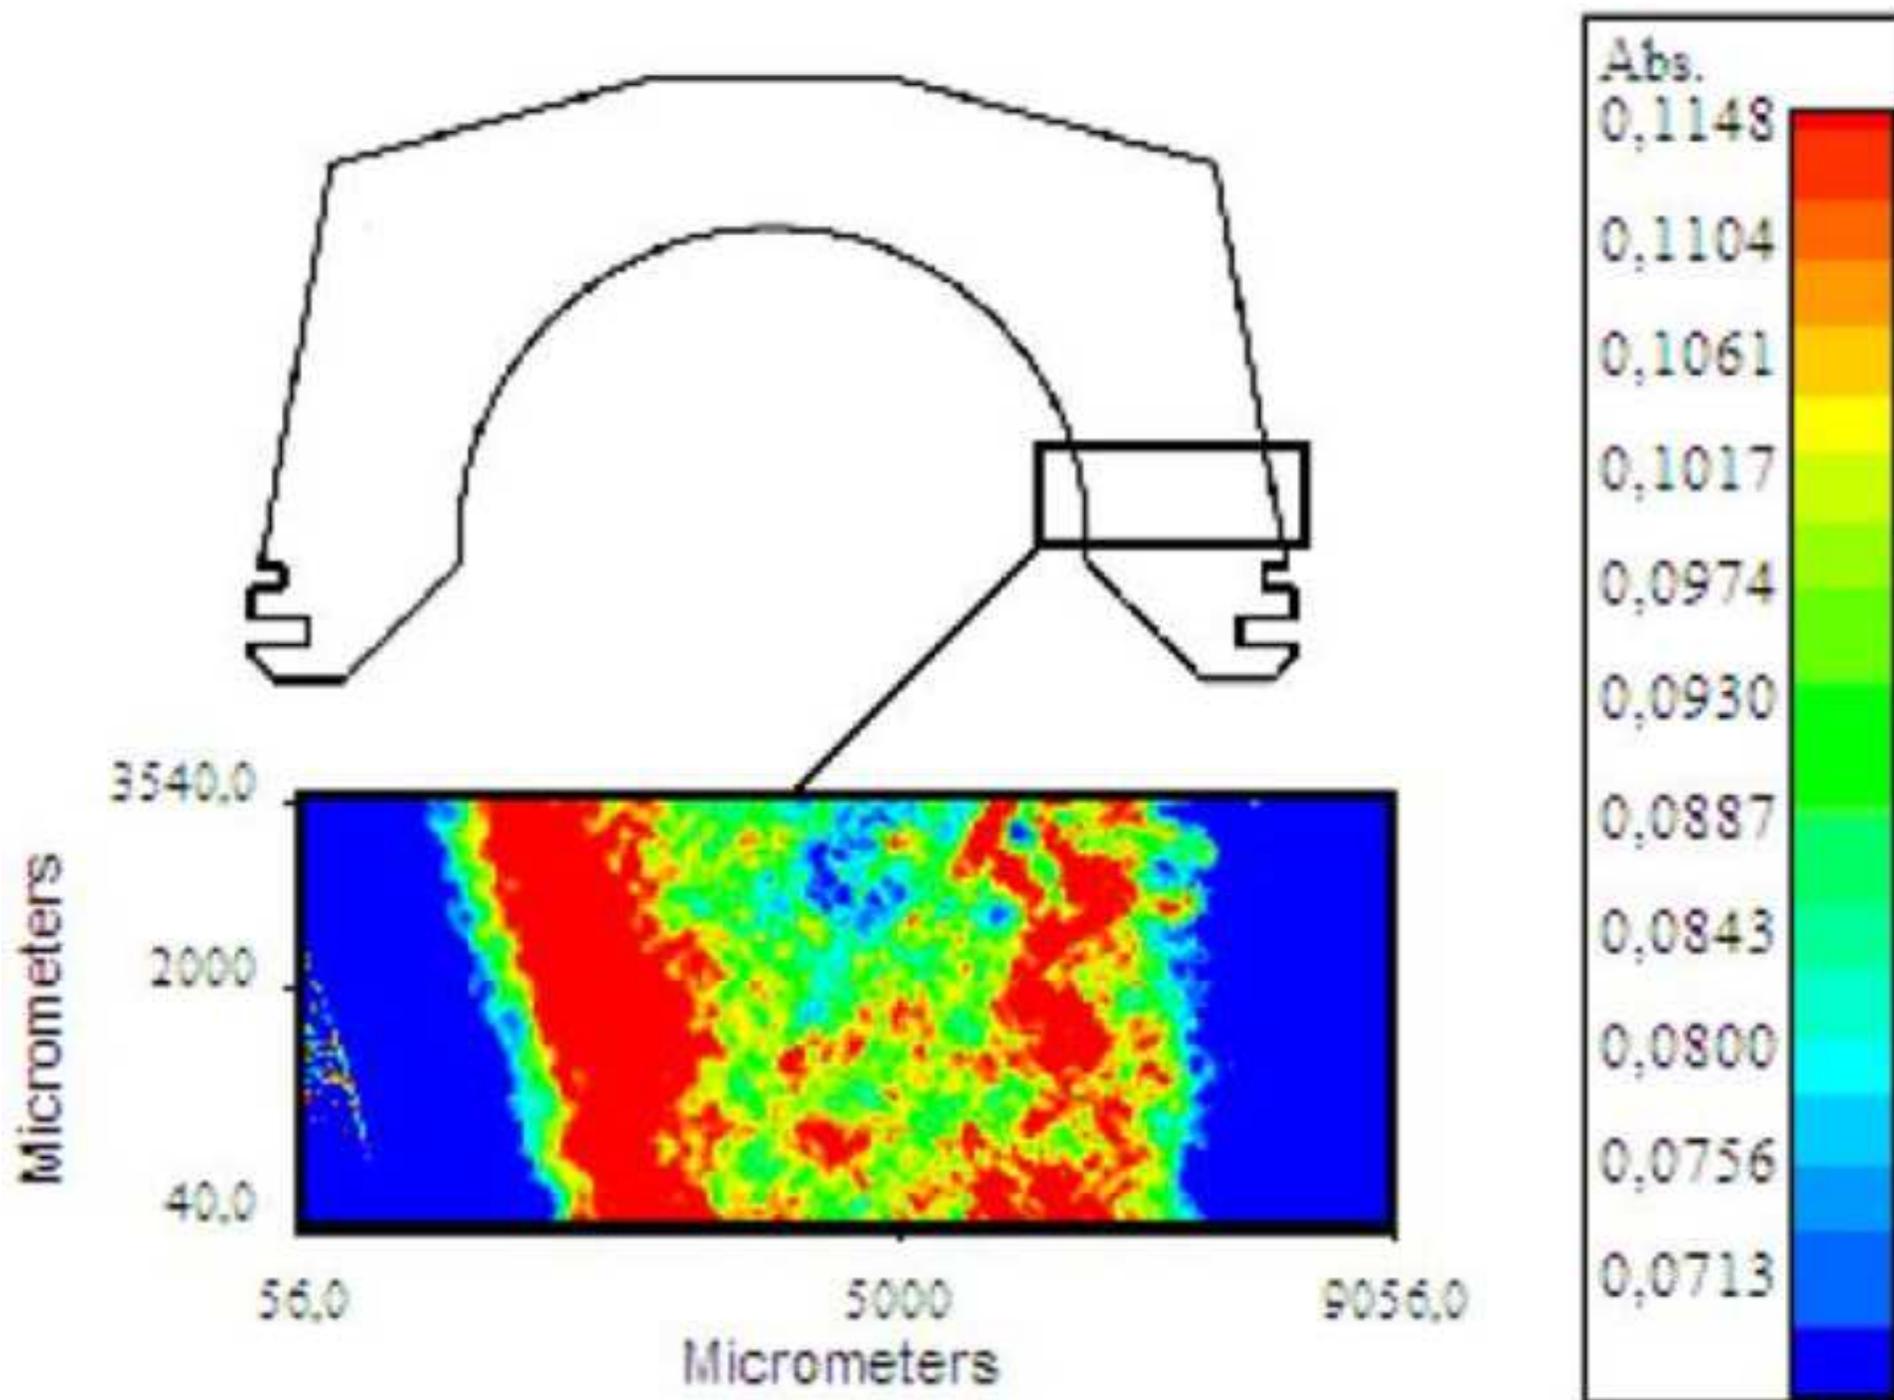
Figure 5  
[Click here to download high resolution image](#)

Figure 5. FTIR map of the ketones absorption ( $1718\text{ cm}^{-1}$ ) in the shelf aged liner (E0). The maximum oxidation is located in the bulk of the liner.

Different geometries showed different IR maps, as documented by the data obtained from the lower rim detailed scans. In particular, oxidation distribution in the Ø32mm liner flanged area is different in respect to the non flanged Ø28mm liner geometry. As for the line scan analysis, the FTIR detailed map of sample E0 showed a different distribution of the oxidation products compared to E1-E4 retrieved liners (Figure 5).

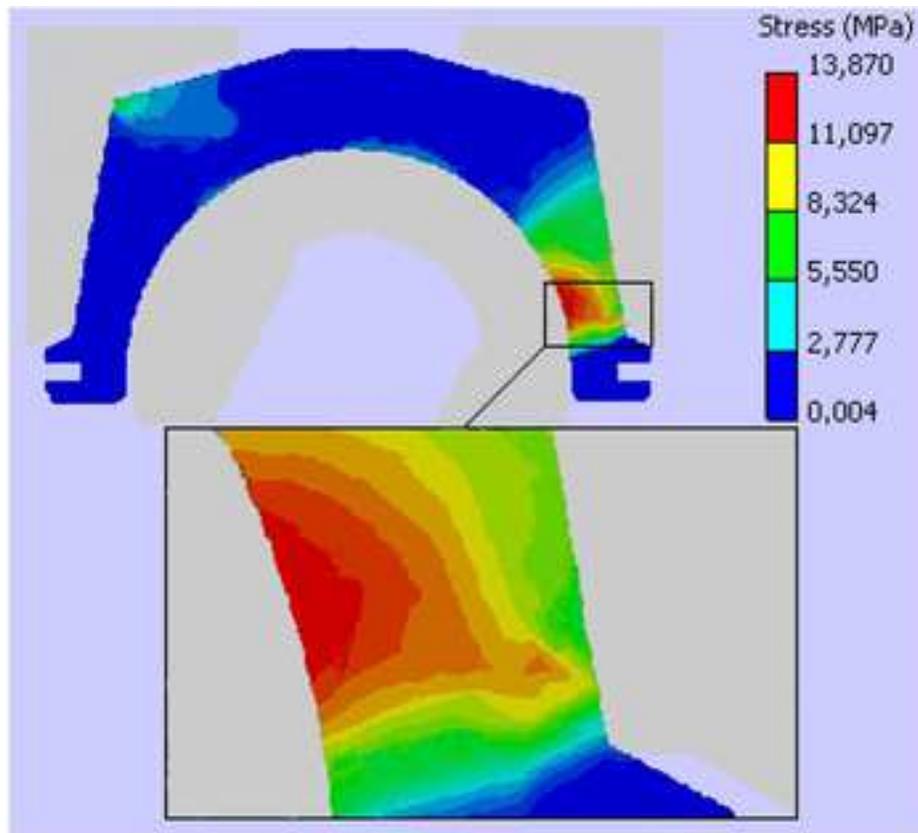
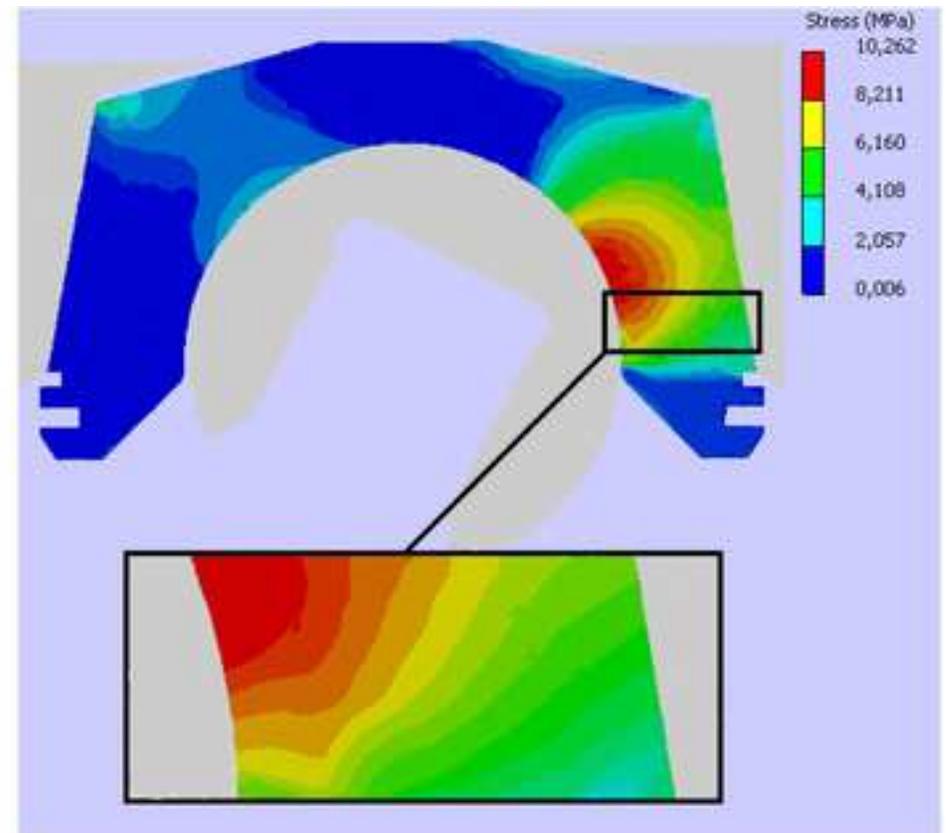
Figure 6  
[Click here to download high resolution image](#)

Figure 6. FE analysis of the stress distribution in the cross-section of the liners (left  $\text{Ø}32\text{ mm}$  and right  $\text{Ø}28\text{ mm}$ ).

FE analyses revealed that the load distribution is located in the same liner cross section regions affected by oxidation (Figure 6). As for the IR maps, different geometries led to different stress fields. In fact, as expected, the flanged area affects the stress distribution in the Ø32mm liner, creating a different profile in respect to the Ø28mm non-flanged geometry. Moreover, it is observed that also the stress field range varies accordingly to the liner thickness, as for the Ø32mm liner it is more spread towards the bulk of the cross section. This is in accordance to literature data concerning the rise of stresses and applied loads for thinner and larger UHMWPE liners [37]. Stress levels, in terms of von Mises criterion, are 10.3 MPa and 13.9 MPa for the Ø28mm and Ø32mm geometries respectively. Values are in accordance with the liner geometry and thickness. Stress

field range covers the same region of the observed oxidised area for Ø28mm and Ø32mm liners, and maximum values of both von Mises stress and KI are located in the same area.

In our FE simulations, the applied load resulted in higher stress values for Ø32 mm liners with respect to Ø28mm geometry. On the contrary, the highest oxidation values were found in Ø28mm liners. This suggests that peak load should not be considered as the key factor for determining the amount of resulting oxidation, which may come instead from the total amount of cyclic stress applied during the *in vivo* lifetime of the component. In this sense, more comprehensive analyses are needed in order to quantitatively correlate stress and oxidation, as well as more details in patients and working conditions of the prostheses are mandatory to attain a better assessment of the total stress UHMWPE liners are subjected to.
