Correlation between in vivo stresses and oxidation of UHMWPE in total hip arthroplasty

M. Regis, P. Bracco, L. Giorgini, S. Fusi, P. Dalla Pria, L. Costa, C. Schmid
*Correlation between in vivo stresses and oxidation of UHMWPE in total hip
arthroplasty*

JOURNAL OF MATERIALS SCIENCE. MATERIALS IN MEDICINE
(2014)

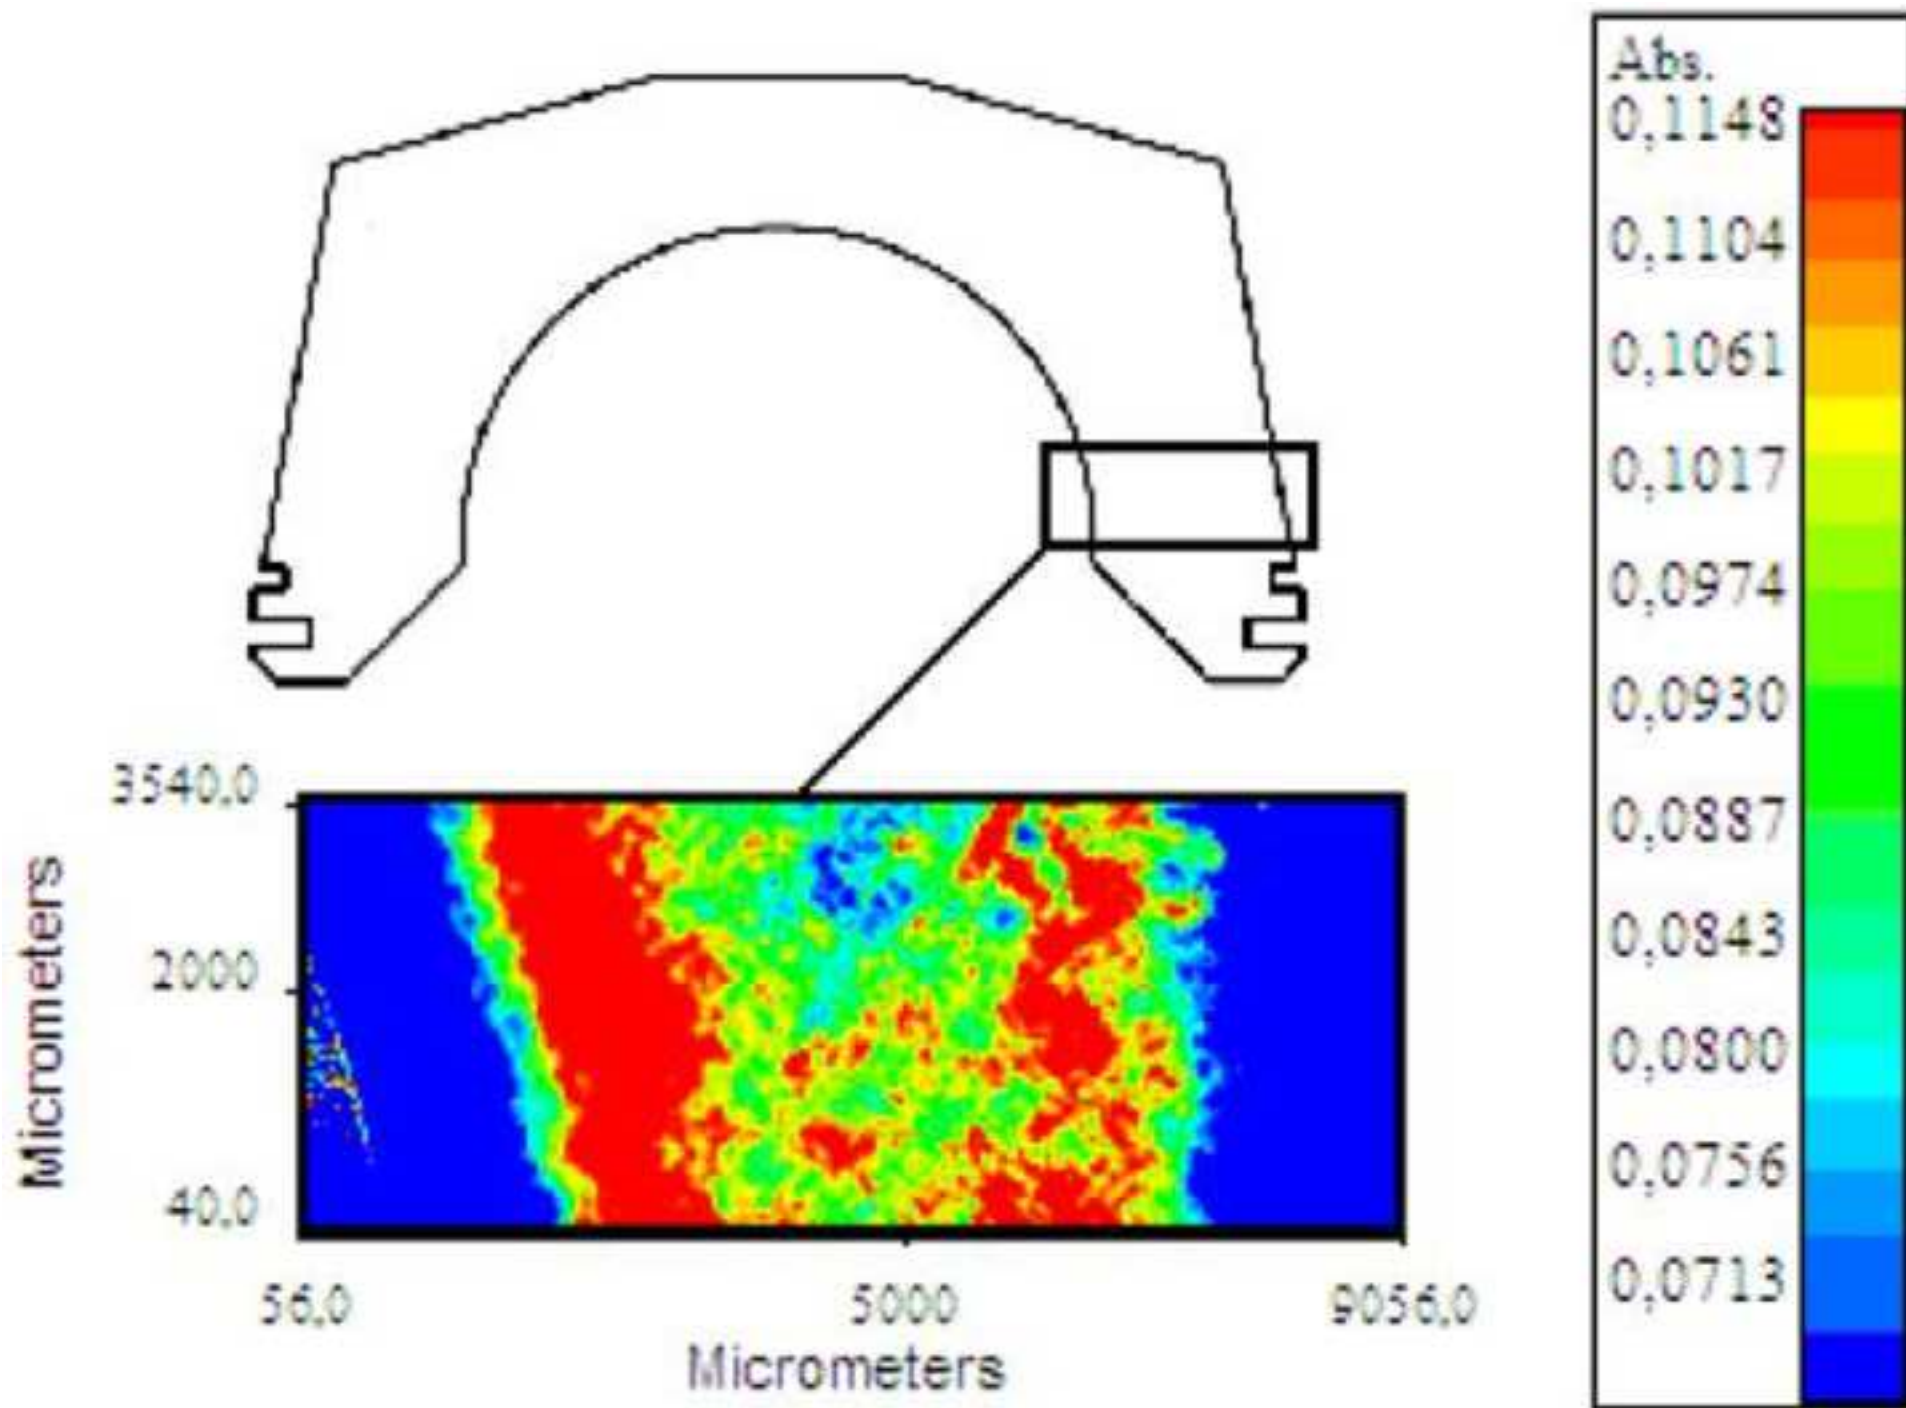
Figure 5
[Click here to download high resolution image](#)

Figure 5. FTIR map of the ketones absorption (1718 cm^{-1}) in the shelf aged liner (E0). The maximum oxidation is located in the bulk of the liner.

Different geometries showed different IR maps, as documented by the data obtained from the lower rim detailed scans. In particular, oxidation distribution in the Ø32mm liner flanged area is different in respect to the non flanged Ø28mm liner geometry. As for the line scan analysis, the FTIR detailed map of sample E0 showed a different distribution of the oxidation products compared to E1-E4 retrieved liners (Figure 5).
