Lichens and other lithobionts on the carbonate rock surfaces of the heritage site of the tomb of Lazarus (Palestinian territories): diversity, biodeterioration, and control issues in a semi-arid environment

**LICHENS AND OTHER LITHOBIONTS ON THE CARBONATE ROCK SURFACES OF
THE HERITAGE SITE OF THE TOMB OF LAZARUS (PALESTINIAN TERRITORIES):
DIVERSITY, BIODETERIORATION AND CONTROL ISSUES IN A SEMI-ARID
ENVIRONMENT**

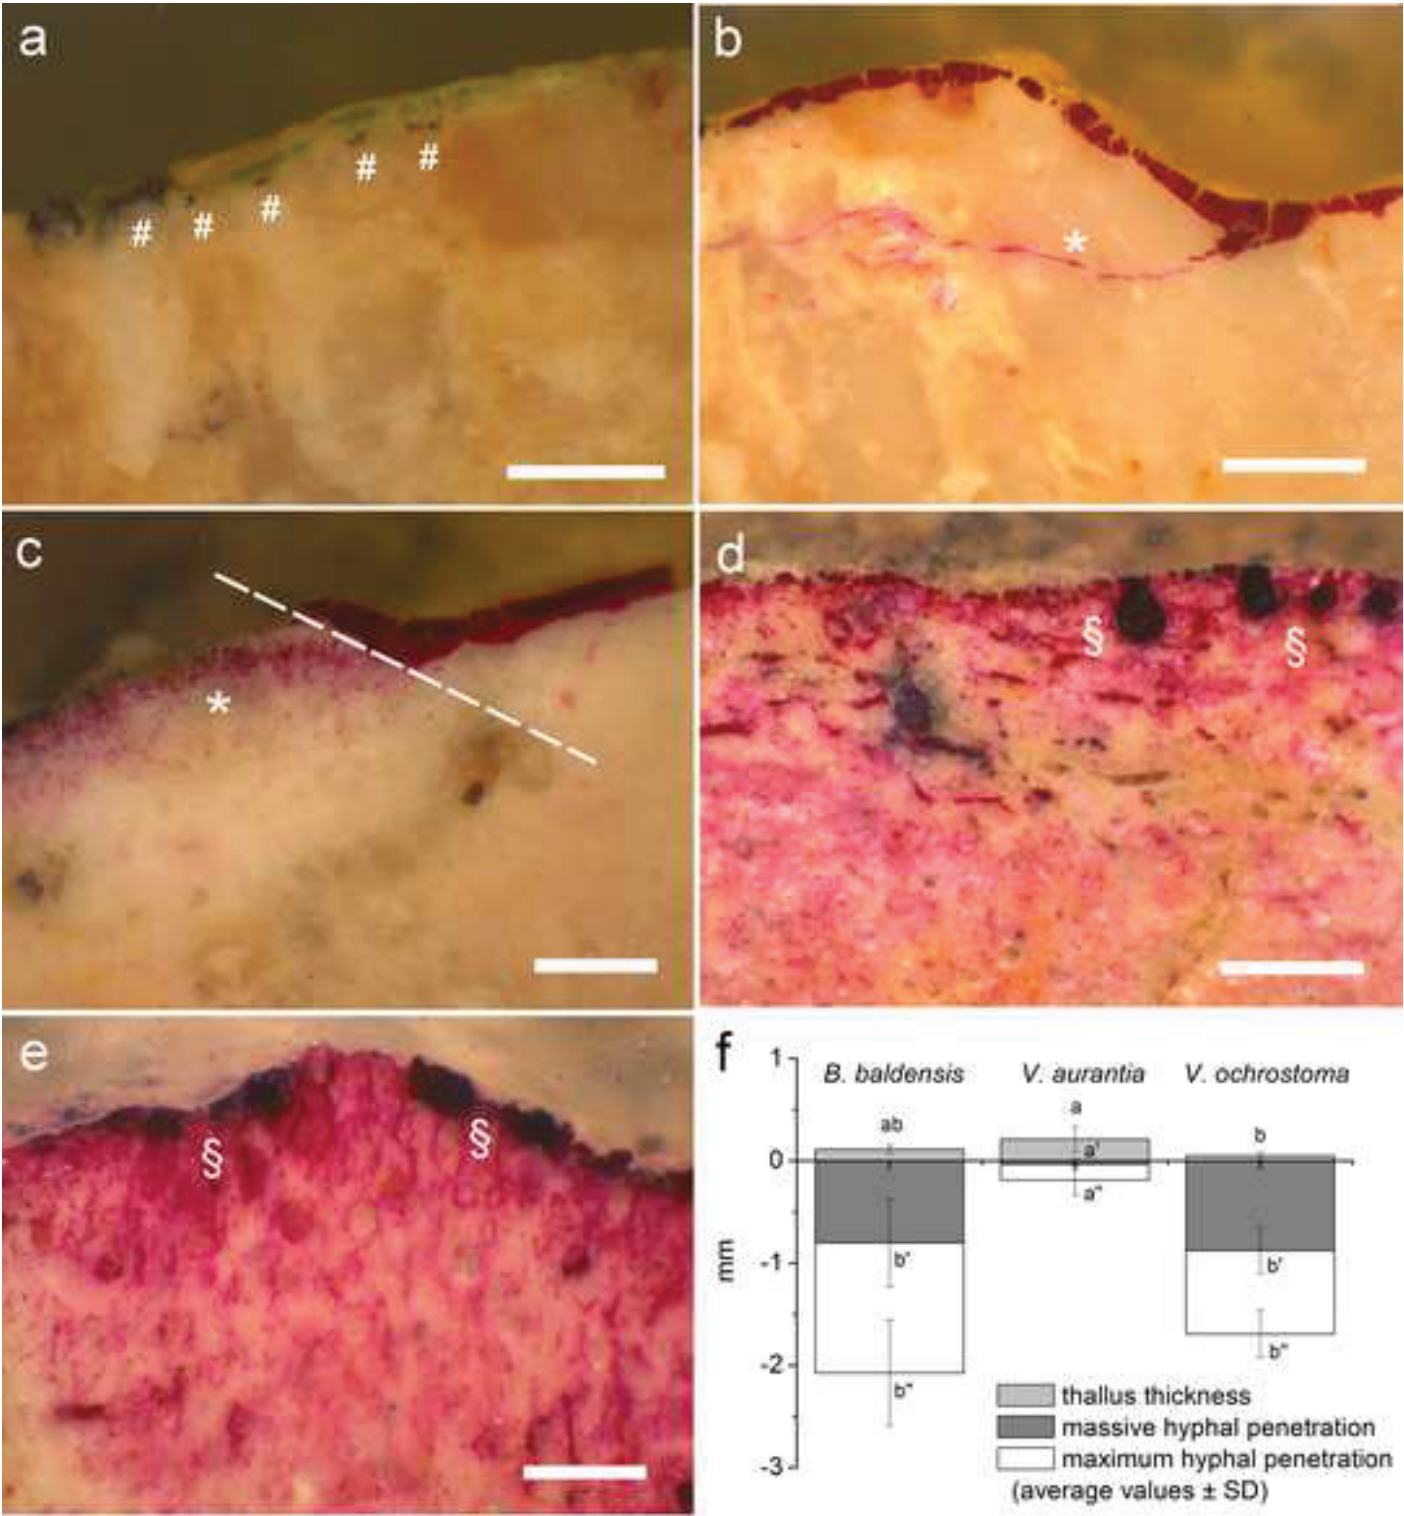
Figure 4

Fig. 4 Interface between lichens and the Jerusalem stone (cross sections observed by RLM). **a** Free colonies of dematiaceous fungi (#) beneath a thallus of *Variospora aurantia*. **b-e** Hyphal penetration component of epilithic and endolithic lichens (cross sections stained by PAS, visualizing biological structures in violet): **b**, *Variospora aurantia* (*, hyphal penetration limited to a crack), **c**, *Pyrenodesmia erodens* (left) and *V. aurantia* (right), **d**, *Bagliettoa baldensis* (§, perithecia), **e**, *Verrucaria ochrostoma* (§, perithecia). Scale bars: 0.5 mm (**a**, **c**, **e**), 1 mm (**b**, **d**). **f** Quantitative characterization of the specific structural organization (av. thallus thickness, massive and maximum depth of hyphal penetration component). For each parameter, columns which do not share letters are significantly different (ANOVA, Tukey's test, $p < 0.05$).

RLM observations at the lichen-substrate interface showed a different structural organization of the epilithic *V. aurantia* and endolithic species (Fig. 4). The former displayed a thicker thalline component (av. 0.2 mm), but its hyphal penetration component (HPC sensu Favero-Longo et al. 2005) was scarce, characterized by an av. depth of massive penetration of 0.03 mm and av. values of maximum penetration of 0.2 mm (Fig. 4b-c). In some cases, local staining of biological structures within the substrate beneath the *V. aurantia* thalli corresponded to free colonies of dematiaceous fungi, already observed for their coloured appearance before the PAS treatment, and not to mycobiont penetrating hyphae (Fig. 4a). By contrast, only a thin lithocortex and discontinuous thalline structures (av. thickness \leq 0.1 mm) were visible on surfaces colonized by the endolithic *B. baldensis* and *V. ochrostoma*, respectively. Both the species showed a remarkable hyphal penetration component, massively penetrating the substrate down to av. depths of 0.8 mm and with maximum penetration av. values of 2.1 and 1.7 mm, respectively (Fig. 4d-e). Moreover, their perithecia endolithically developed down to 0.3-0.4 mm, their growth appearing the potential

responsible for pitting phenomena sparsely observed on the carbonate blocks through the site. Massive hyphal growth through the carbonate matrix, rather than limited to intragranular porosities or rock fractures (as sometimes observed for *V. aurantia*) characterized both endolithic species. It is worth noting that strong penetration of endolithic thalli (like those of *Pyrenodesmia erodens* in Fig. 4c) growing adjacently to *V. aurantia*, which shows negligible hyphal penetration component, indicates that the different species, rather than variations in substrate properties, are responsible for the heterogeneous structural organizations of the different *taxa* above and beneath the rock surface.

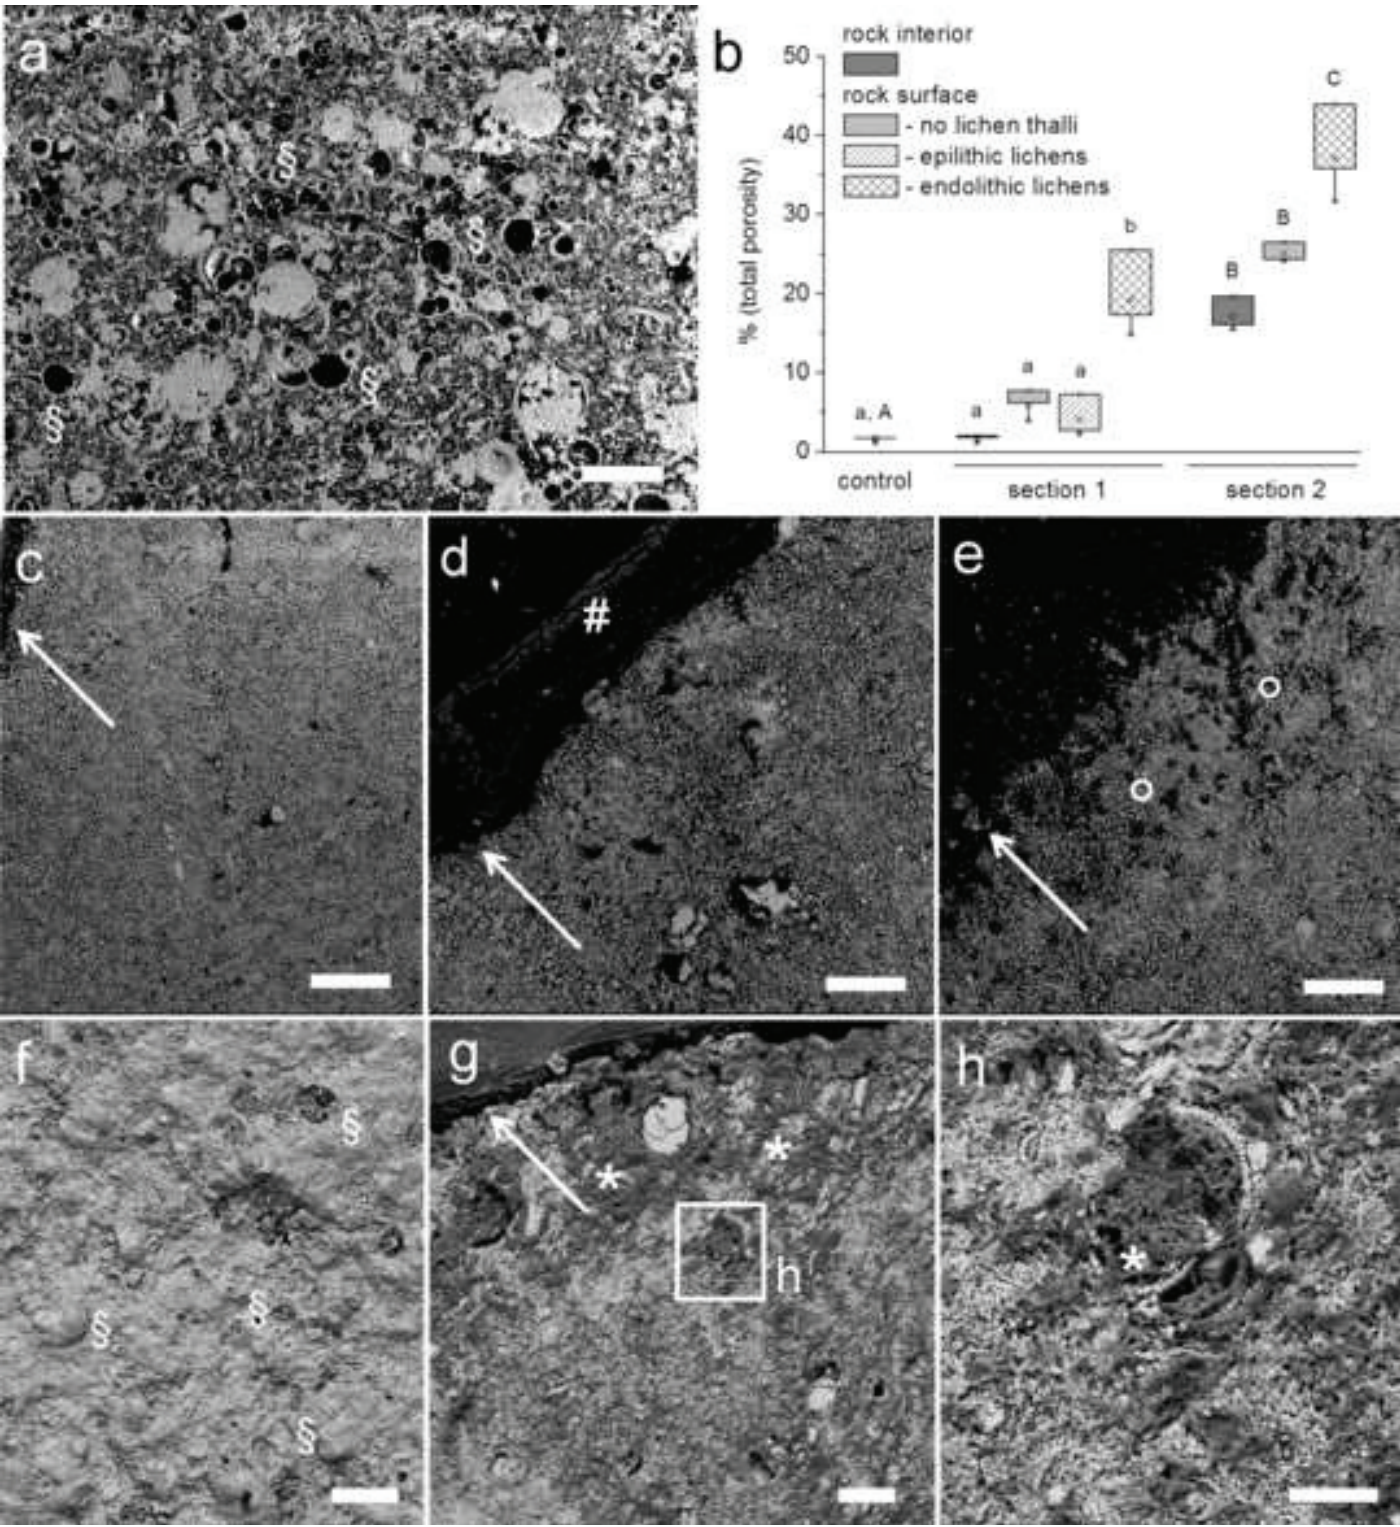
Fig. 5 Lichen effect on the total porosity of the Jerusalem stone (sections observed by SEM-BSE). **a** Petrographic thin section of a fresh fragment, showing porosity internal to bioclats (§). **b** Quantitative characterization, based on image analysis, of the total porosity of: a 300 µm layer beneath the surface showing the epilithic *Variospora aurantia*, the endolithic *Pyrenodesmia erodens*, and absence of lichens (polished cross section 1); a 300 µm layer beneath the surface showing the endolithic *Bagliettoa baldensis* and absence of lichens (section 2); 300 µm layers at more than 2 mm from the surface (sections 1 and 2); 300 µm layers of fresh fragments as control. For each section, columns which do not share letters are significantly different (ANOVA, Tukey's test, $p < 0.05$). **c-e** BED-C images of section 1: **c**, rock surface (arrow) not colonized by lichen thalli, **d**, rock surface (arrow) covered by a *V. aurantia* thallus (#), **e**, rock surface (arrow) dissolved by *P. erodens* (°). **f** BED-S image of a polished cross sectioned fresh fragment, with bioclats (§) embedded in a fine-grained calcite matrix. **g-h** BED-S images of section 2: **g**, rock surface (arrow) penetrated by *B. baldensis* (*), with hyphae invading the internal porosity of bioclats (magnification in **h**). Scale bars: 100 µm (**a**, **c-g**), 25 µm (**h**).

SEM-BSE observations of the petrographic thin sections showed the bioclastic structure of the Jerusalem stone and a remarkable porosity internal to bioclasts (Fig. 5a). The polished cross sections of the same fresh fragments highlighted that the microfossils are tightly embedded within a fine-grained calcite matrix (Fig. 5f). The massive hyphal penetration by endolithic lichens affects the total porosity of the upper rock layers (Fig. 5b). The 300 µm layer penetrated by *P. erodens* (Fig. 5e) and *B. baldensis* (Fig. 5g-h) beneath the rock surface showed significantly higher values of total porosity than those covered by *V. aurantia* (Fig. 5d) or not colonized by lichen thalli (Fig. 5c). Such endolithic effect was observed on both section 1, which in absence of *P. erodens* showed a low total porosity similar to control sections, and section 2, showing a total porosity higher than control sections even at depths lower than 2 mm from the surface. BED-S observations confirmed the hyphal penetration through the rock matrix (Fig. 5g) and showed the hyphal invasion of the bioclast internal porosity (Fig. 5h).
