**Lichens and other lithobionts on the carbonate rock surfaces of the heritage site of the tomb of Lazarus (Palestinian territories): diversity, biodeterioration, and control issues in a semi-arid environment**

1 **LICHENS AND OTHER LITHOBIANTS ON THE CARBONATE ROCK SURFACES OF**  
2 **THE HERITAGE SITE OF THE TOMB OF LAZARUS (PALESTINIAN TERRITORIES):**  
3 **DIVERSITY, BIODETERIORATION AND CONTROL ISSUES IN A SEMI-ARID**  
4 **ENVIRONMENT**

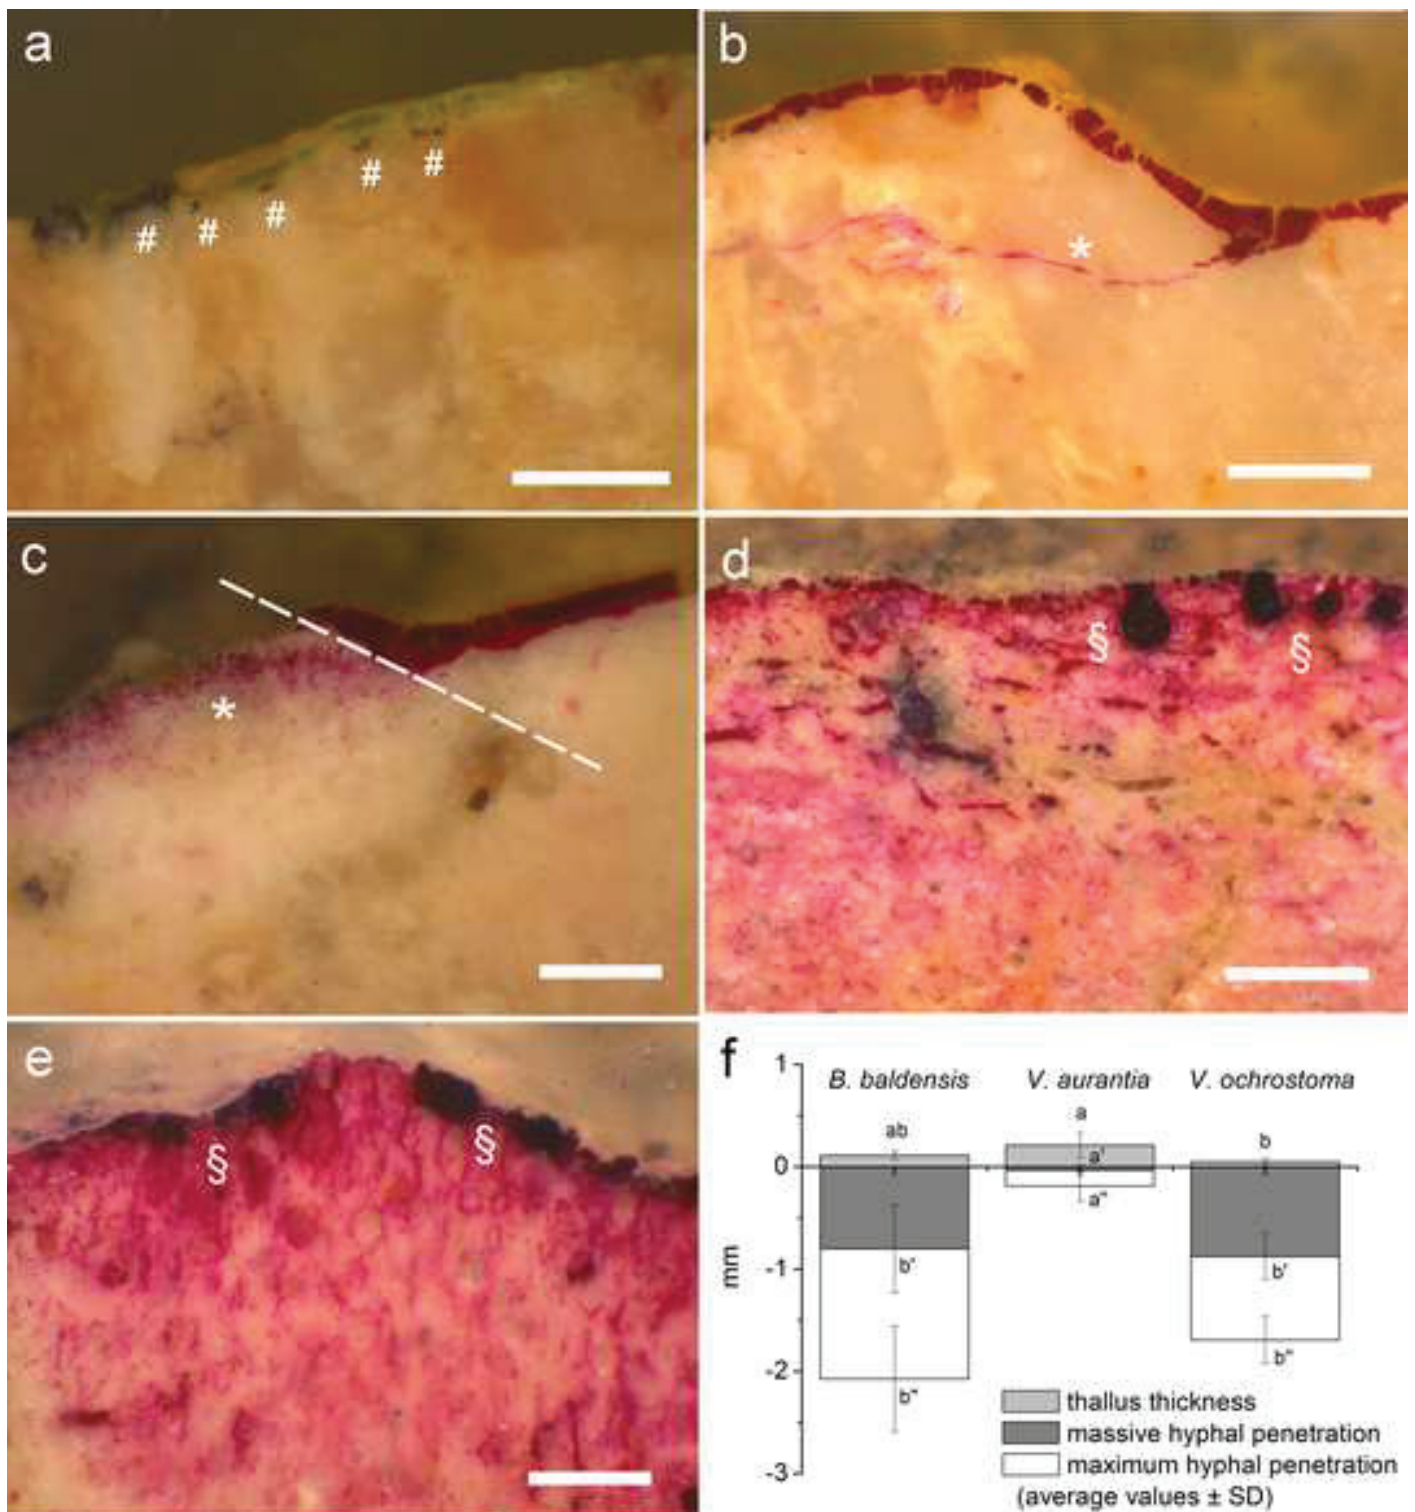
26  
 2733 Fig. 4 Interface between lichens and the Jerusalem stone (cross sections observed by RLM). **a** Free  
 2834 colonies of dematiaceous fungi (#) beneath a thallus of *Variospora aurantia*. **b-e** Hyphal  
 2935 penetration component of epilithic and endolithic lichens (cross sections stained by PAS,  
 30  
 31 736 visualizing biological structures in violet): **b**, *Variospora aurantia* (\*, hyphal penetration limited to  
 32  
 3337 a crack), **c**, *Pyrenodesmia erodens* (left) and *V. aurantia* (right), **d**, *Bagliettoa baldensis* (§,  
 3338 perithecia), **e**, *Verrucaria ochrostoma* (§, perithecia). Scale bars: 0.5 mm (**a**, **c**, **e**), 1 mm (**b**, **d**). **f**  
 3439 Quantitative characterization of the specific structural organization (av. thallus thickness, massive  
 3540 and maximum depth of hyphal penetration component). For each parameter, columns which do not

43  
 44 RLM observations at the lichen-substrate interface showed a different structural organization of the  
 45 epilithic *V. aurantia* and endolithic species (Fig. 4). The former displayed a thicker thalline  
 46 component (av. 0.2 mm), but its hyphal penetration component (HPC sensu Favero-Longo et al.  
 47 2005) was scarce, characterized by an av. depth of massive penetration of 0.03 mm and av. values  
 48 of maximum penetration of 0.2 mm (Fig. 4b-c). In some cases, local staining of biological  
 49 structures within the substrate beneath the *V. aurantia* thalli corresponded to free colonies of  
 50 dematiaceous fungi, already observed for their coloured appearance before the PAS treatment, and  
 51 not to mycobiont penetrating hyphae (Fig. 4a). By contrast, only a thin lithocortex and  
 52 discontinuous thalline structures (av. thickness  $\leq$  0.1 mm) were visible on surfaces colonized by the

53 endolithic *B. baldensis* and *V. ochrostoma*, respectively. Both the species showed a remarkable  
 54 hyphal penetration component, massively penetrating the substrate down to av. depths of 0.8 mm  
 55 and with maximum penetration av. values of 2.1 and 1.7 mm, respectively (Fig. 4d-e). Moreover,  
 56 their perithecia endolithically developed down to 0.3-0.4 mm, their growth appearing the potential

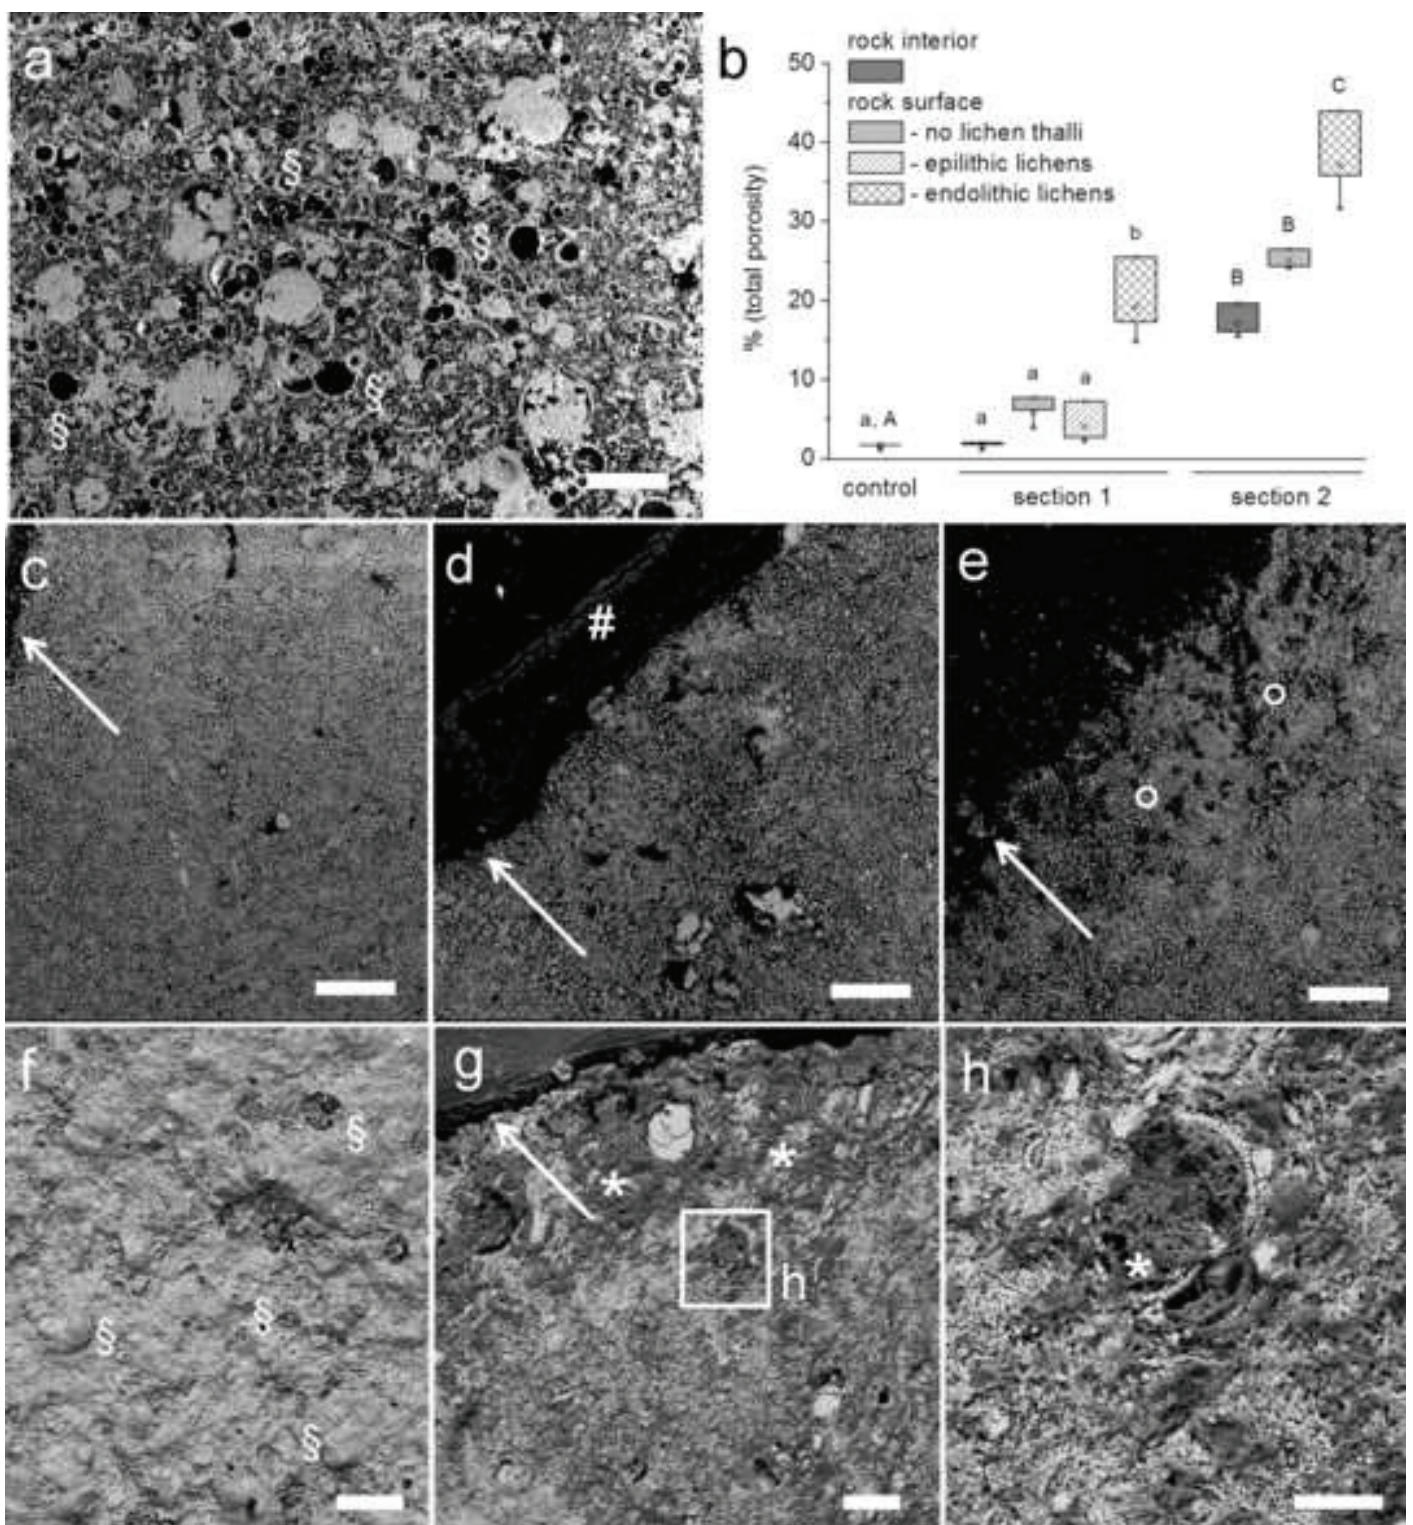
38  
 3942 Fig. 5 Lichen effect on the total porosity of the Jerusalem stone (sections observed by SEM-BSE). **a**  
 4043 Petrographic thin section of a fresh fragment, showing porosity internal to bioclats (§). **b**  
 41  
 42 744 Quantitative characterization, based on image analysis, of the total porosity of: a 300 µm layer  
 43  
 4445 beneath the surface showing the epilithic *Variospora aurantia*, the endolithic *Pyrenodesmia*  
 45  
 4646 *erodens*, and absence of lichens (polished cross section 1); a 300 µm layer beneath the surface  
 4747 showing the endolithic *Bagliettoa baldensis* and absence of lichens (section 2); 300 µm layers at  
 4848 more than 2 mm from the surface (sections 1 and 2); 300 µm layers of fresh fragments as control.  
 49  
 5049 For each section, columns which do not share letters are significantly different (ANOVA, Tukey's  
 51  
 5251 test, p<0.05). **c-e** BED-C images of section 1: **c**, rock surface (arrow) not colonized by lichen thalli,

274 responsible for pitting phenomena sparsely observed on the carbonate blocks through the site.  
275 Massive hyphal growth through the carbonate matrix, rather than limited to intragranular porosities  
276 or rock fractures (as sometimes observed for *V. aurantia*) characterized both endolithic species. It is  
277 worth noting that strong penetration of endolithic thalli (like those of *Pyrenodesmia erodens* in Fig.  
278 4c) growing adjacently to *V. aurantia*, which shows negligible hyphal penetration component,  
279 indicates that the different species, rather than variations in substrate properties, are responsible for  
280 the heterogeneous structural organizations of the different *taxa* above and beneath the rock surface.  
281 SEM-BSE observations of the petrographic thin sections showed the bioclastic structure of the  
282 Jerusalem stone and a remarkable porosity internal to bioclats (Fig. 5a). The polished cross

283 sections of the same fresh fragments highlighted that the microfossils are tightly embedded within a  
284 fine-grained calcite matrix (Fig. 5f). The massive hyphal penetration by endolithic lichens affects  
285 the total porosity of the upper rock layers (Fig. 5b). The 300 µm layer penetrated by *P. erodens*  
286 (Fig. 5e) and *B. baldensis* (Fig. 5g-h) beneath the rock surface showed significantly higher values of  
287 total porosity than those covered by *V. aurantia* (Fig. 5d) or not colonized by lichen thalli (Fig. 5c).  
288 Such endolithic effect was observed on both section 1, which in absence of *P. erodens* showed a  
289 low total porosity similar to control sections, and section 2, showing a total porosity higher than  
290 control sections even at depths lower than 2 mm from the surface. BED-S observations confirmed  
291 the hyphal penetration through the rock matrix (Fig. 5g) and showed the hyphal invasion of the
