Properties, best management practices and conservation of terraced soils in Southern Europe (from Mediterranean areas to the Alps); a review

Properties, best management practices and conservation of terraced soils in Southern Europe (from Mediterranean areas to the Alps): a review

S. Stanchi¹, M. Freppaz¹, A. Agnelli², T. Reinsch³, E. Zanini¹

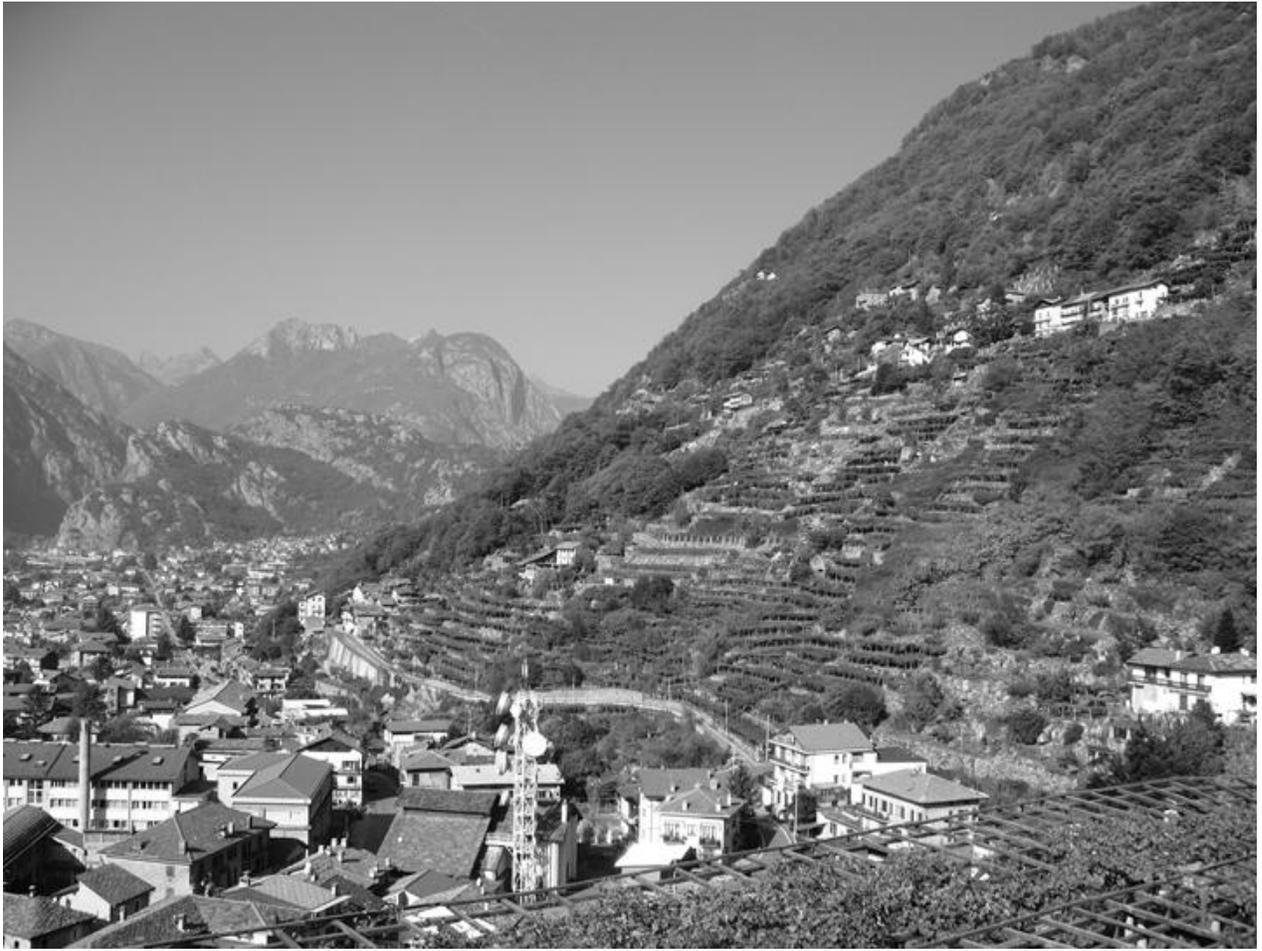
Figure 1: terraced pergola vineyards in Pont-Saint-Martin (Valle d'Aosta, Italy)

In a recent work, Freppaz et al. (2008a), studied terraced vineyards in Valle d'Aosta, Italy (Figure 1,4), and classified these soils as Technic Cambisols Escalic. Some of the soil properties analyzed during this study were rather homogeneous (Table 3), e.g. the presence of coarse or very coarse texture (up to 80% sand); abundance of skeleton that increased with increasing soil depth; and good organic C content in the A horizons, often due to constant manure inputs. No significant limitations were observed in terms of nutrient availability and chemical properties, while a very rapid drainage could represent a problem.

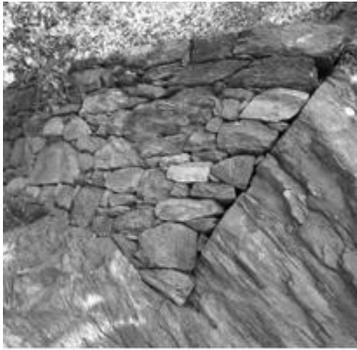
a

Figure 2: terraced slopes in Valle d'Aosta. Structural typologies and details (Photos M. Freppaz). a) wall foundation; b) connection between terraces; c) example of restored wall; d) terraced slope - vineyard; d) terraced slope – chestnut wood; e) detail of wall structure
