**Properties, best management practices and conservation of terraced soils in Southern Europe (from Mediterranean areas to the Alps): a review**

**S. Stanchi<sup>1</sup>, M. Freppaz<sup>1</sup>, A. Agnelli<sup>2</sup>, T. Reinsch<sup>3</sup>, E. Zanini<sup>1</sup>**

Keywords: terraces, soil management, anthropogenic

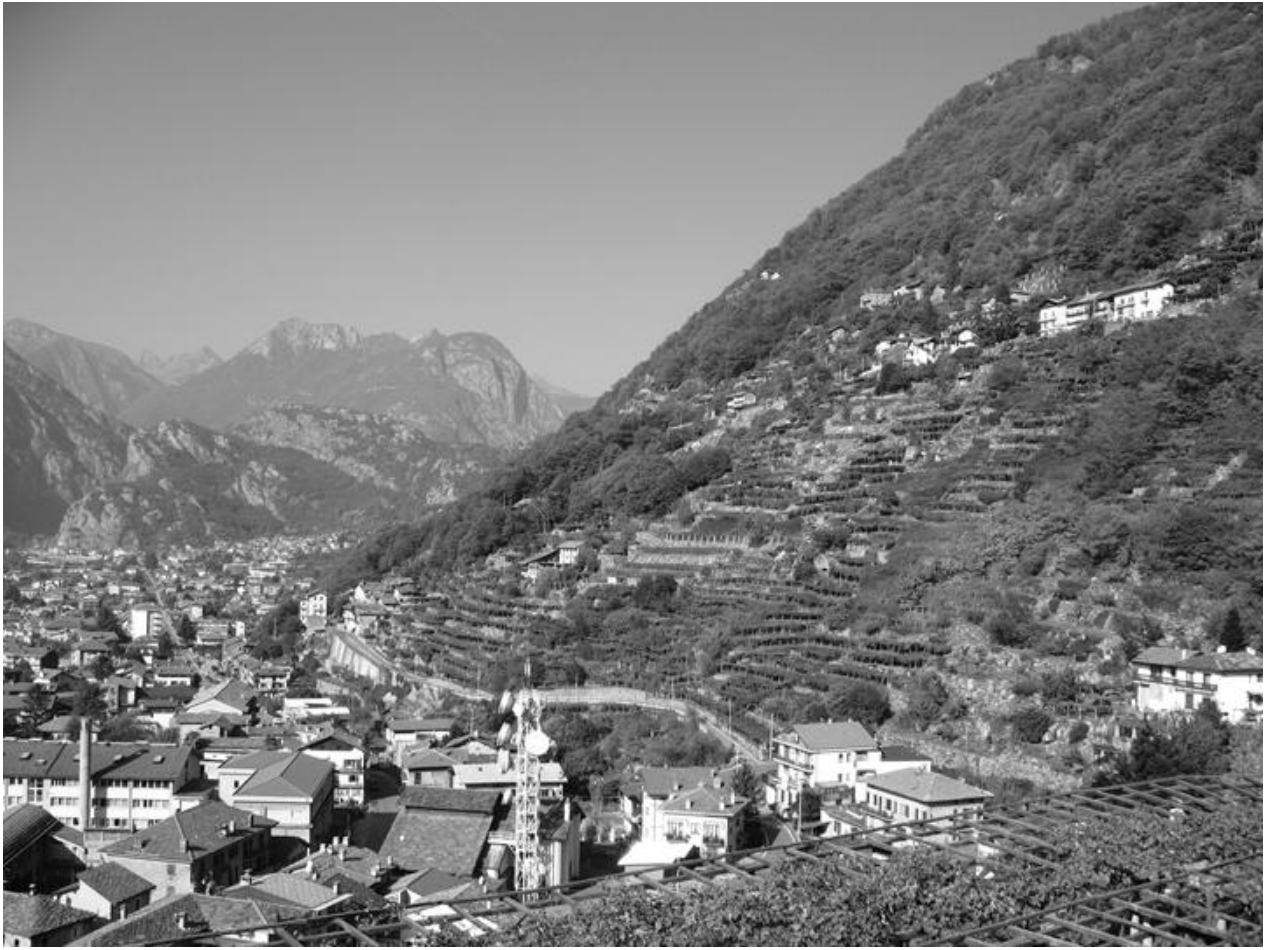
**Figure 1: terraced pergola vineyards in Pont-Saint-Martin (Valle d'Aosta, Italy)**

In a recent work, Freppaz et al. (2008a), studied terraced vineyards in Valle d'Aosta, Italy (Figure 1,4), and classified these soils as Technic Cambisols Escalic. Some of the soil properties analyzed during this study were rather homogeneous (Table 3), e.g. the presence of coarse or very coarse texture (up to 80% sand); abundance of skeleton that increased with increasing soil depth; and good organic C content in the A horizons, often due to constant manure inputs. No significant limitations were observed in terms of nutrient availability and chemical properties, while a very rapid drainage could represent a problem.

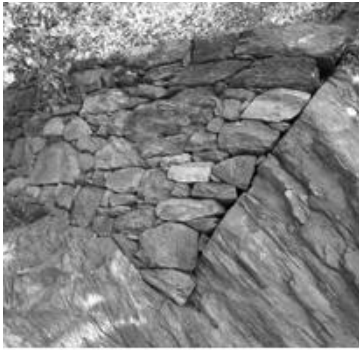
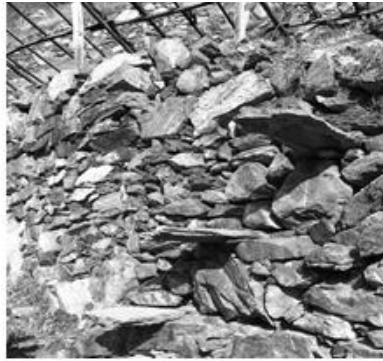
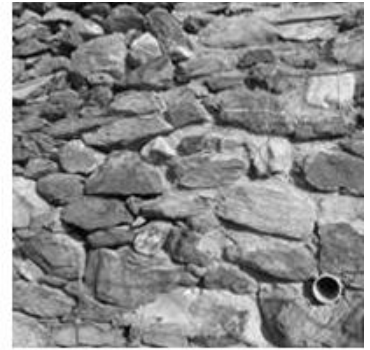
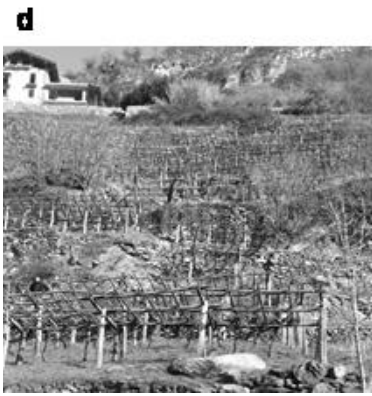
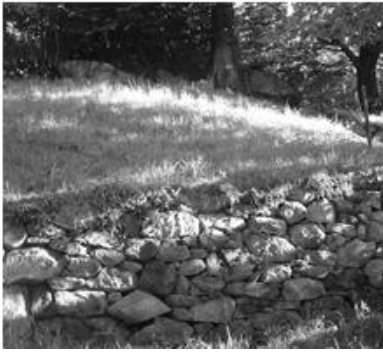
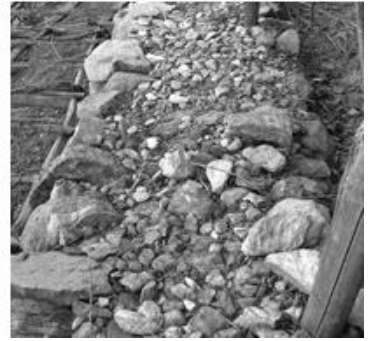
**Figure 2: terraced slopes in Valle d'Aosta. Structural typologies and details (Photos M. Freppaz). a) wall foundation; b) connection between terraces; c) example of restored wall; d) terraced slope - vineyard; d) terraced slope – chestnut wood; e) detail of wall structure**

The most common typologies of terracing (table 2) for the Alpine area were collected in the Alpter database ([www.alpter.net](http://www.alpter.net), Scaramellini & Varotto, 2008). They include: building typology (dry stone, wooden, concrete, solid wall), foundation (on rock, sediments, terrain, mixed material), wall length (from decimetres to hundreds meters), height (from 2-3 decimetres to several meters), wall and tread slope, tread width (very diverse, terracing density, average terrain slope (often more than 100%). Terraces can be linked by ramps, stairs (parallel or perpendicular to walls), suspended stairs, mobile stairs, or mixed systems. The drainage network may be parallel or perpendicular to treads, sometimes overlapping with paths and main accesses (Scaramellini & Varotto, 2008). Figure 2 illustrates some of these features for the terraced area of Aosta Valley Region (NW-Italy).

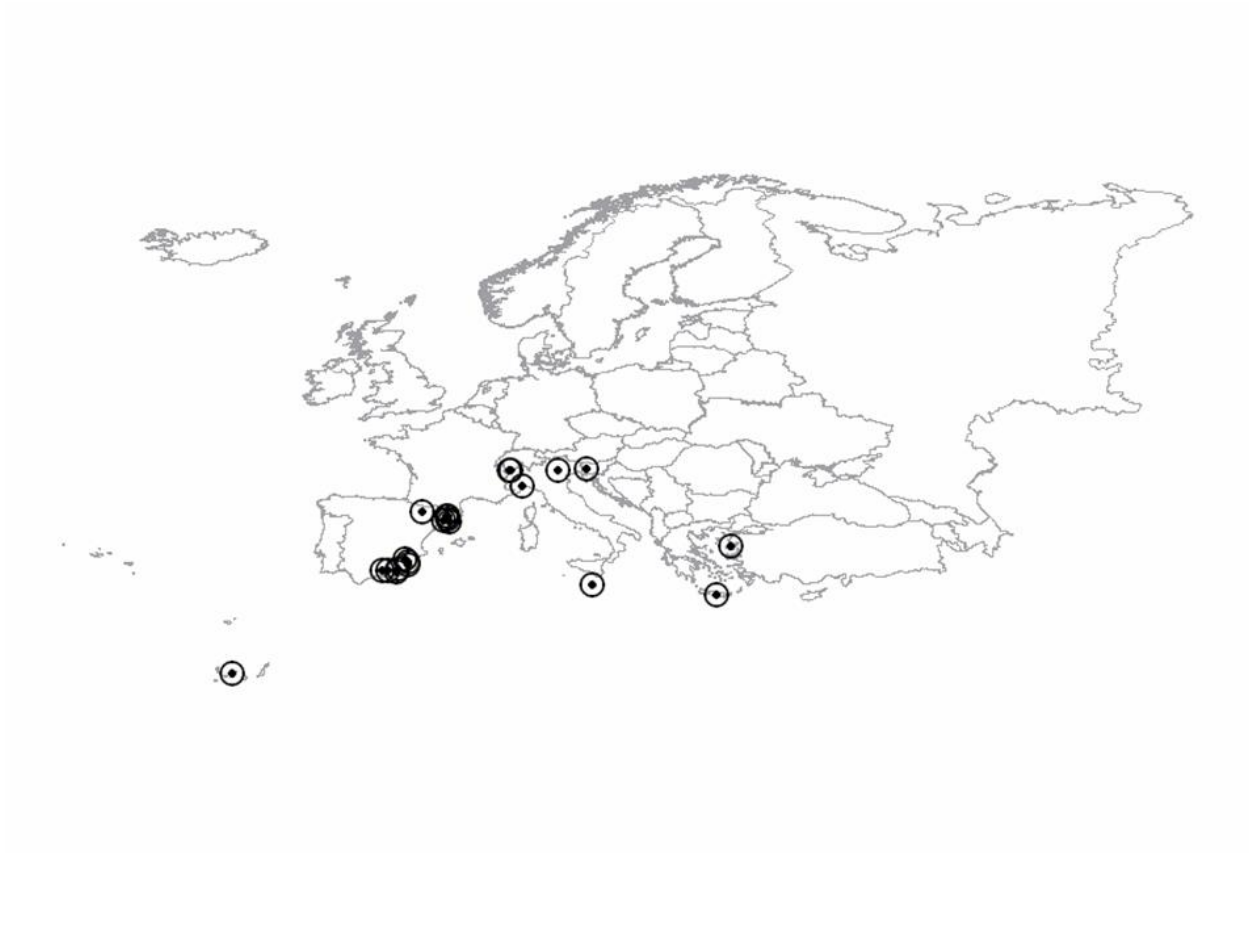
**Figure 3: relevant literature on terraced soils in Southern Europe. The map represents the study area**

While most literature on terraces focuses on the landscape or building aspects, the studies on terraced soils are relatively scarce, and they focus on a few regions (Figure 3). Many studies on terraced soils were carried out in Southern Spain, while a few examples are available for the rest of Southern Europe.
