# **PLYBIOTEST**

**Biological performance testing methodology to evaluate the durability of plywood as an indicator for exterior construction purposes**

**REPORT for the period  
01/01/2003 – 31/12/2006  
(finalized 10/11/2008)**

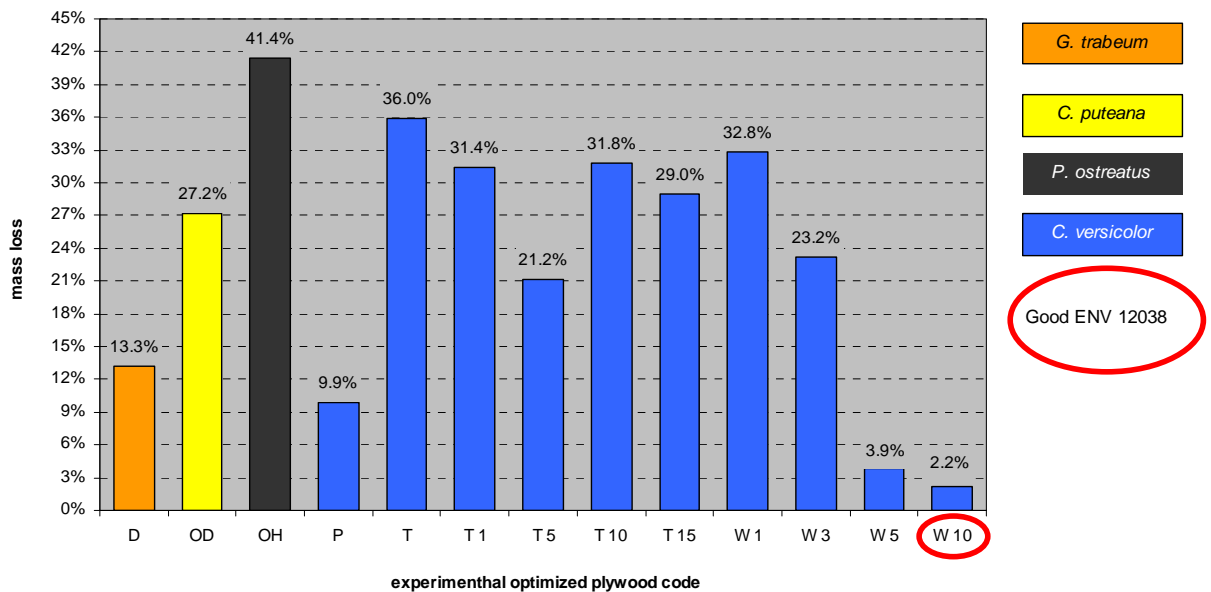
The following graph shows the mass loss averages recorded for each plywood type in respect to the critical fungus.

The results confirmed the vitro tests: only the panels with a Wolsit concentration above 5% were resistant to fungal decay.

The results obtained on the experimental uncoated panels made with different wood species suggested no resistance against decay, with mass losses near to 30%. Only paulownia plywood showed the lowest mass loss of 9.9% caused by *Coriolus versicolor*.

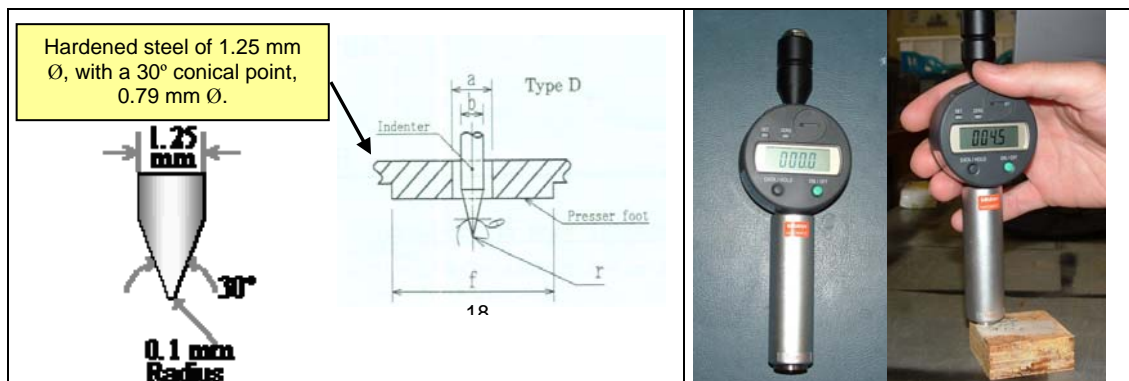
*Figure: Shore D portable device.*

Five sound samples of all reference plywood conditioned at 20°C/65%RH were selected and a double series of 6 hardness measurements were made with the two portable devices shore A and D. The best repeatability was found for shore D.

The results obtained during some preliminary tests have confirmed that especially shore D (for its better precision) is a reliable comparative for determining the surface hardness of plywood of the same type and structure (species/composition etc.). In this context it gives accurate results, with a good repeatability, homogeneous values and low standard deviations. Consequently, five different measurements for each sample were done on the reference plywood with shore D portable device. The measurements were made before and after exposure to the ENV 12038 test in correspondence of the four corners and the centre of each specimen.

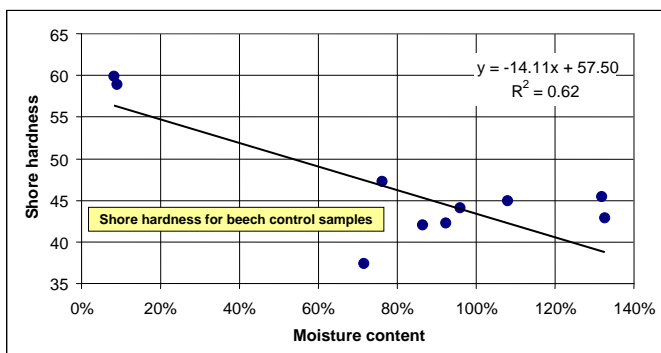
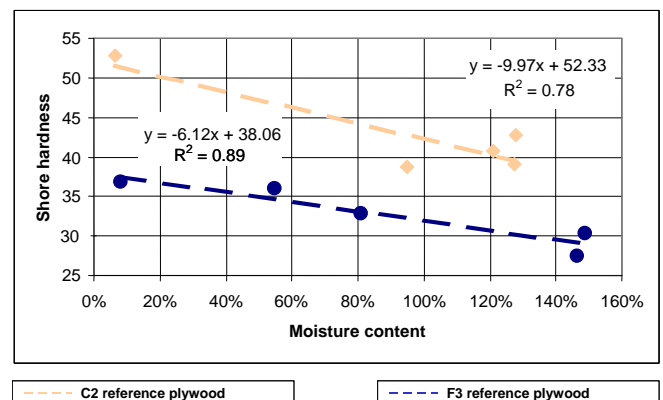
As expected, in the beech sound solid wood samples the shore hardness decreases with the increasing of MC and the same trend was registered for the reference sound plywood samples (see figures below). The results anyway show that generally it does not exist always a high correlation between shore hardness and MC since in some cases (for P3 and S4/S5 we found  $r^2 < 0.5$ ).

For this reason, we stated that shore hardness test values and its relationship with MC may be quite accurate only for homogeneous groups of plywood (same specie and structure).

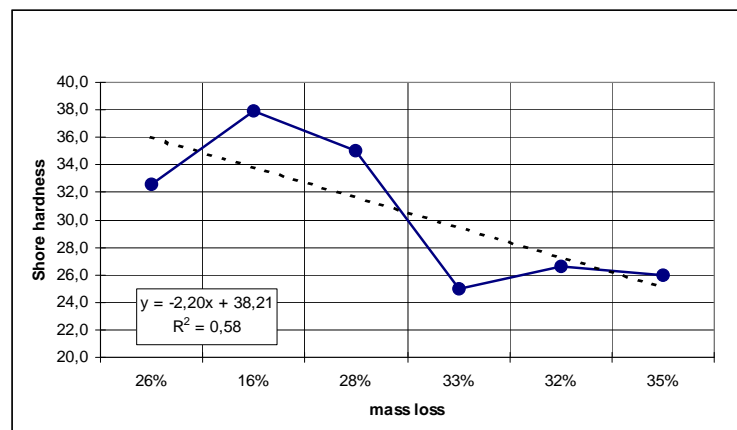
- generally, the analysis of the experimental results highlights that also between shore hardness and mass loss it does exist an high correlation because quite often the shore hardness shows irregular trend with the increasing of fungi attack;
- in some cases (C2 reference plywood) the above correlation gave us an  $r^2 < 0.58$ ;
- considering the different types of samples the results show a different trend in the decreasing of the shore hardness for the same level of mass loss which seems difficult to be explained only for the influence of the different wood density and moisture content of plywood (after ENV 12038 test for Coriolus versicolor F2 samples show an average mass loss of 4.2% against an average decrease of shore hardness of 39%, while C2 samples show an average mass loss of 26% versus an average shore hardness variation of 52%).

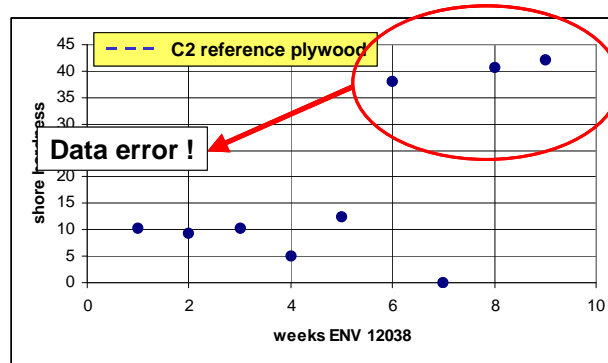
- shore hardness value (indenter penetration under the applied force) do not depends only on the shape of the indenter but also on the phenomena of swelling and irregularity of the decay surfaces of the sample that can affect the measurement. In presence of a strongly irregular surface, the source of error (see figure below) due to friction and surface characteristics is evident, therefore one cannot expect an “absolute value of hardness”.

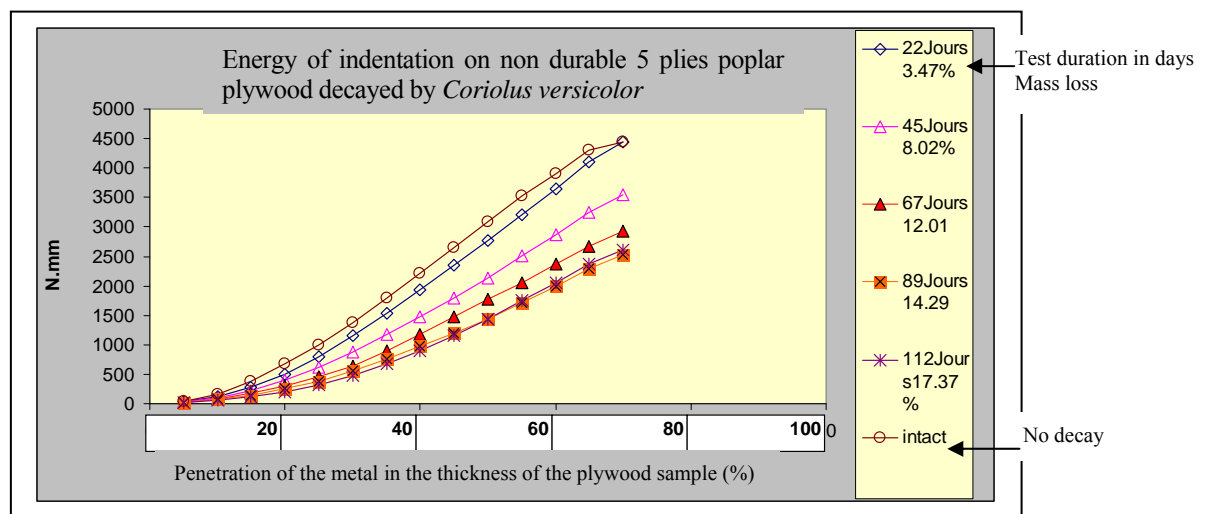
In order to evaluate the potential use of indentation tests to qualify plywood after biological degradation, biological tests were carried out on non durable plywood (5 plies, made of non durable timber, only one timber used per plywood). The biological tests were done according to ENV12038, using *Coriolus versicolor* or *Coniophora puteana*, and the test was stopped at 22, 45, 67, 90 and 112 days (112 days being the total duration of the test). Mass loss was determined and samples were conditioned at 20°C, 65% RH prior to the indentation tests. Mechanical tests were performed only with the samples degraded by *Coriolus versicolor*. *Coniophora puteana* caused too important decay to allow the re-use of the samples. From Figure 1, it can be seen that the energy of indentation can be correlated with the mass loss of the sample. Moreover, the curves obtained can explain the behaviour of the plywood.

**Figure 1. Energy of indentation obtained on poplar plywood decayed by *Coriolus versicolor*.**

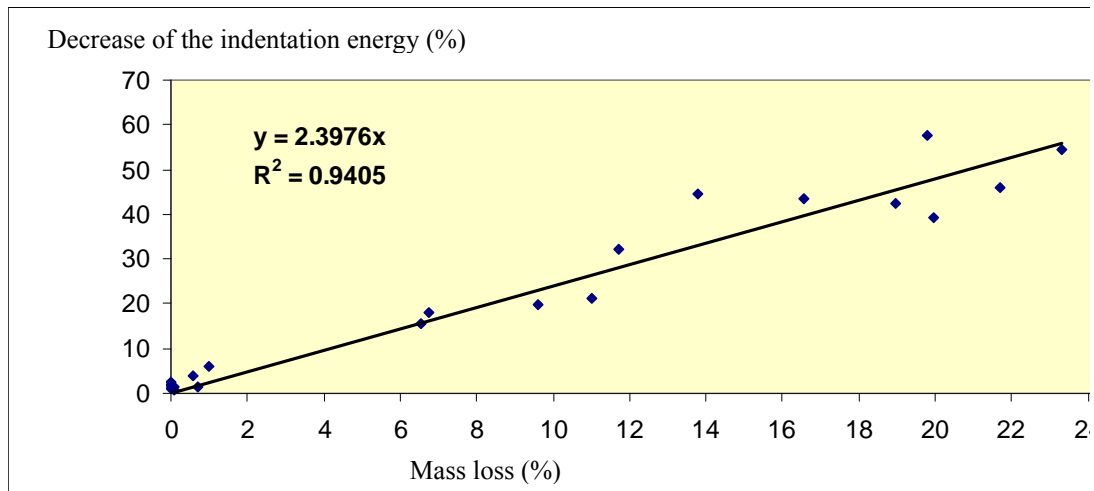
In the same manner, indentation tests have been done after fungal exposure to *Coriolus versicolor* (for 16 weeks according to ENV 12038) on experimental plywood. For each case, the mass loss was correlated to the decrease of indentation energy (decrease between non-decayed samples and samples exposed to fungal attack). Figures 2 shows the results obtained for the “pure” durable and non-durable plywood (plywood made of one timber only). These results indicate that this linear correlation is very good, and this for low weight loss as well as for high decay; contrary to ultrasonic measurements, for which decay above 16% could not be linked to a decrease of ultrasonic velocity. Figure 3 shows the same relation established for all the experimental plywood, including the plywood with durable top-veneers. On average, the proportionality between the mass loss and the decrease of indentation energy is 2.5. This indicates that the indentation is a more sensitive test, and that it could be useful to detect the early stages of decay.

**Figure 2. Relation between the decrease of the indentation energy and the mass loss due to fungal decay (20 plywoods tested, 12 samples for each plywood).**

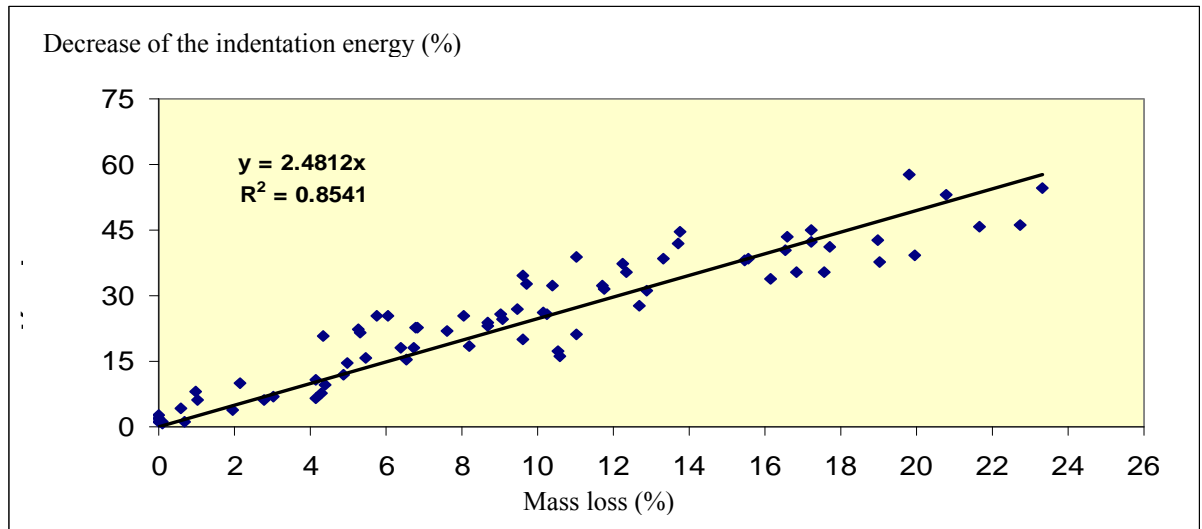
**Figure 3. Relation between the decrease of the indentation energy and the mass loss due to fungal decay (96 plywoods tested, 12 samples for each plywood).**

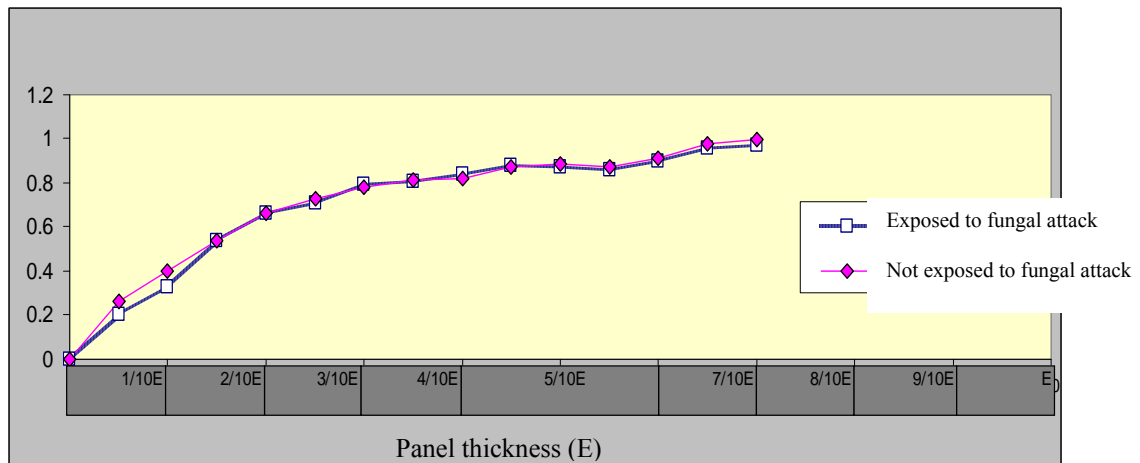
**Figure 4. Indentation force for “pure” durable plywoods, made of chestnut, cedar or cypress heartwood.**

Figures 4 and 5 show the results for the “pure” durable and non-durable plywood, and as a comparison, figures 6 and 8 show the results for the plywood with durable exterior plies only (for 1 or 2 durable plies). Two models of plywood are discussed. For the model 1 (figure 6), the average mass loss between all plywood tested was 10% towards *Coriolus versicolor*. The beginning of the curves is the same for the non-exposed and decayed samples, until about 1/4<sup>th</sup> of the 1<sup>st</sup> ply width (0.65 mm). It is the elasticity of this ply that explains the slope at the beginning of the test. It has not been modified by the fungal action (as this ply is durable). Once the 1<sup>st</sup> ply has been pierced, the increasing of the force due to the metal piece rubbing is quite similar for the degraded samples or not. Figure 7 presents the probable displacement of the 1<sup>st</sup> durable ply, this 1<sup>st</sup> ply being not supported anymore by the decayed inner plies.

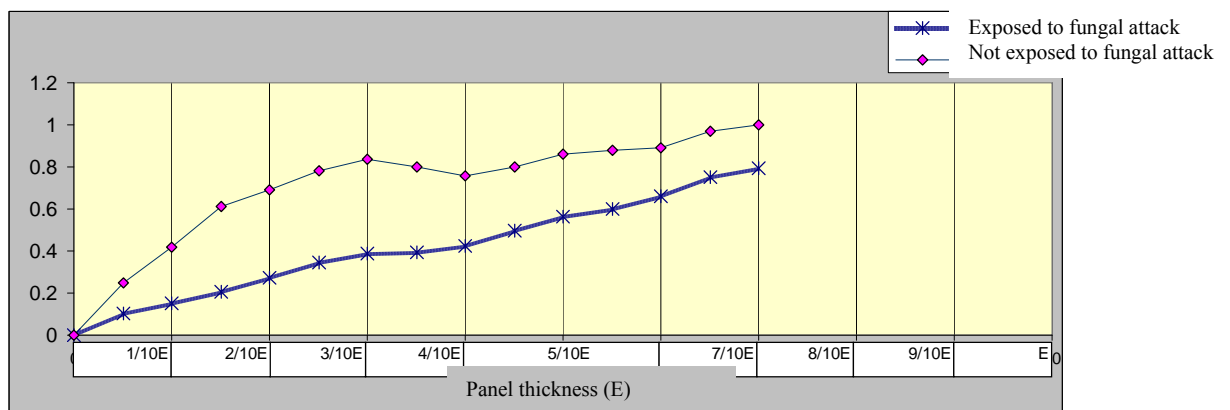
**Figure 5. Indentation force for “pure” non durable plywoods, made of poplar or beech.**

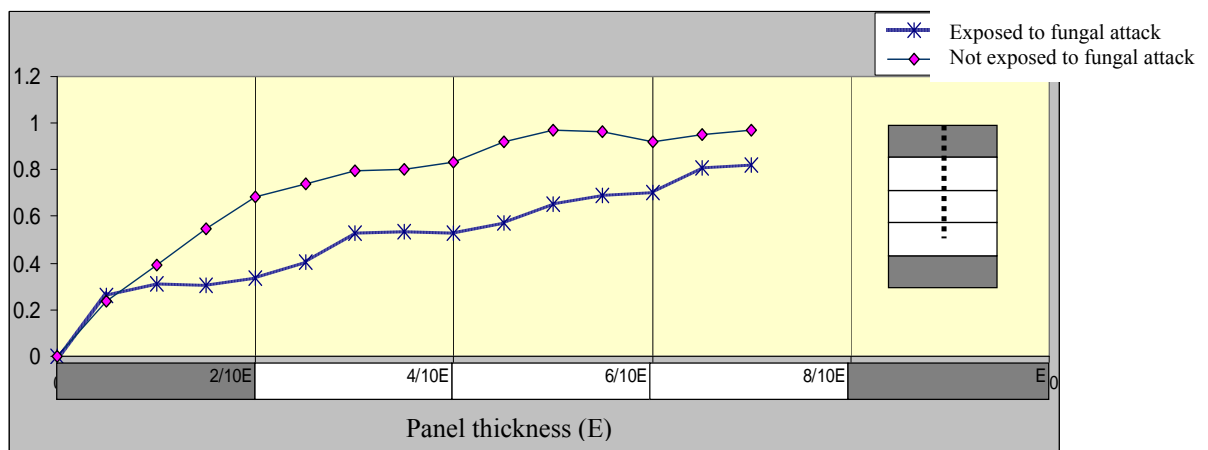
**Figure 6. Indentation force for 5 plies plywoods, made of durable top veneers (Model 1)**

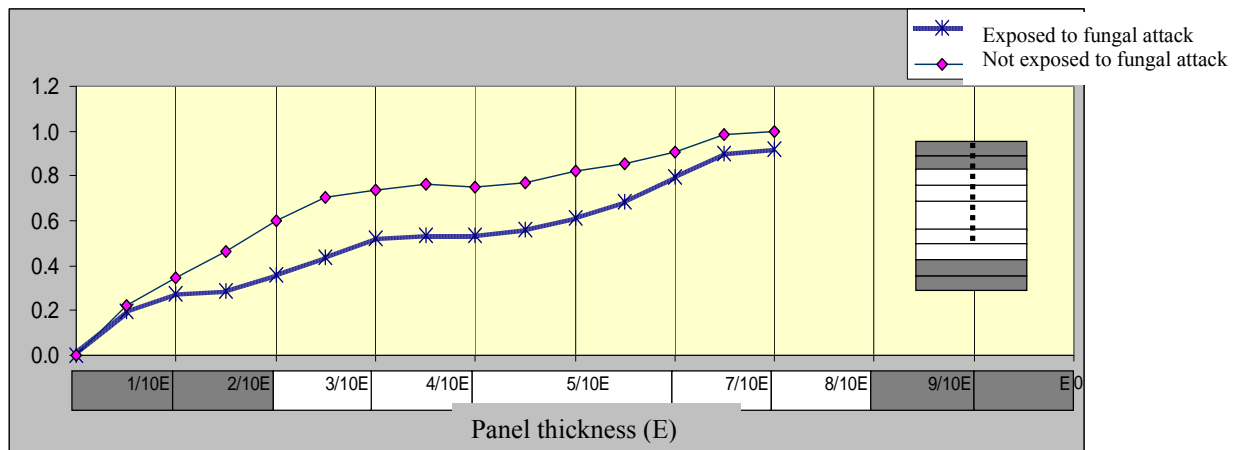
**Figure 8. Indentation force for 9 plies plywoods, made of durable top veneers (2 exterior plies on each face) (Model 2)**

For the model 2 (figure 8), the average mass loss between all plywood tested was 8.6% against *Coriolus versicolor*. The curves obtained are very similar to those found for the model 1. The difference between the models is the number of plies, and the number of glue lines, thus increasing the resistance towards the fungus.

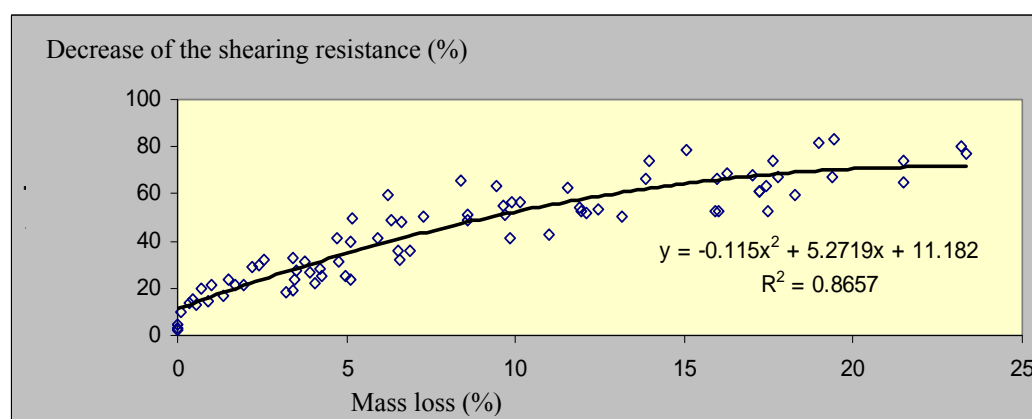
As the indentation test is extremely little destructive, shearing test was performed afterwards on the same samples. Initial shearing resistance was determined from spare samples of each plywood type. The relation between the decrease of shearing resistance (before and after fungal attack) and mass loss, obtained for all experimental plywood types, is presented in Figure 9.

The mass loss of the plywood is well correlated to the decrease of shearing resistance. On average, this mechanical test is 3.5 times more sensitive than the mass loss measurement. The shearing test is the most pertinent test (used in this study) to evaluate the loss of mechanical integrity of the plywood samples.

**Figure 9. Relation between the decrease of the shearing resistance and the mass loss due to fungal decay (96 plywoods tested, 12 samples for each plywood).**

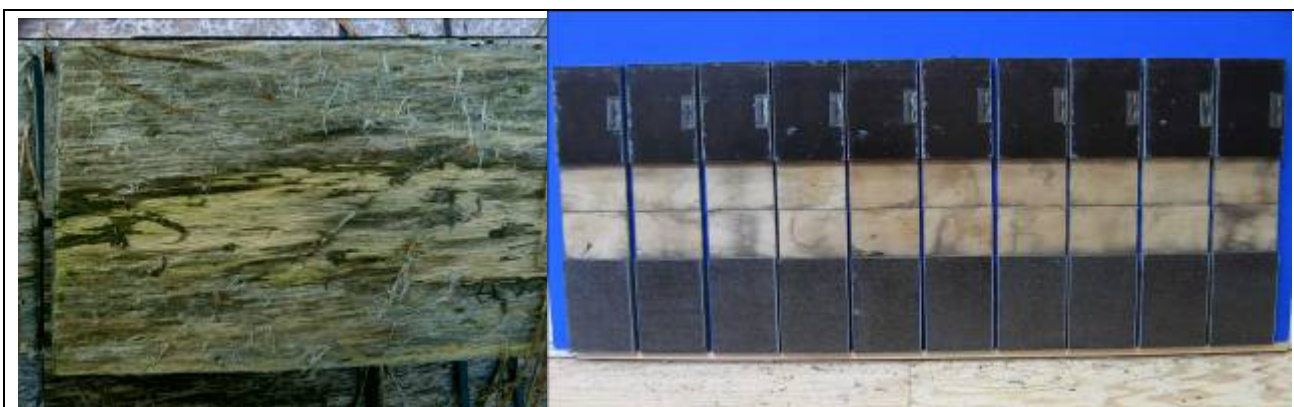
In the *Lap joint set up* several panel types were affected by starting decay (see table below). Two Poplar panel types (C2 and P3) showed intensive decay, while coated

**Figure: Lap joint samples after 1.5 years exposure (intensive decay in Poplar plywood C2; any decay in coated birch K3)**

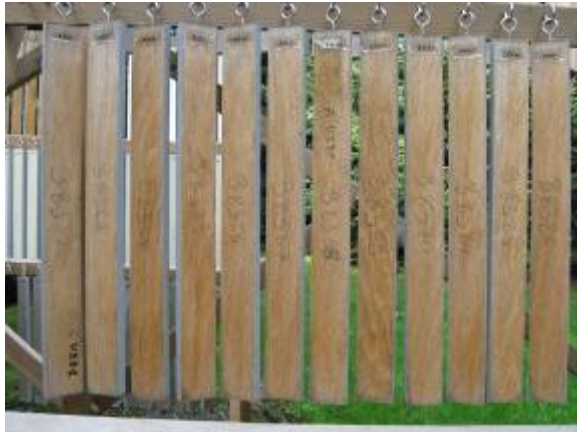
**Figure: Oak plywood P 9**

Regarding Single hanging with edge sealing no decay occurred at all. Focussing on discolouring, coated panels were in very good condition (P9 , R5 see figures below) and selected non-coated panels showed low staining while all others were discoloured heavily (Rating: 3 acc. to ENV 12037)

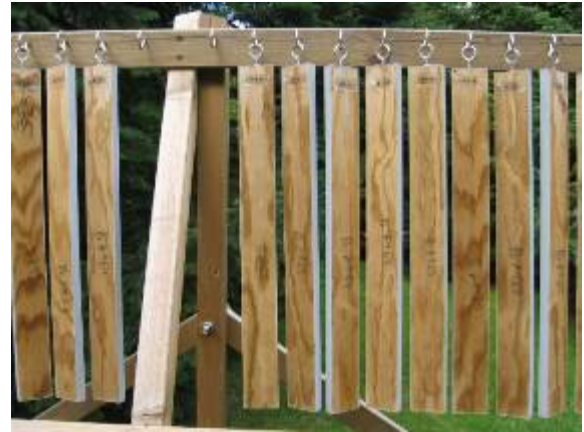
**Figure : Maritime plywood R5**

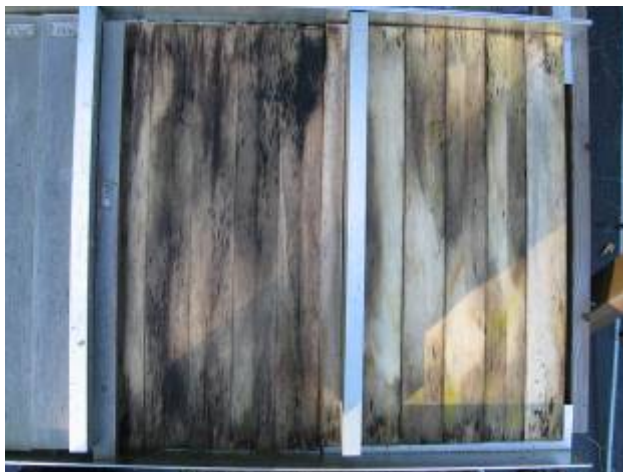
**Figure: P6, Double layer set-up without edge sealing (opened): First decay in Poplar uncoated P6, Tannin glued left: lower side right: upper side**

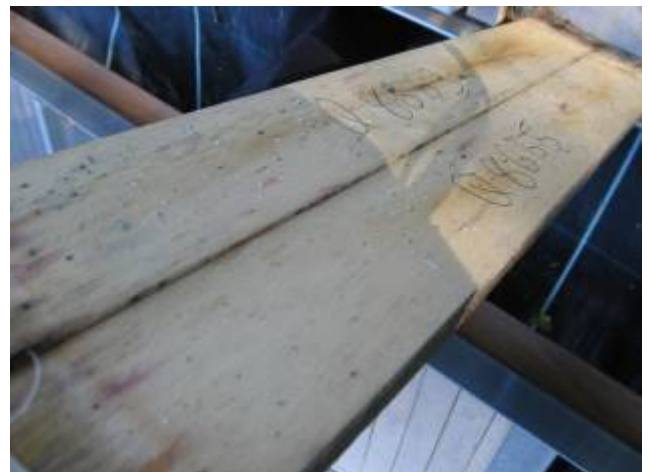
**Figure: P12, Poplar uncoated, MUF, P12: Moulds inside of double layer**

Comparable to the hanging set up, the discoloration of the non-coated panel types P9 (oak plywood) and R5 (Maritime Pine plywood with wood preservative) was very low. All other non-coated panels were rated 3 acc. the rating scheme of ENV 12037: moulds occurred in Poplar uncoated P12 and mycelium detected on the edges of Beech/Poplar C4

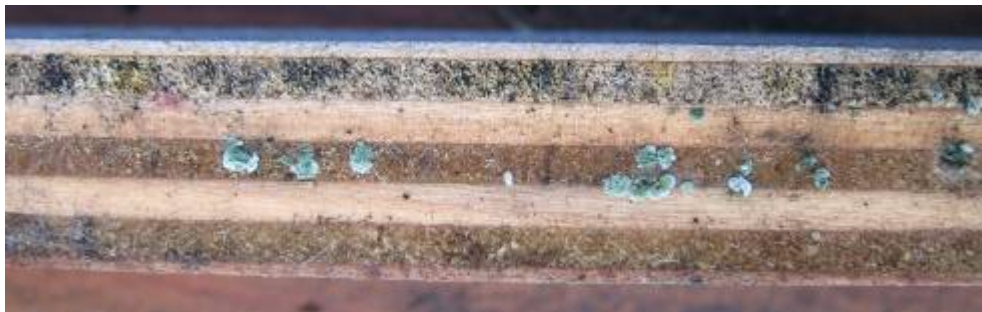
**Figure: Beech/Poplar, C4 Mycelium on edges**

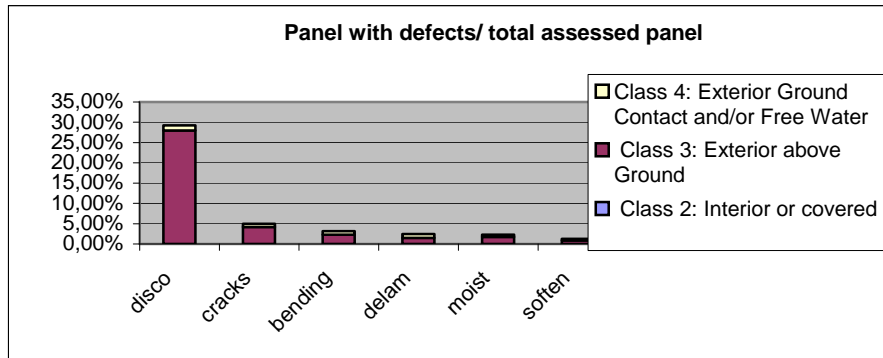
**Figure 1 Panels with defects / total assessed panels by type of defects**

The results of the evaluation are presented in Figures 1 and 2.

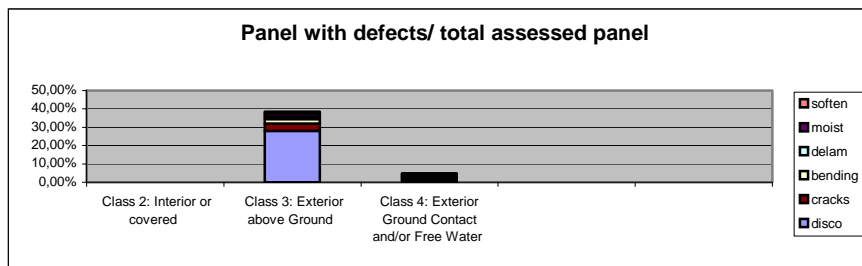
**Figure 2 Panels with defects / total assessed panels by Hazard Class 2, 3 and 4**

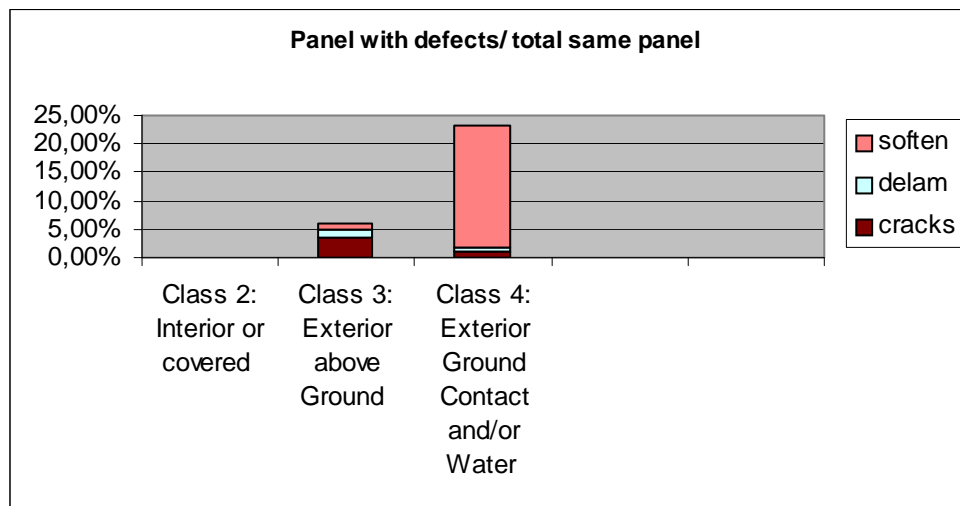
***Figure 3 Panels with defects / total assessed panels by hazard class***

Results of this evaluation are presented in Figures 3 to 6.

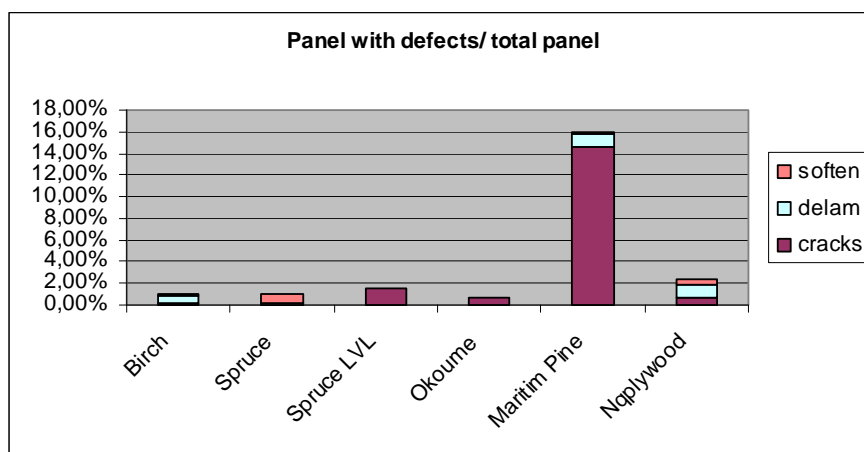
**Figure 4 Hazard Class 3 situations, panels with defects / total assessed panels by type of panel**

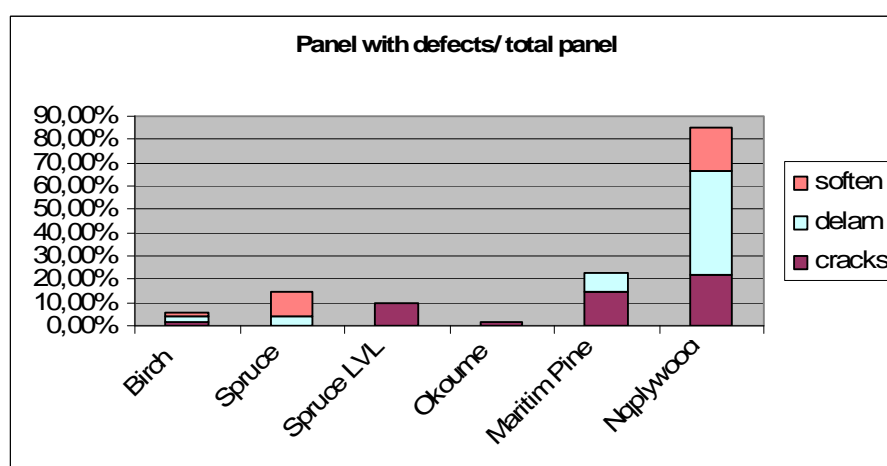
**Figure 5 Hazard Class 3 situations, panels with defects / total assessed panels of the same category by type of panel**

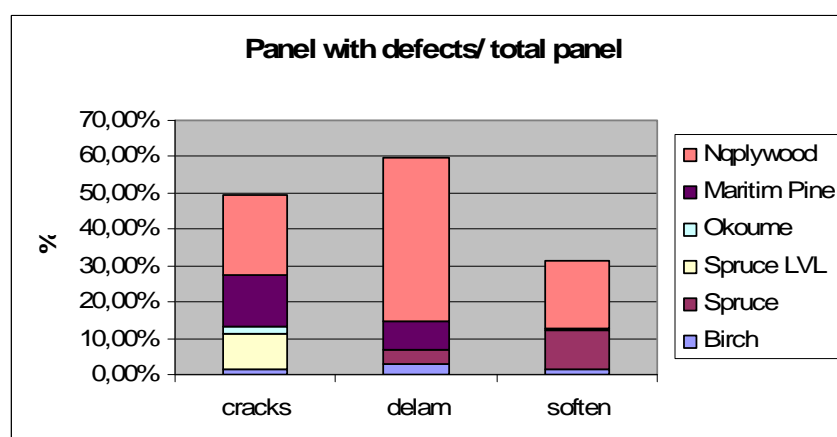
**Figure 6 Hazard Class 3 situations, panels with defects / total assessed panels of the same category by type of decay.**

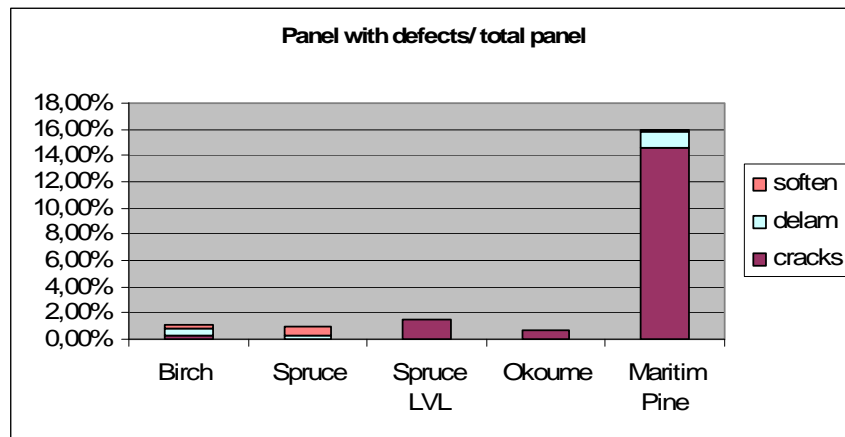
**Figure 7 Hazard class 3 situations, panel with defects/total assessed panels by type of panel.**

Results of this evaluation are presented in Figures 7 to 9.

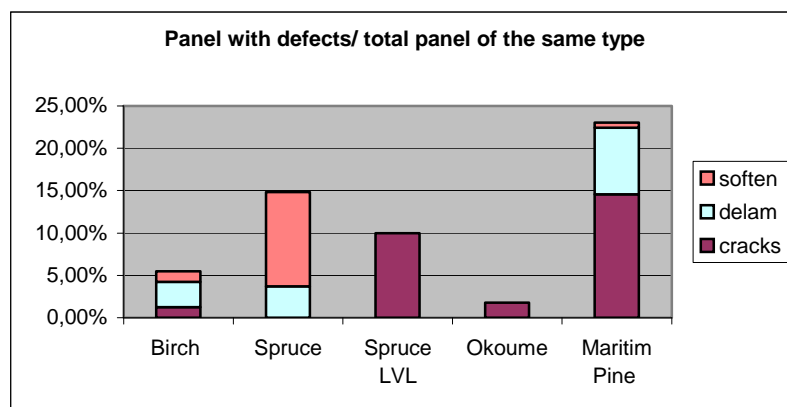
**Figure 8 Hazard class 3 situations, panel with defects / total assessed panels of the same category by type of panel.**

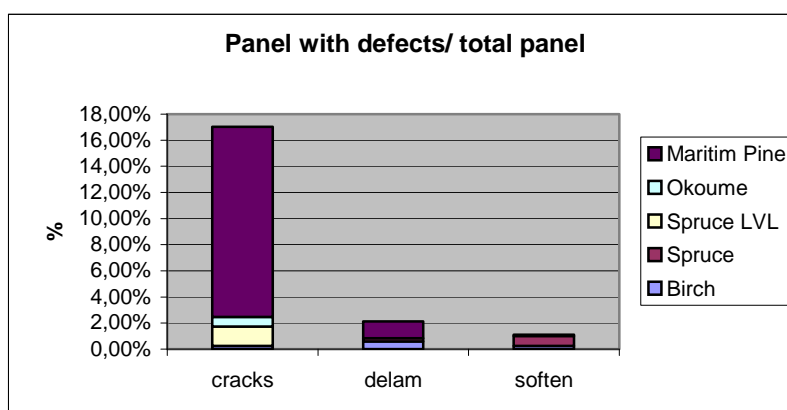
**Figure 9 Hazard class 3 situations, panel with defects / total assessed panels of the same category by type of decay.**

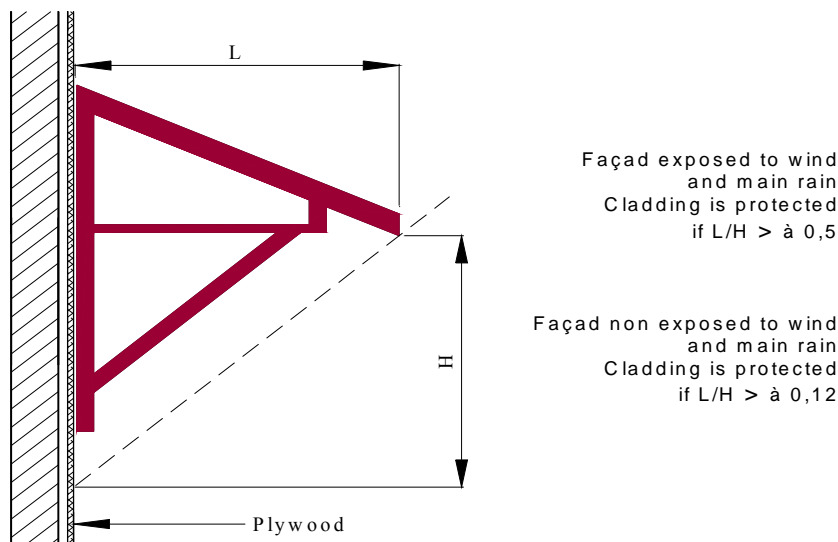
#### EXPOSURE SITUATIONS

- Use class 3 non covered situation  
Non covered situations divided into:  
Frequently wet and can dry very quickly (dry or cold climate and secured design)  
Frequently wet and can't dry very quickly (wet climate and non secured design)
- Exposure situations have to be considered depending on the climate and local situations:  
Façades exposed to main rain and wind:  
For example the main rain exposure for the oceanic climate in France is West exposure
