# GEOLOGICAL AND GEOPHYSICAL TESTS TO MODEL A SMALL LANDSLIDE IN THE LANGHE HILLS

Abstract In April 2009, North-West Italy was interested by heavy rainfalls that triggered several landslides, especially of shallow type, and caused relevant rise of water level in many rivers, in some cases even beyond the alert level. Particularly in the hills near Alba (NW Italy), many landslides occurred, most of them belonging to the debris flow or soil slip types. In this area, a small but interesting landslide involved a local road and a high quality, recently planted, vineyard. The present study shows the use of different disciplinary approaches focused to understand the behaviour of this landslide: in particular, besides geological and geomorphologic studies, detailed topographic and geophysical surveys together with an in situ geotechnical/geomechanic characterization were applied. The combined interpretation of the different techniques and of field observations allowed to define a geological and technical model of the landslide, both in surface than in depth, that clarified the triggering mechanism of the landslide and allowed to perform a back analysis on both strength and pore pressure p

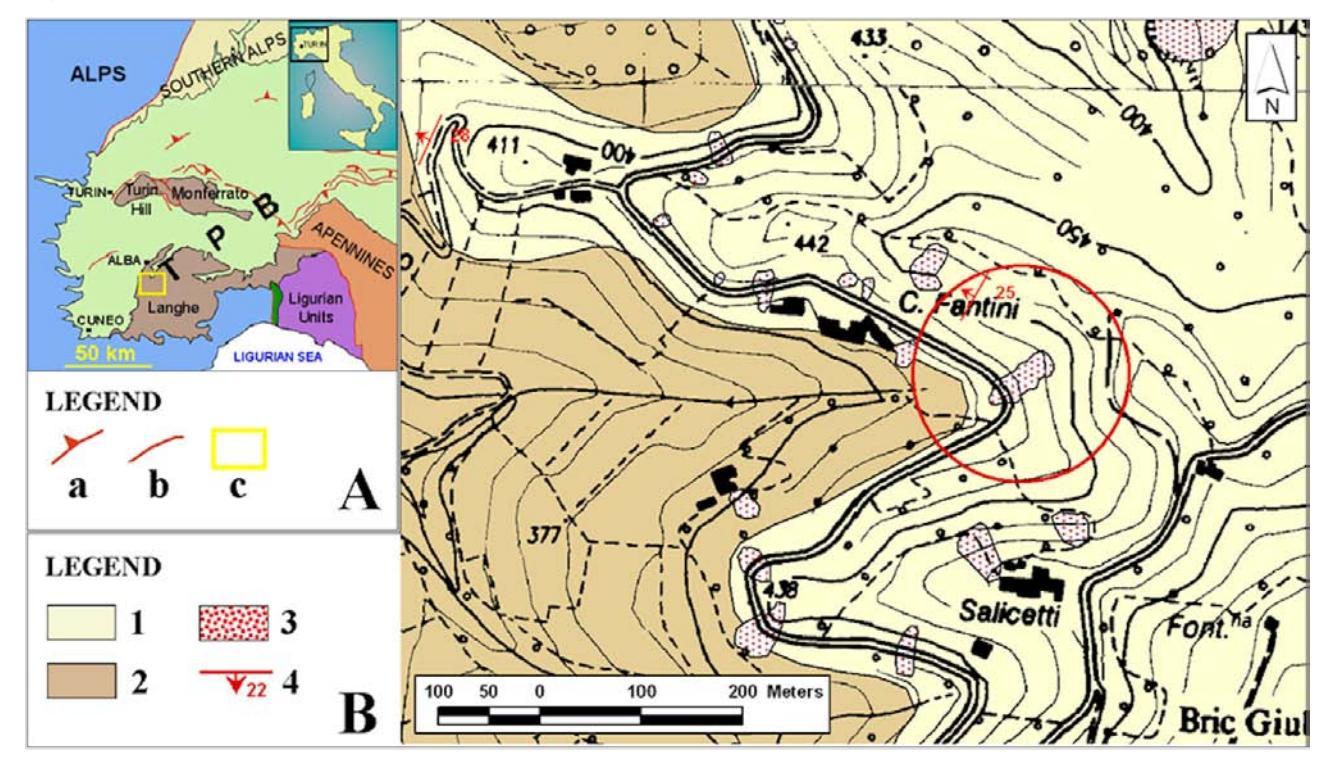
Figure 1

Fig.1 - Location map and geological setting of the study area. A) geological sketch map of Tertiary Piedmont Basin (TPB): a - thrust fault, b – fault, c - study area; B) geological setting of the study area: 1 - Diano d'Alba Sandstones F., 2 - Sant'Agata Fossili Marls F., 3 - recent landslides occurred in April 2009, 4 - strike and dip of beds. The studied area is marked by a red circle.

The study area is located in the southern Piedmont's hilly territory (Langhe), near Alba (fig. 1A). The geology is represented by sedimentary units mainly composed of terrigenous successions of interbedded layers of sandstone, marls and siltstone which are shaped with a typical "cuestas" morphology.

As it can be observed in fig. 1B, the study area is characterized by many recent landslides related to the mentioned rain event. The present study is focalized on a small failure, about 100 m long x 50 m wide, involving a road and a recently planted vineyard (fig. 1B). A multidisciplinary integrated approach (Chelli et al., 2006) has been adopted: topographic surveys, geophysical surveys and geotechnical characterization were combined to obtain a geological and technical model of the slope.

Two geological formations characterize in detail the studied area (fig. 1B): the Diano d'Alba Sandstones Formation at the top of the hill, and the S. Agata Fossili Marls Formation, in the lower part of the slope. The former is represented by sand and sandstones dark-grey or yellowish coloured, some metres thick, interbedded to clayey-sandy marls, some decimetres thick. The latter is characterized by marls and clayey-marls, blue-grey coloured. These formations are usually considered as impermeable, but a remarkable water circulation takes place during heavy or prolonged rainfalls within the coarser levels and/or within the less cemented ones. The bedrock coverage is usually very thin (less than half meter) and characterized by silts and fine sands.

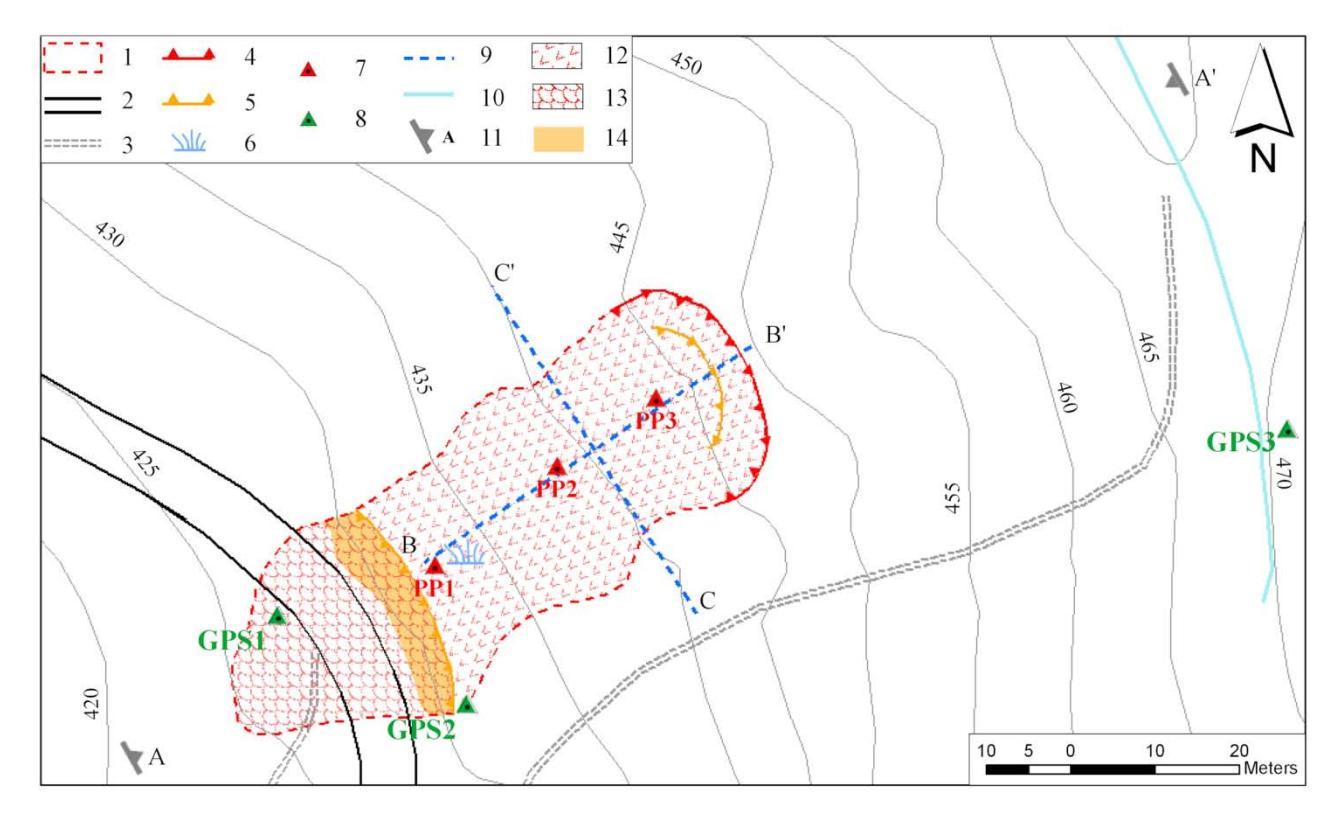
Figure 2

Fig.2: Details of the landslide and of the field investigations: 1 - landslide borders, 2 - road, 3 - track, 4 - main scarp, 5 - minor scarp, 6 - water impoundments, 7 - dynamic penetration test sites, 8 - GPS ground control point and total station bases, 9 - geophysical arrays, 10 - trace of geological section, 11 - slide, 12 - flow, 13 - man-made slope.

The landslide involved a concave slope dipping SW of about  $20^{\circ}$  which is cut by a road just at the bottom (fig. 2 and 3). After the event, a field survey was carried out on the area: preliminary surface observations pointed out two scarps, at the top of the landslide area, with height of about 1 m each. Using a total station, a more detailed topographic survey investigated the landslide and a significant area around it, allowing to define the morphometry after the failure. Georeferentiation was obtained using information from accurate location of ground control points during post-processing elaborations. These points (3 stations) were collected through a GPS device (dual frequency, dual-constellation RTK GPS, 24 GPS + 11 GLONASS Satellites with fully integrated receiver/antenna). Data elaboration was carried out by a GIS system to relate the collected data with the following digital thematic cartographies.

Two different geophysical methods were applied: respectively, electric and seismic tomography (concerning both P and S waves velocities) along the major and minor axis of the ellipse drawn by the border of the landslide (for location, see fig. 2).

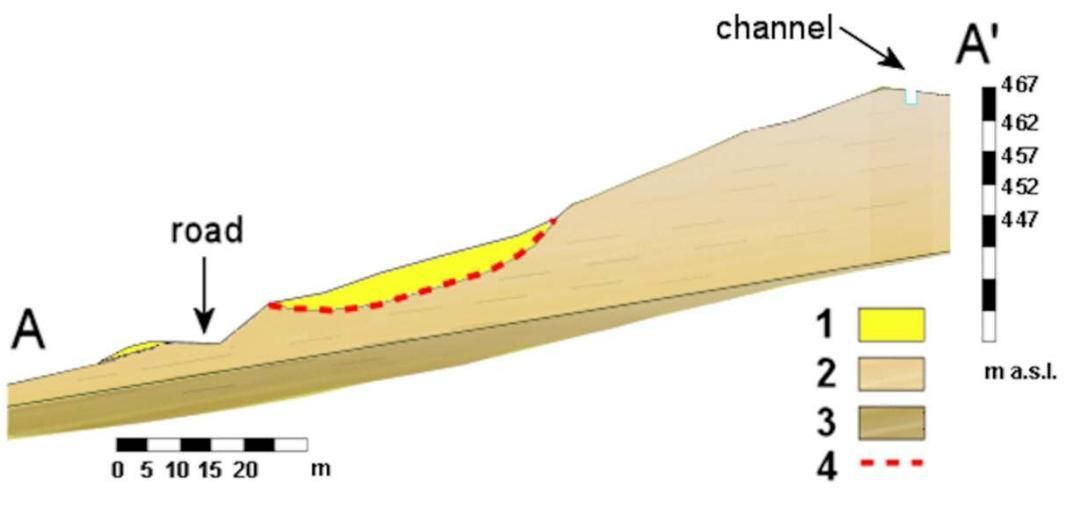
Fig.3: Longitudinal section of landslide (for location see Fig 2): 1 - displaced material; 2 - Diano d'Alba Sandstones F.; 3 - Sant'Agata Fossili Marls F.; 4 – sliding surface.

Just on the other side of the hill, a man made trench was observed (fig. 3). This trench acts as agricultural channel and collects water from houses and fields located to the E of the study area; due to the abundant rainfalls of the days immediately before the sliding, it should be almost full when the slope failed.

The multidisciplinary approach used for this small landslide allowed to reconstruct a detailed geological model. Fig. 3 and 8 show the conceptual model of the slope according to geological surveys, which was confirmed by the subsurface investigations. The landslide involved a flysch-type bedrock; it moved - at the top - as a rotational slide, and - in the middle part - as a translational one. The mobilized material turned into a debris flow that swept the road and part of the slope below.

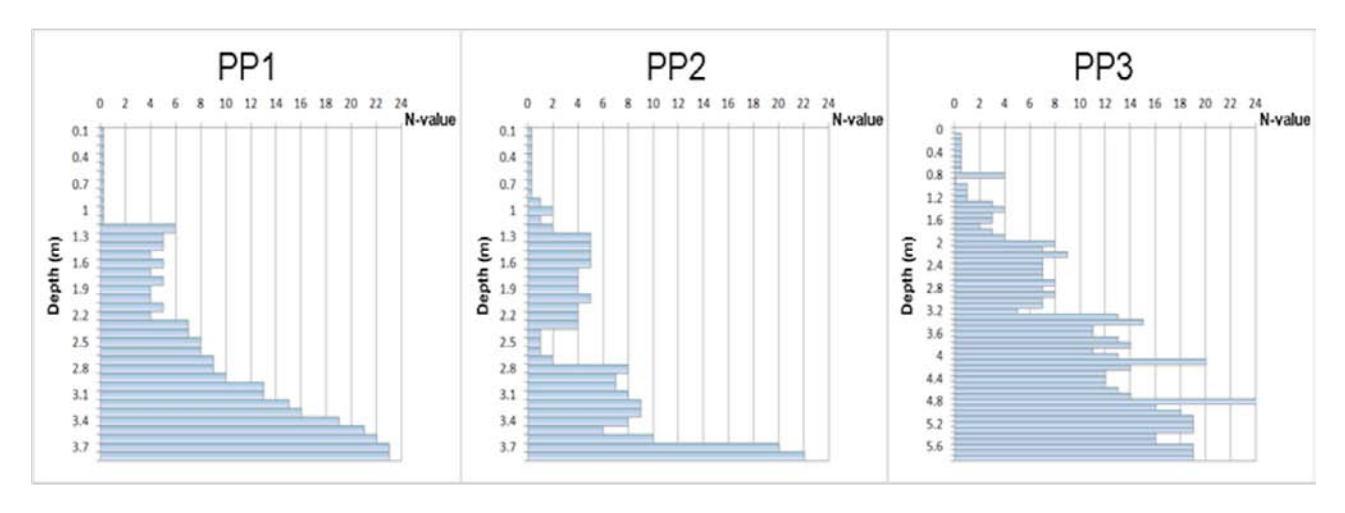
Fig.4 Technical profiles of the dynamic penetrometer tests.

The results of the three surveys are reported in fig. 4. All tests revealed a general increase in soil density with depth. First change is evident at 0.8 - 1 m of depth, probably in correspondence of the soil-subsoil transition. However, at this depth, a still low subsoil resistance is noted; an abrupt change in penetration resistance can be instead observed at about 3-3,5 m of depth, where the bedrock was probably reached.

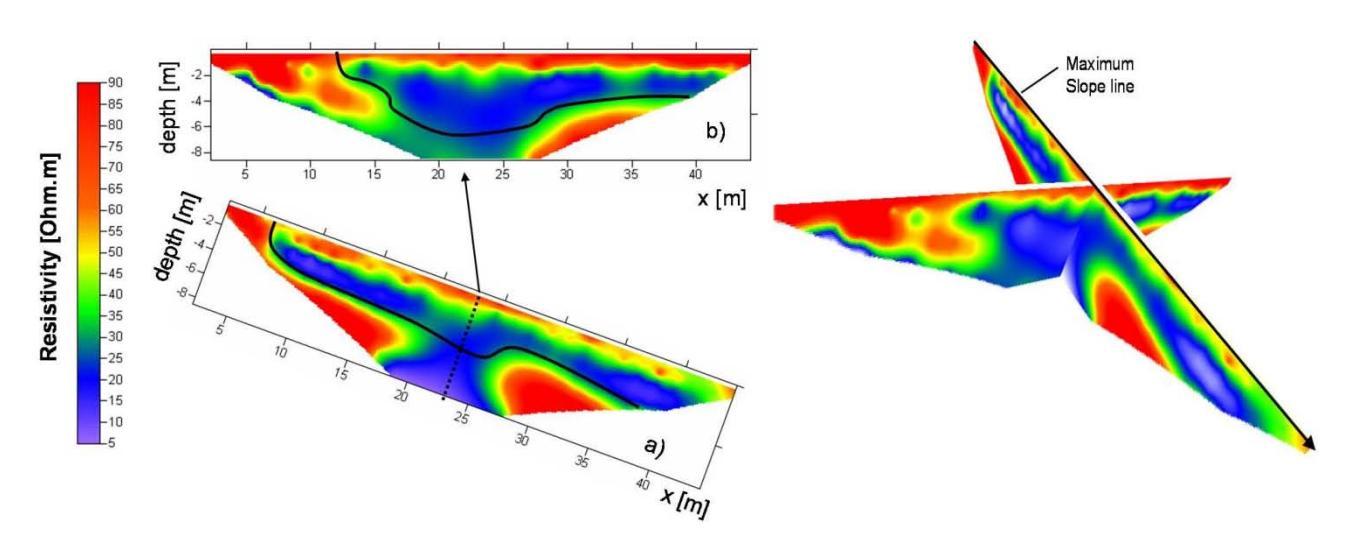
Figure 5

The results of the two electric tomographies are shown in fig. 5. A very shallow (1 - 1,5 m) dry layer overlying a zone of reduced resistivity can be noticed. This zone is located inside the sliding body and is probably related to porous wet material. At the bottom of this high-conductivity zone, evidence of an increase in resistivity can be related to the contact between the landslide body and the bedrock. A very good coherence in the results of the two surveys can be observed, particularly in the overlapping central zone where both images underline a decrease in resistivity in the central part of the slope. This can be explained by the presence of preferential flow path that can have favoured the sliding movement. Indeed, field evidence underlined the presence of a significant amount of water in this area right after landslide activation.

Fig.5 Electric topographies, executed a) longitudinal (B'-B) and b) transversal (C'-C) to the slope, and probable position of the sliding surface (thick black line). On the right, a combined view of the two sections.

Electric tomographies were acquired with two different spreads of 32 electrodes with 1.5 m electrode spacing deployed along the B-B' and C-C' lines, to provide an image of the slope in both directions. The acquisition used a PASI tomograph and a Wenner- Schlumberger measuring sequence; with such a sequence, it is indeed possible to obtain a good compromise between both vertical and lateral resolution. Due to the relatively shallow expected sliding surface, reduced arrays length were used allowing for an investigation depth of about 10 m. Acquired data were inverted by the commercial inversion code Res2Dinv® (Loke and Barker, 1996).

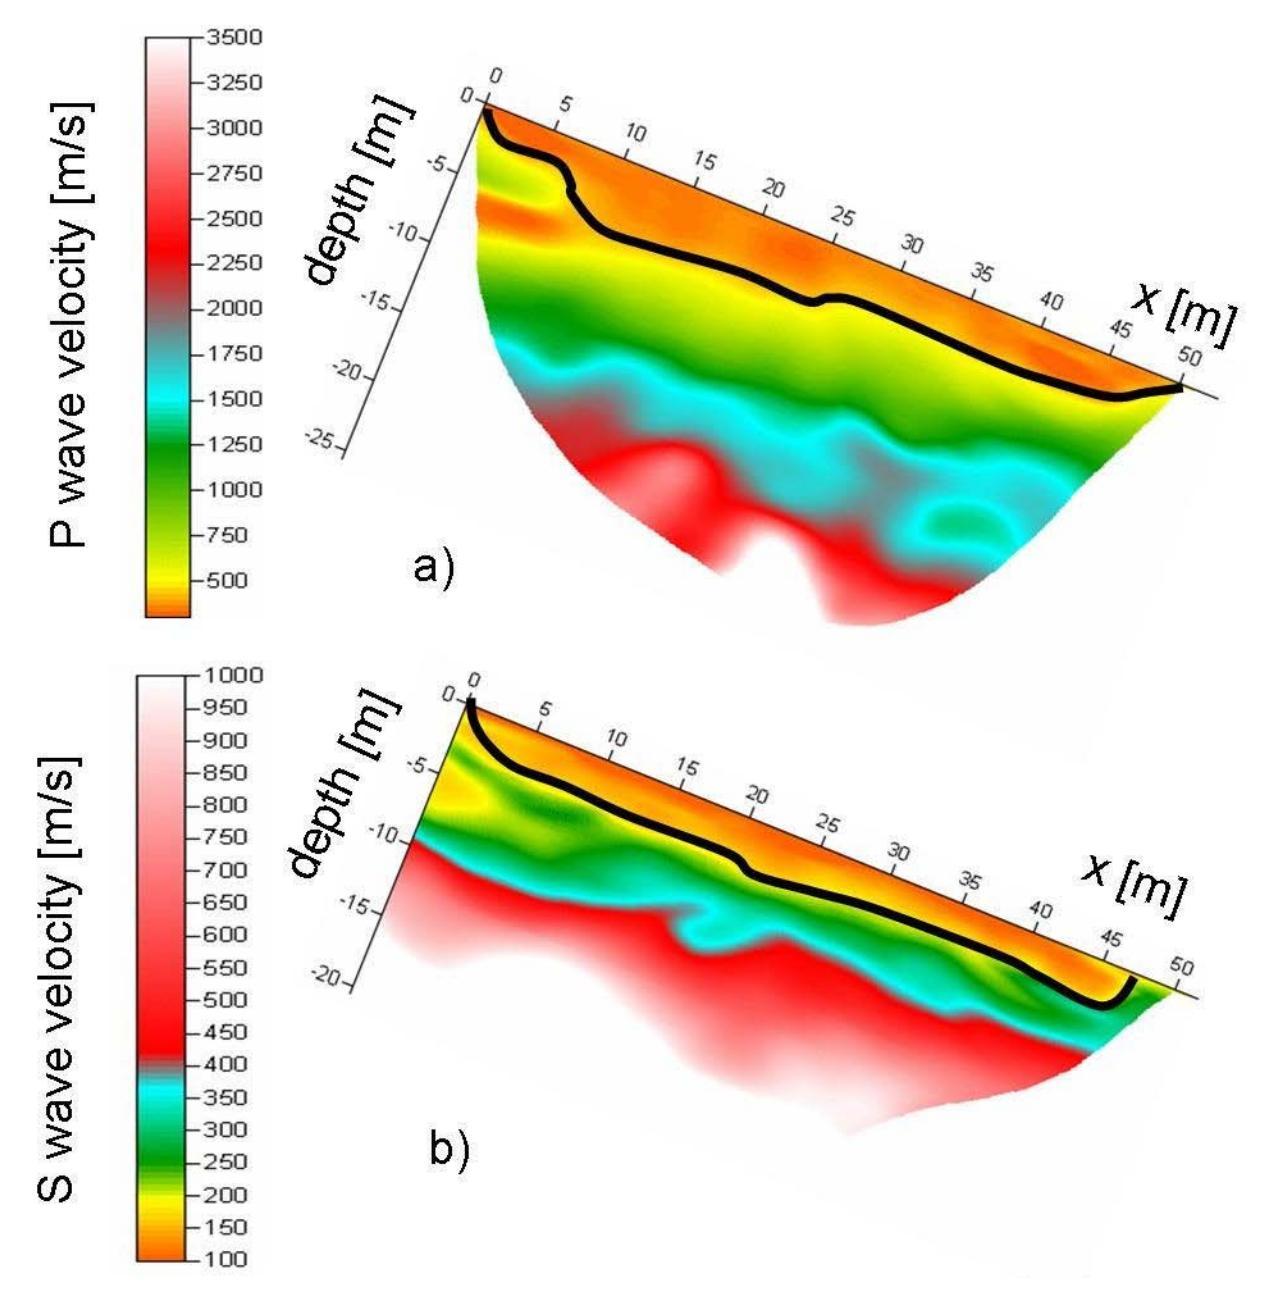
With respect to seismic tomographies, in fig. 6 the results of P and S wave tests are shown. From both images, a clear evidence of the contact between the displaced material and the stable rock can be evidenced, helping to delineate the sliding surface. The P wave tomography seems to identify the presence of a low water table (around 15 m depth for P wave velocities of 1500 m/s). This is coherent with previous data in the area since the tests were executed some times after the rainfall events, and a requilibration of the water level probably occurred. In this respect, the results of the electric tomographies can be reinterpreted by excluding the presence of saturated material near the surface, and by attributing the decrease in resistivity to wet material with some clay content (cf. grain size distribution curves). Due to the increased sensitivity of shear waves to the soil skeleton properties, the S wave tomography is instead more able to delineate the variations in the structure of the soil near the slope. Indeed, the presence of a reduced velocity zone just in the middle of the slope is highlighted. The position of this zone is very coherent with the reduced resistivity of the central portion of the slope body, and can be related to loose material which favoured the water flow in the slope.

Fig.6 - Seismic P wave tomography and seismic S wave tomography executed longitudinal (B'-B) to the slope with probable position of the sliding surface (thick black line).

Seismic tomographies were performed only along the maximum slope line (B-B' line) but, in order to retrieve both S and P wave velocities, different sources and sensors were used. For P waves, an array of 24 vertical 4.5 Hz geophones with 2 m spacing and a vertical hammer source were used; for S waves, an array of 24 swyphones<sup>tm</sup> (Sambuelli and Deidda, 1999) with 2 m spacing and an appropriate SH source were adopted. Different shot positions were used along the survey line in order to have adequate data for tomographic interpretation. Both arrays were acquired with a Geometrics Geode Seismograph and interpreted for tomography with the commercial code Rayfract®. The use of swyphones<sup>tm</sup> allowed a reduced time acquisition since no inversion of the source was necessary. The measuring techniques for S wave velocities usually require a more complex acquisition, which are particularly difficult to be attained - especially in complicated logistical conditions such as the ones that commonly characterize landslide sites.

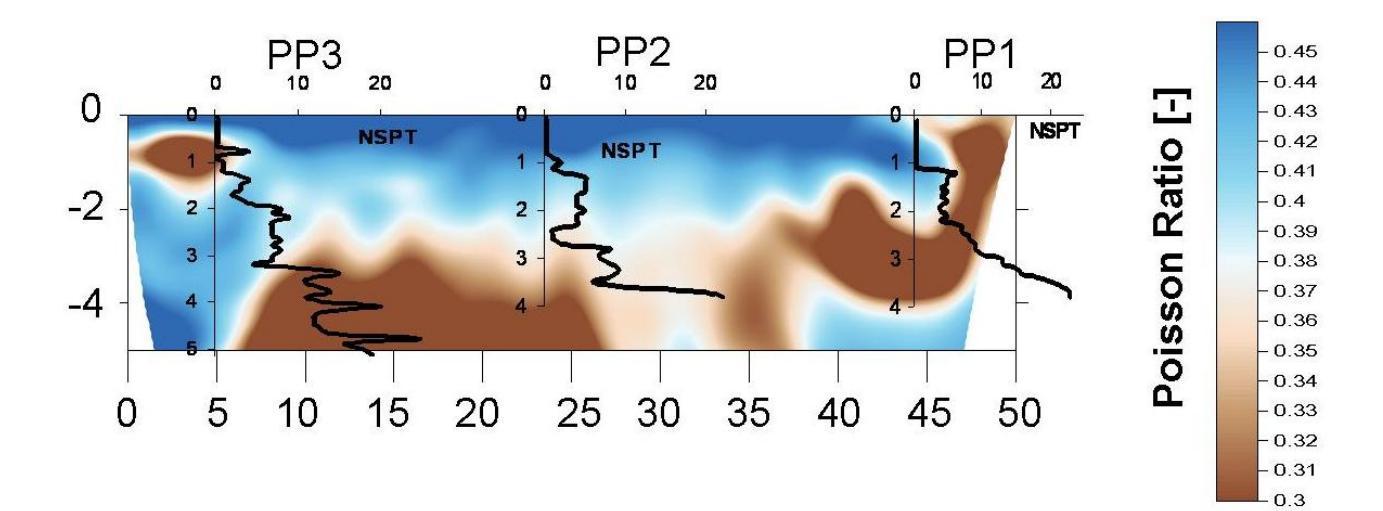
Fig.7 - Poisson ratio map in relation to of penetrometer tests along the major axis of the landslide.

Field observations and geophysical investigations highlighted that the landslide probably involved also the bedrock, and that the landslide body was composed by silty-sand about 3-4 m thick. Coherently with field observations and dynamic penetrometer tests, the sliding surface extracted from geophysical tests seemed to have a compound shape (rotational and translational). In this respect, in fig. 7 a representation based on the poisson ratio extracted from the P and S wave velocity values is used to relate the results of both seismic and penetrometer tests. A very good correspondence is observed between the two results: particularly, the decrease in poisson ratio from typical values of shallow unconsolidated soils to the ones of more consistent and compacted bedrock is observed with a high correspondence with the increase in penetration resistance. Moreover, a remarkable difference is observed between the different locations of penetrometer tests. In particular, near the PP2 test, a reduced resistance zone was found.

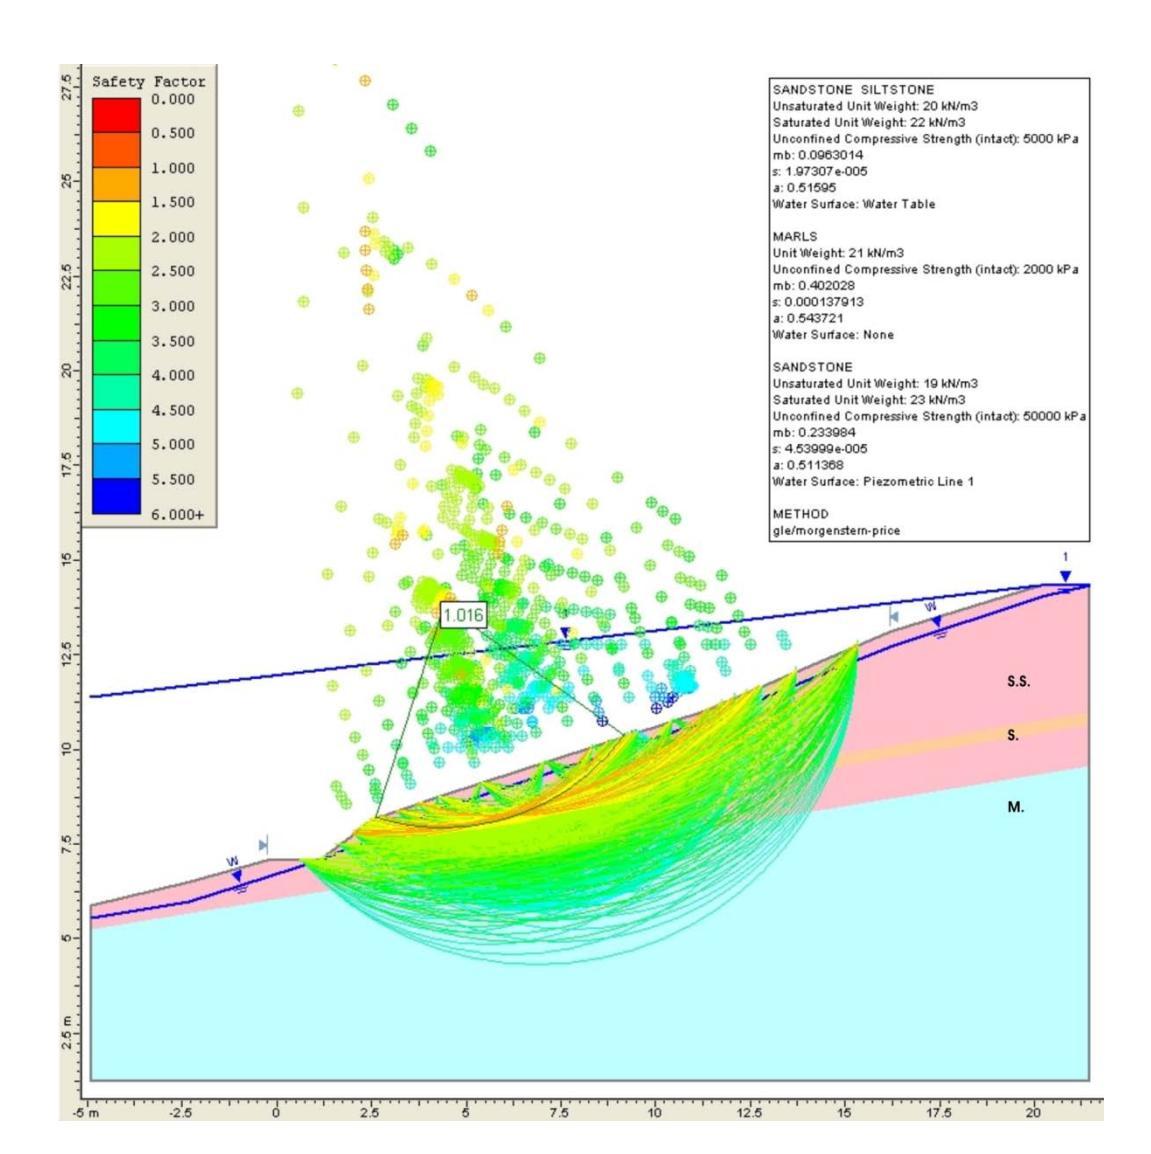
Figure 8

In particular, we were successful to reconstruct the observed sliding surface introducing the following characteristics: 1) a high permeable sandy level below the landslide, were the wet level is located, implemented the simple geology of the slope; this level is probably connected to the channel at the top of the hill thanks to the jointing of the rock mass in that area, 2) a free water table in the Diano d'Alba formation close to the surface ("w" in fig. 8), 3) a pressured fast water circulation in the sandy level ("1" in fig. 8) fed by waters in the channel at the top of the hill.

Fig. 8 – Slope stability analysis with minor safety factor value coherent with measured sliding surface. Keys: S.S. = sandstone and siltstone, S. = sandy level, M. = marl, w = water table in S.S., 1 = pressured water table in S.
