# Whole-body vibration: Measurement of horizontal and vertical transmissibility of an agricultural tractor seat

# Effects of the operative characteristics of an agricultural tractor on seat vibration transmissibility

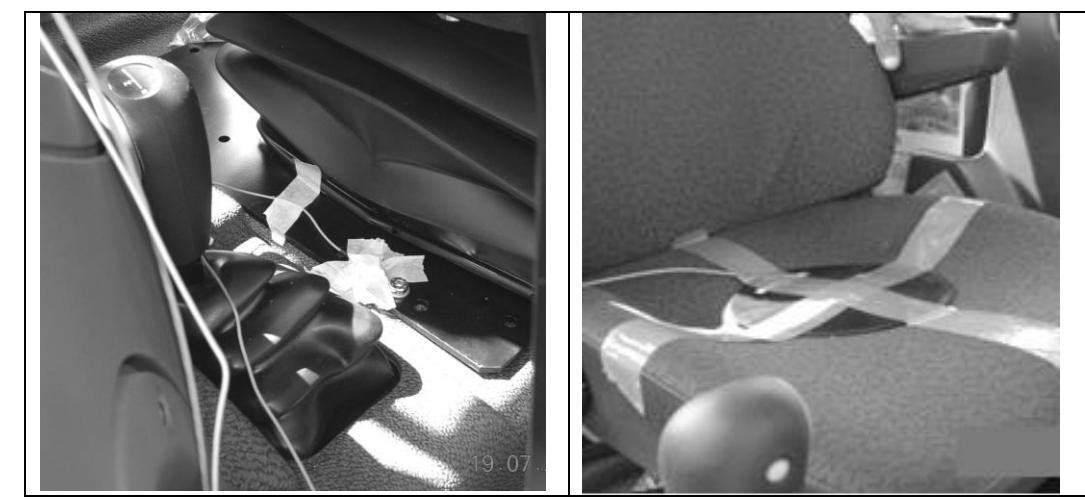
- Figure 1. Accelerometer position on the cab floor of the tractor, near the seat anchorage (left), and over the seat (right).

Accelerations were measured along the three mutually perpendicular directions (X, longitudinal; Y transverse; Z, vertical), both on the surface of the operator's seat and on the vehicle cab floor, close to the seat mounting (Figure 1).

10 A semi-rigid disc, incorporating three mutually-perpendicular piezoelectric accelerometers (ICP<sup>®</sup>, Integrate Current Preamplifier, from PCB, type 356B41 with sensitivity of 100mV/g, frequency range 11  $\pm 5$  % from 0.5 to 1000 Hz), was positioned on the seat cushion of the driver under his ischial 12 13 tuberosities (below the SIP - Seat Index Point), to measure the vibration on the driver's seat. A second three mutually-perpendicular piezoelectric accelerometer (ICP®, Integrate Current Preamplifier, from 14 15 PCB, type 356A02 with sensitivity of 10 mV/g, frequency range  $\pm 5$  % from 1 to 5000 Hz) was 16 positioned on the cab floor close to the seat mounting, using a magnetic mounting base. The output 17 signals from the accelerometers were processed in real time through an eight channels NI (National 18 Instruments) 9402 (cut-off frequency 1 Hz, - 1dB). The Sound and Vibration Assistant software 19 (National Instruments) was used to post-process the data. All the measurement chain was previously 20 calibrated. The acquisition time during each test was always more than 10 minutes.

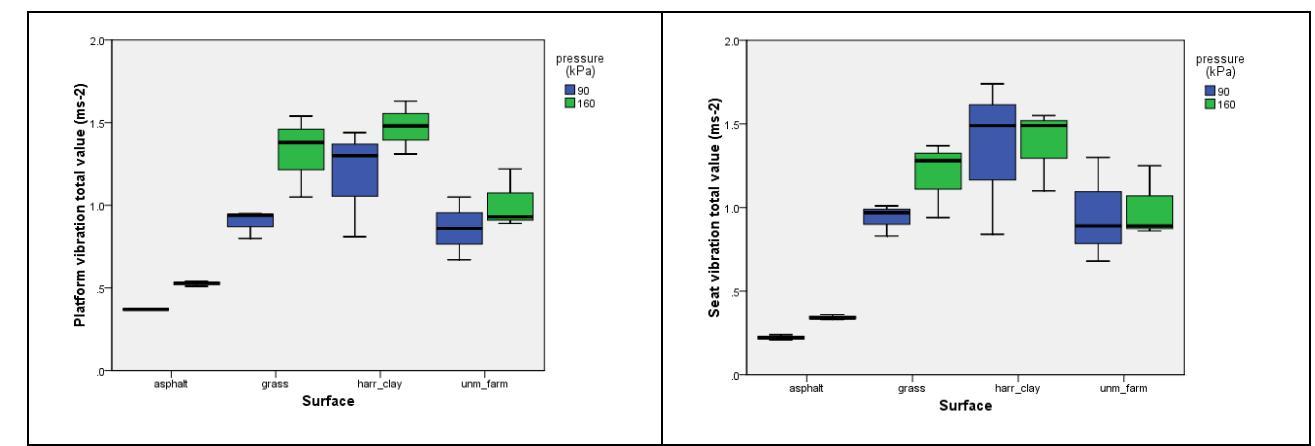
Figure 2. Box whisker graph of the vibration total values on the platform and on the seat with the 2 3 4 5 tractor crossing all the surfaces at the same forward speed of 2.78 m/s with tire pressures at 90 and 160 kPa.

13 The averaged vibration total values,  $a_v$ , measured on the seat and on the platform were quite similar (as 14 values) (Figure 2) and higher data were usually obtained with the tires pressure at 160 kPa. On the

15 asphalt the registered acceleration were always lower than  $0.5 \text{ ms}^{-2}$  (except the value corresponding to

16 the tire pressure at 160 kPa on the platform). The highest vibration total values were found on the

- harrowed clay and on the grass with the tire pressures at 160 kPa, while on the unmetalled farm road the values ranged around  $1 \text{ ms}^{-2}$ .
- Along the crossed surfaces, the acceleration  $a_v$  obtained on the seat and on the platform were statistically different among them. The surface always influenced the vibration total values on both the platform and the seat, while concerning the tire pressures, it influenced the acceleration on the platform, not on the seat (Table 4). The post-hoc analysis (based on the Tukey test) revealed similarities of the vibration data obtained on the grass and on the unmetalled farm road surfaces on both the seat and the platform.

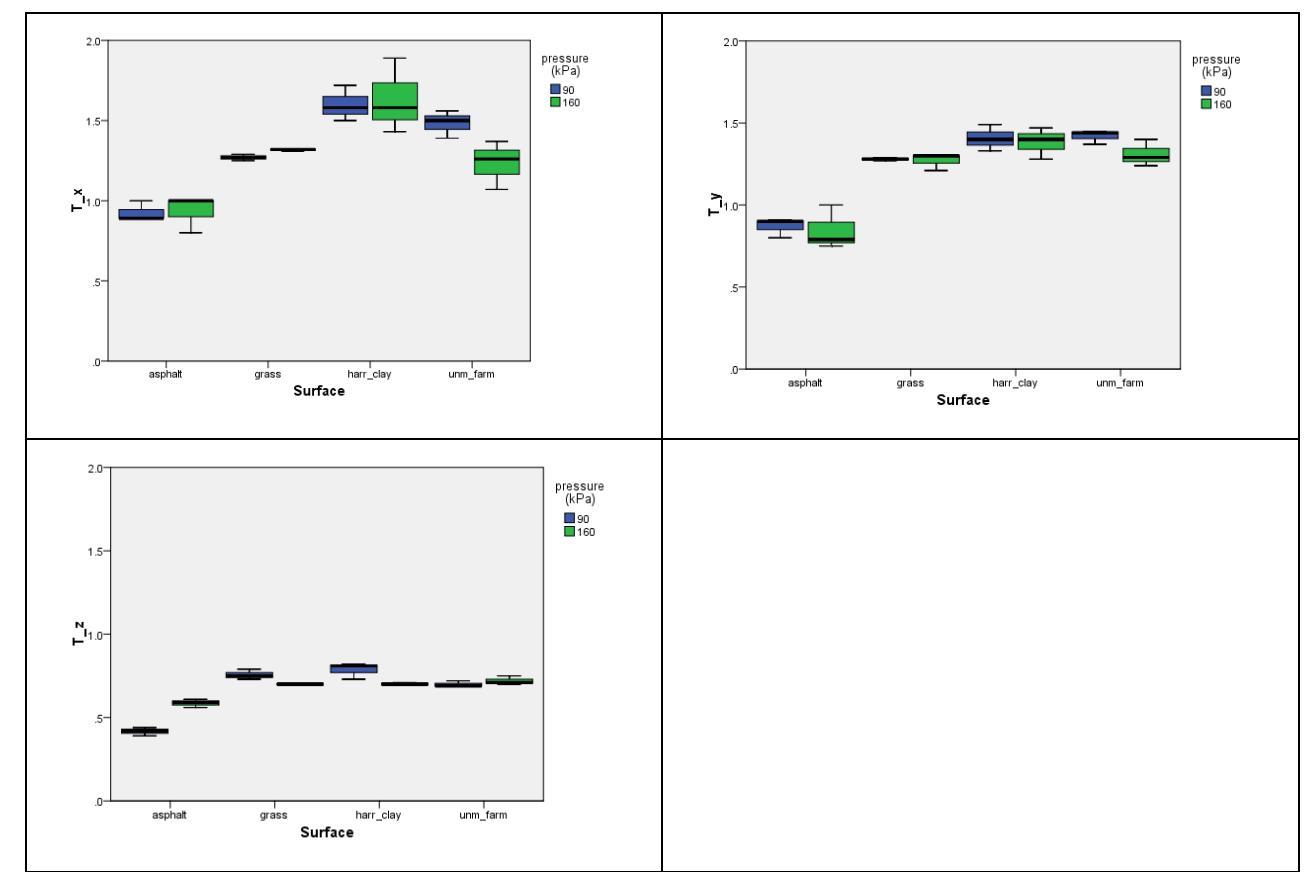
Figure 3. Box whisker graph of the transmissibility data along the three directions (T\_x, T\_y, T\_z). 2 3 4 Tractor is crossing all the surfaces, with tire pressures at 90 and 160 kPa.

The transmissibility along the Z axis was always less than 1 (approximatively around 0.75), save for the asphalt, whereas it was lower (around 0.5, Figure 3).

Along the X and Y axis on the asphalt the transmissibility was around 1, while for the other surfaces it was possible to notice that the ratio along the Y axis was more concentrated around 1.2-1.3 and normally lower than 1.5, whereas along the longitudinal X direction the ratio was variable in a wider range (between 1.2 and 1.8).

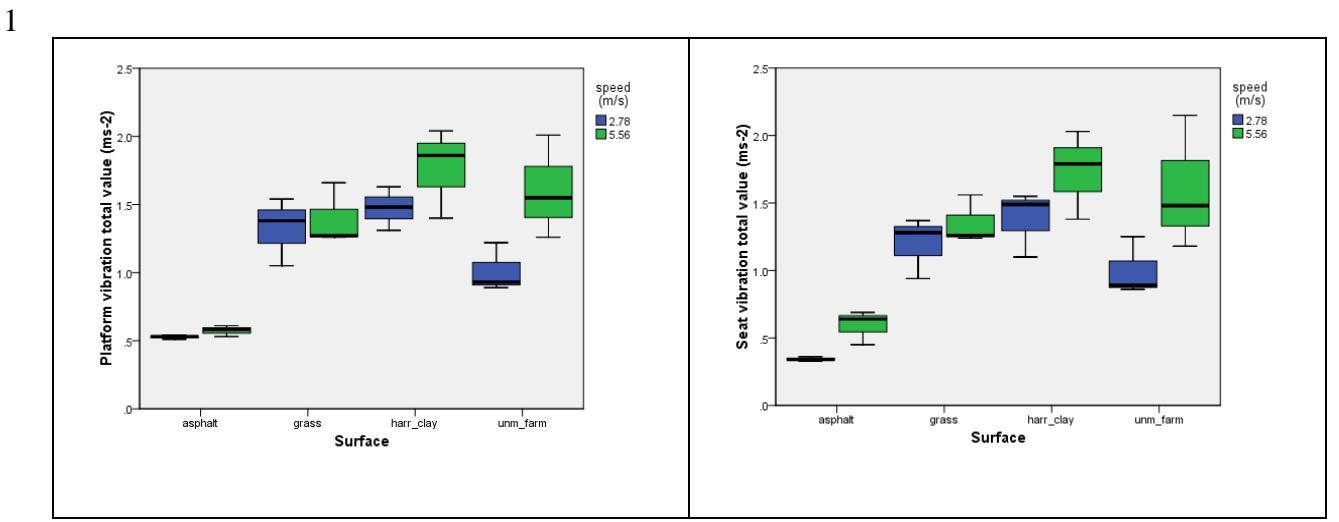
Figure 4. Box whisker graph of the vibration total values on the platform and on the seat (tractor 2 3 4 crossing all the surfaces, at the forward speed of 2.78 and 5.56 m/s with tire pressures at 160 kPa).

The forward speed detected different vibration total values almost for all the surfaces, except for the grass (Figure 4). On both the platform and the seat, acceleration higher than  $2 \text{ ms}^{-2}$  were reached at the speed of 5.56 m/s.

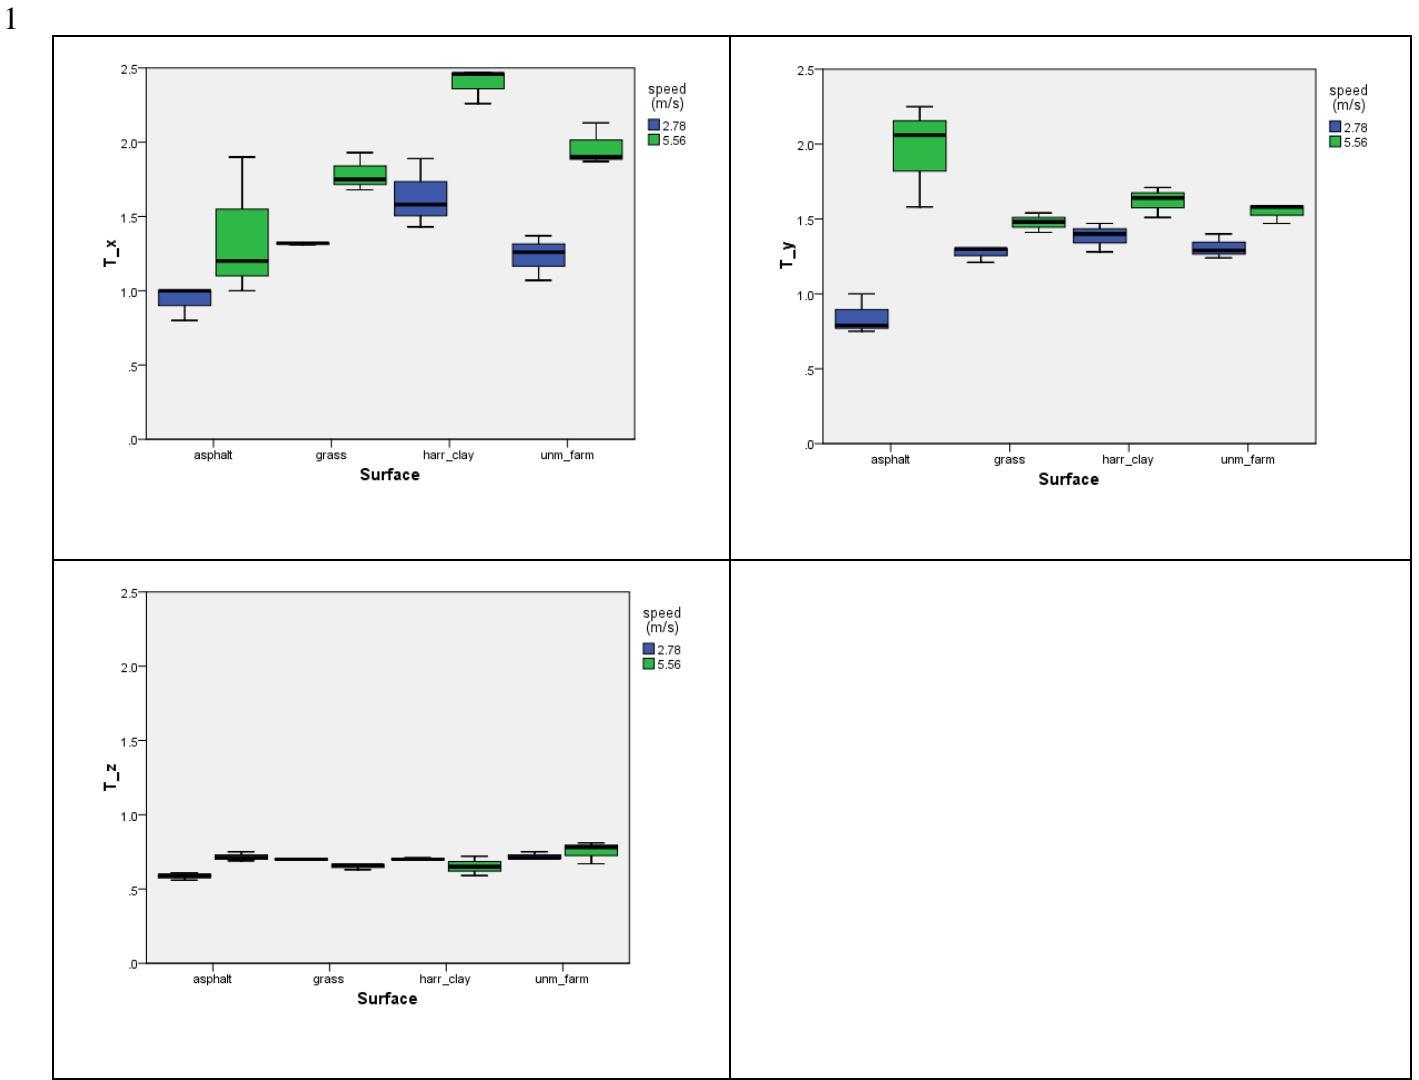
- Figure 5. Box whisker graph of the transmissibility data along the three directions (T\_x, T\_y, T\_z). 2 3 4 5 Tractor is crossing all the surfaces, at the forward speed of 2.78 and 5.56 m/s with tire pressures at 160
- kPa.

| 1 | |
|---|---|
| 4<br>5 | High transmissibility values, with the majority of data between 1.3 and 2.4, were present along the X axis (sometimes more than 2, Figure 5); here, the highest values were determined by the forward speed |
| 6 | at 5.56 m/s, especially on the harrowed clay and on the unmetalled farm road. At this velocity it is |
| 7 | interesting to notice the high spread of the values on the asphalt, with a maximum equal to 1.9. On the |
| 8 | asphalt, the same happened along the Y axis, with a maximum equal to 2.25. Nevertheless along the |
| 9 | transversal axis in the other combination (surface and speed) the transmissibility was here more |
| 10 | concentrated around 1.5. As usual, the Z axis presented its own story, with a transmissibility around |
| 11 | 0.6, regardless of the crossed surface. |

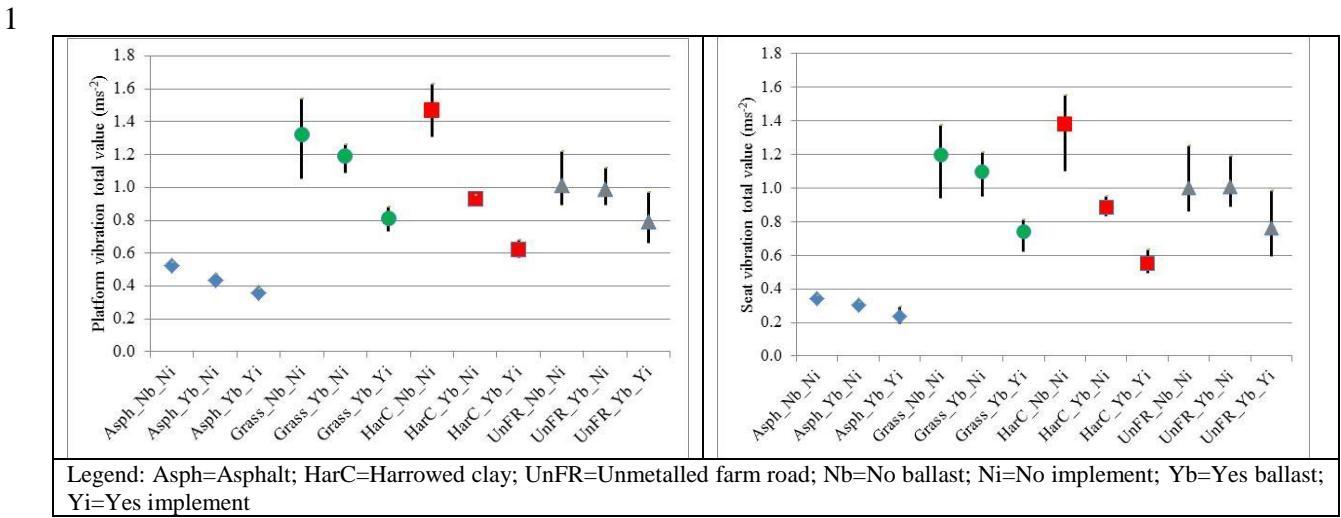
Figure 6. Vibration total values (average, minimum and maximum) on the platform (left) and on the seat (right) obtained in the examined surfaces and machine configuration (without ballast, with ballast and with ballast and implement).

| 1 | |
|---|---|
| 17 | The presence of the ballast first and of the implement later, produced lower vibration total values both |
| 18 | on the seat and on the platform (Figure 6): as it was easy predictable, the lowest acceleration data were |
| 19 | obtained by the double presence of ballast plus implement. On the asphalt, for example, the average |
| 20 | acceleration over the platform decreased from 0.53 to 0.44 (ballast) and to 0.36 (ballast plus |
| 21 | implement): the same decreasing trend was present on all the remaining surfaces, with the exception of |
| 22 | the unmetalled farm road, where the presence of the ballast alone did not seem to influence the |
| 23 | accelerations. |
| 24 | The range (max-min) of the measured acceleration in Figure 6 evidence an higher data variability when |
| 25 | the ballast was not present in the machine and for the unmetalled farm road. Acceleration obtained on |
| 26 | the seat were lower than the same data obtained on the platform, except for the unmetalled farm road. |

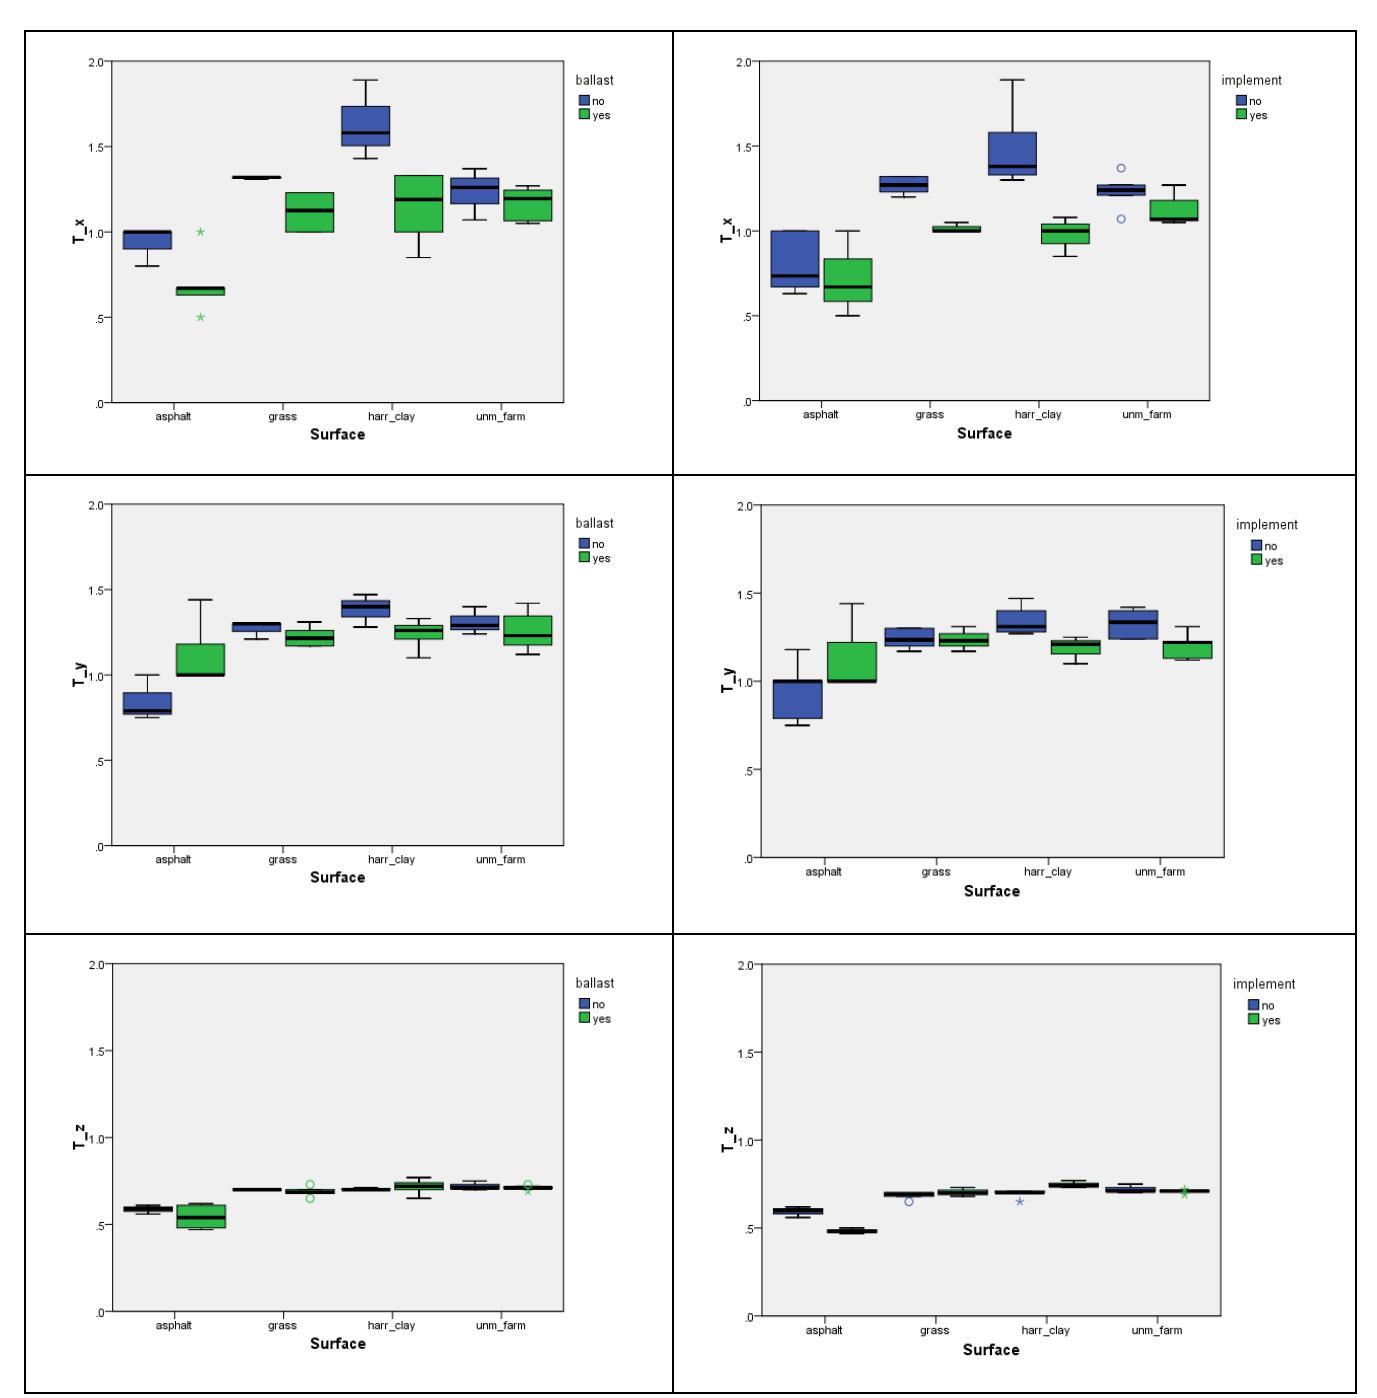
Figure 7. Box whisker graph of the transmissibility along the three directions (T\_x, T\_y, T\_z) with the 2 3 4 absence/presence of the ballast and of the implement.

| 1 | |
|---|---|
| 24<br>25 | The analysis of the transmissibility along the three axis (Figure 7) highlighted the same share |
| 35 | reviously avidenced in the other figures related to the transmissibility: on the asphalt the registered |
| 30<br>27 | values were in the average lower for all the axis (about 1 along X and X and about 0.5 along 7) |
| 38 | The X axis had more spreadable and higher values than the others axis X and Z. The presence of the |
| 30 | hallast or/and of the implement produced lower values along the X axis. The same fact was not so |
| 40 | evident observing the Y axis where on the contrary on the asphalt higher values were observed when |
| 41 | the ballast and the implement were installed: when the machine was unloaded higher transmissibility |
| 42 | values were detected corresponding to higher transversal solicitations for the driver (it must be |
| 43 | however observed that in most cases this higher values only ranged from 1 to 1.25). |
| 44 | Along the Z axis, the transmissibility was always the same (around 0.7, except on the asphalt where it |
| 45 | was slightly lower), regardless of the presence of ballast and implement. |

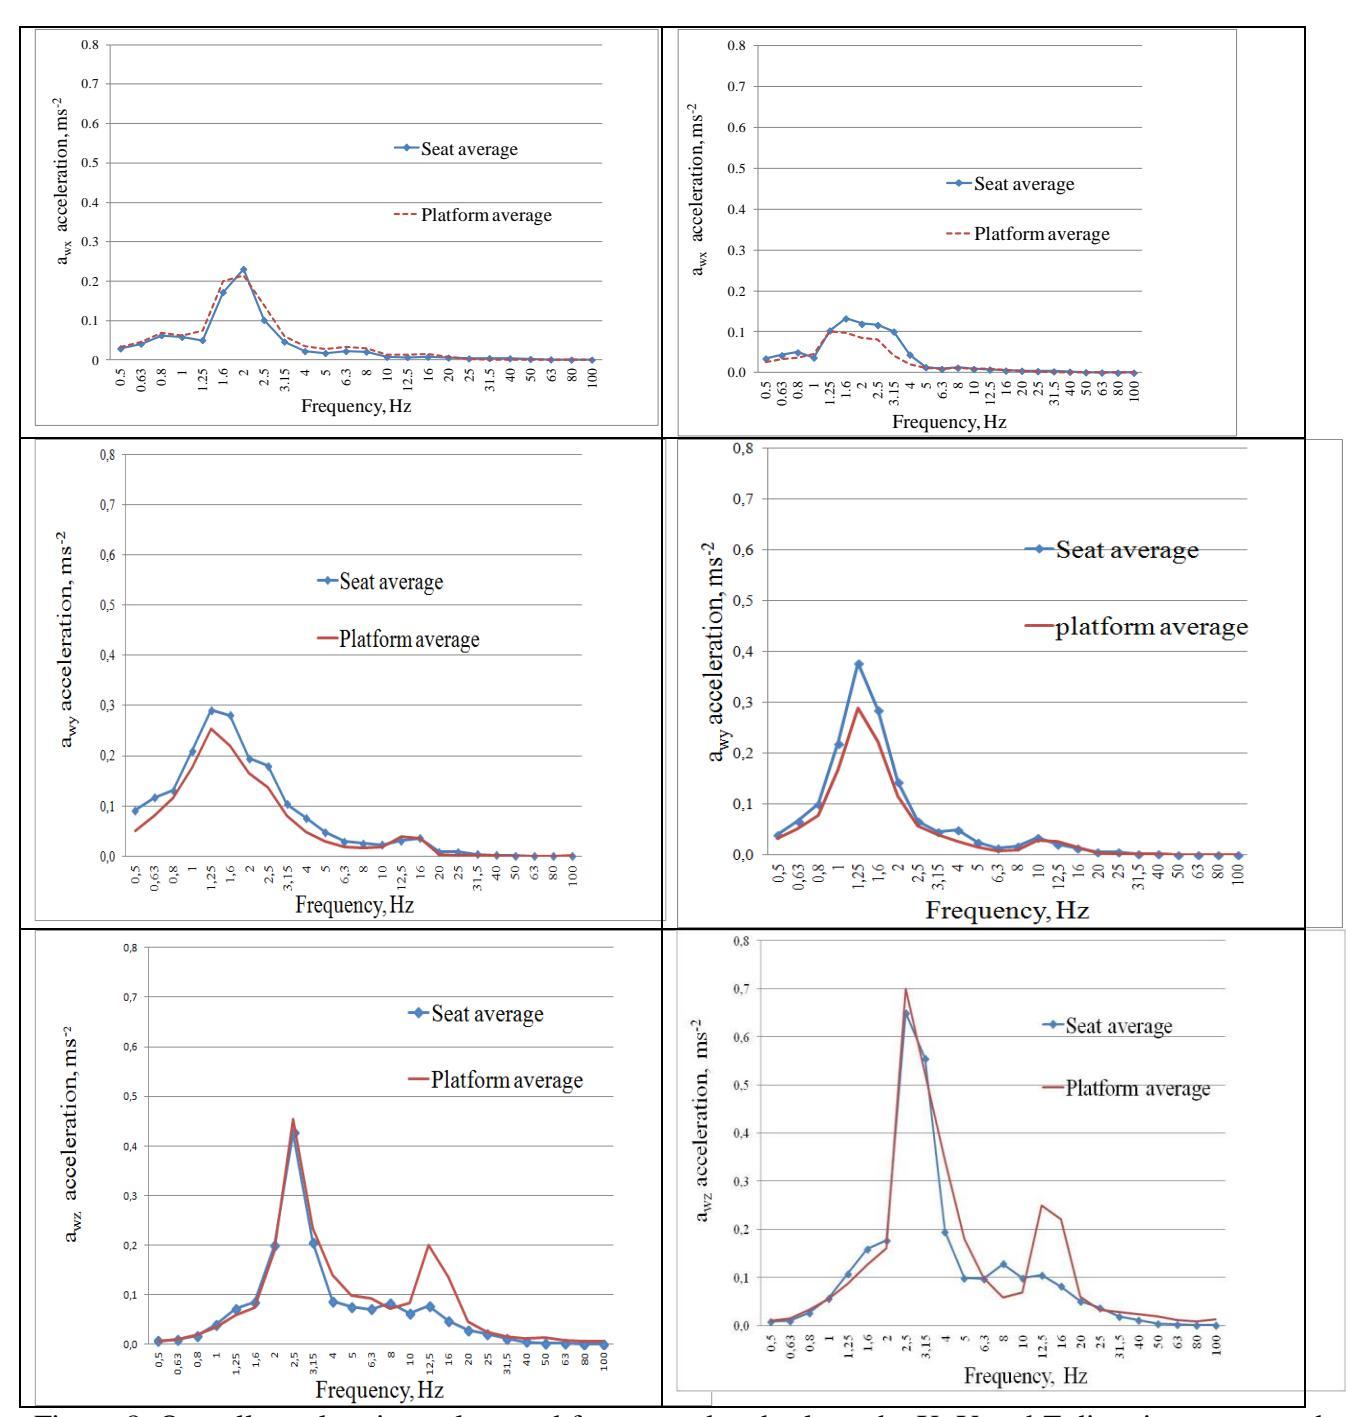
Figure 8. Overall acceleration values and frequency bands along the X, Y and Z direction, measured on the seat and on the platform of the tractor running on the grass at 2.78 m/s with the implement (left) and without the implement (right).

In Figure 8 are reported the frequency spectra in one-third octave bands obtained on both the platform and the seat of the tractor crossing the grass at 2.78 m/s without and with the implement (raised from the ground). Along the X and Y axes the acceleration values measured on the seat were higher than the same obtained on the platform (first 4 graphs in Figure 8), especially when the machine was without the implement. In the last 2 graphs of Figure 8 it is instead noticeable how the accelerations on the seat were lower than the same values obtained of the platform, to confirm that the seat was correctly working as it dumped the vertical solicitations along the Z axis.

Along the longitudinal X axis the vibration energy was between 1.25 and 5 Hz (Figure 8) both with and
 without the presence of the implement.

14 Analysing the energy distribution along the transversal Y axis, a remarkable signal amplification on the

15 seat compared to the platform was present, due to the higher seat position. The energy peak was at 1.25

Hz. Because of the frequency cut (-1dB at 1 Hz) caused by the instruments, the signal amplitudes were
 not guaranteed. On the contrary, their ratio was correct and it demonstrated that along the transversal
 direction an acceleration amplification was present on the seat.

19 In the vertical (Z) axis two peak acceleration were recorded: the first between 2 and 5 Hz, the second

- around 12.5 Hz. The largest acceleration response (0.7 ms<sup>-2</sup>) occurred at 2.5 Hz, with the tractor without the implement. The 2.5 Hz is the oscillating main frequency of category A class 2 wheeled tractor (ISO 5007: 2003) [28].
- 23
