SEM-EDS characterization of historic mortar as a tool in archaeometric study: an updated analytical protocol tested on the Roman theatre of Aosta (NW Italy).

F. Gambino · A. Glarey · R. Cossio · L. Appolonia · A. d'Atri · A. Borghi (2022):

SEM-EDS characterization of historic mortar as a tool in archeologic study: an updated analytical protocol tested on the Roman Theater of Aosta (NW Italy)

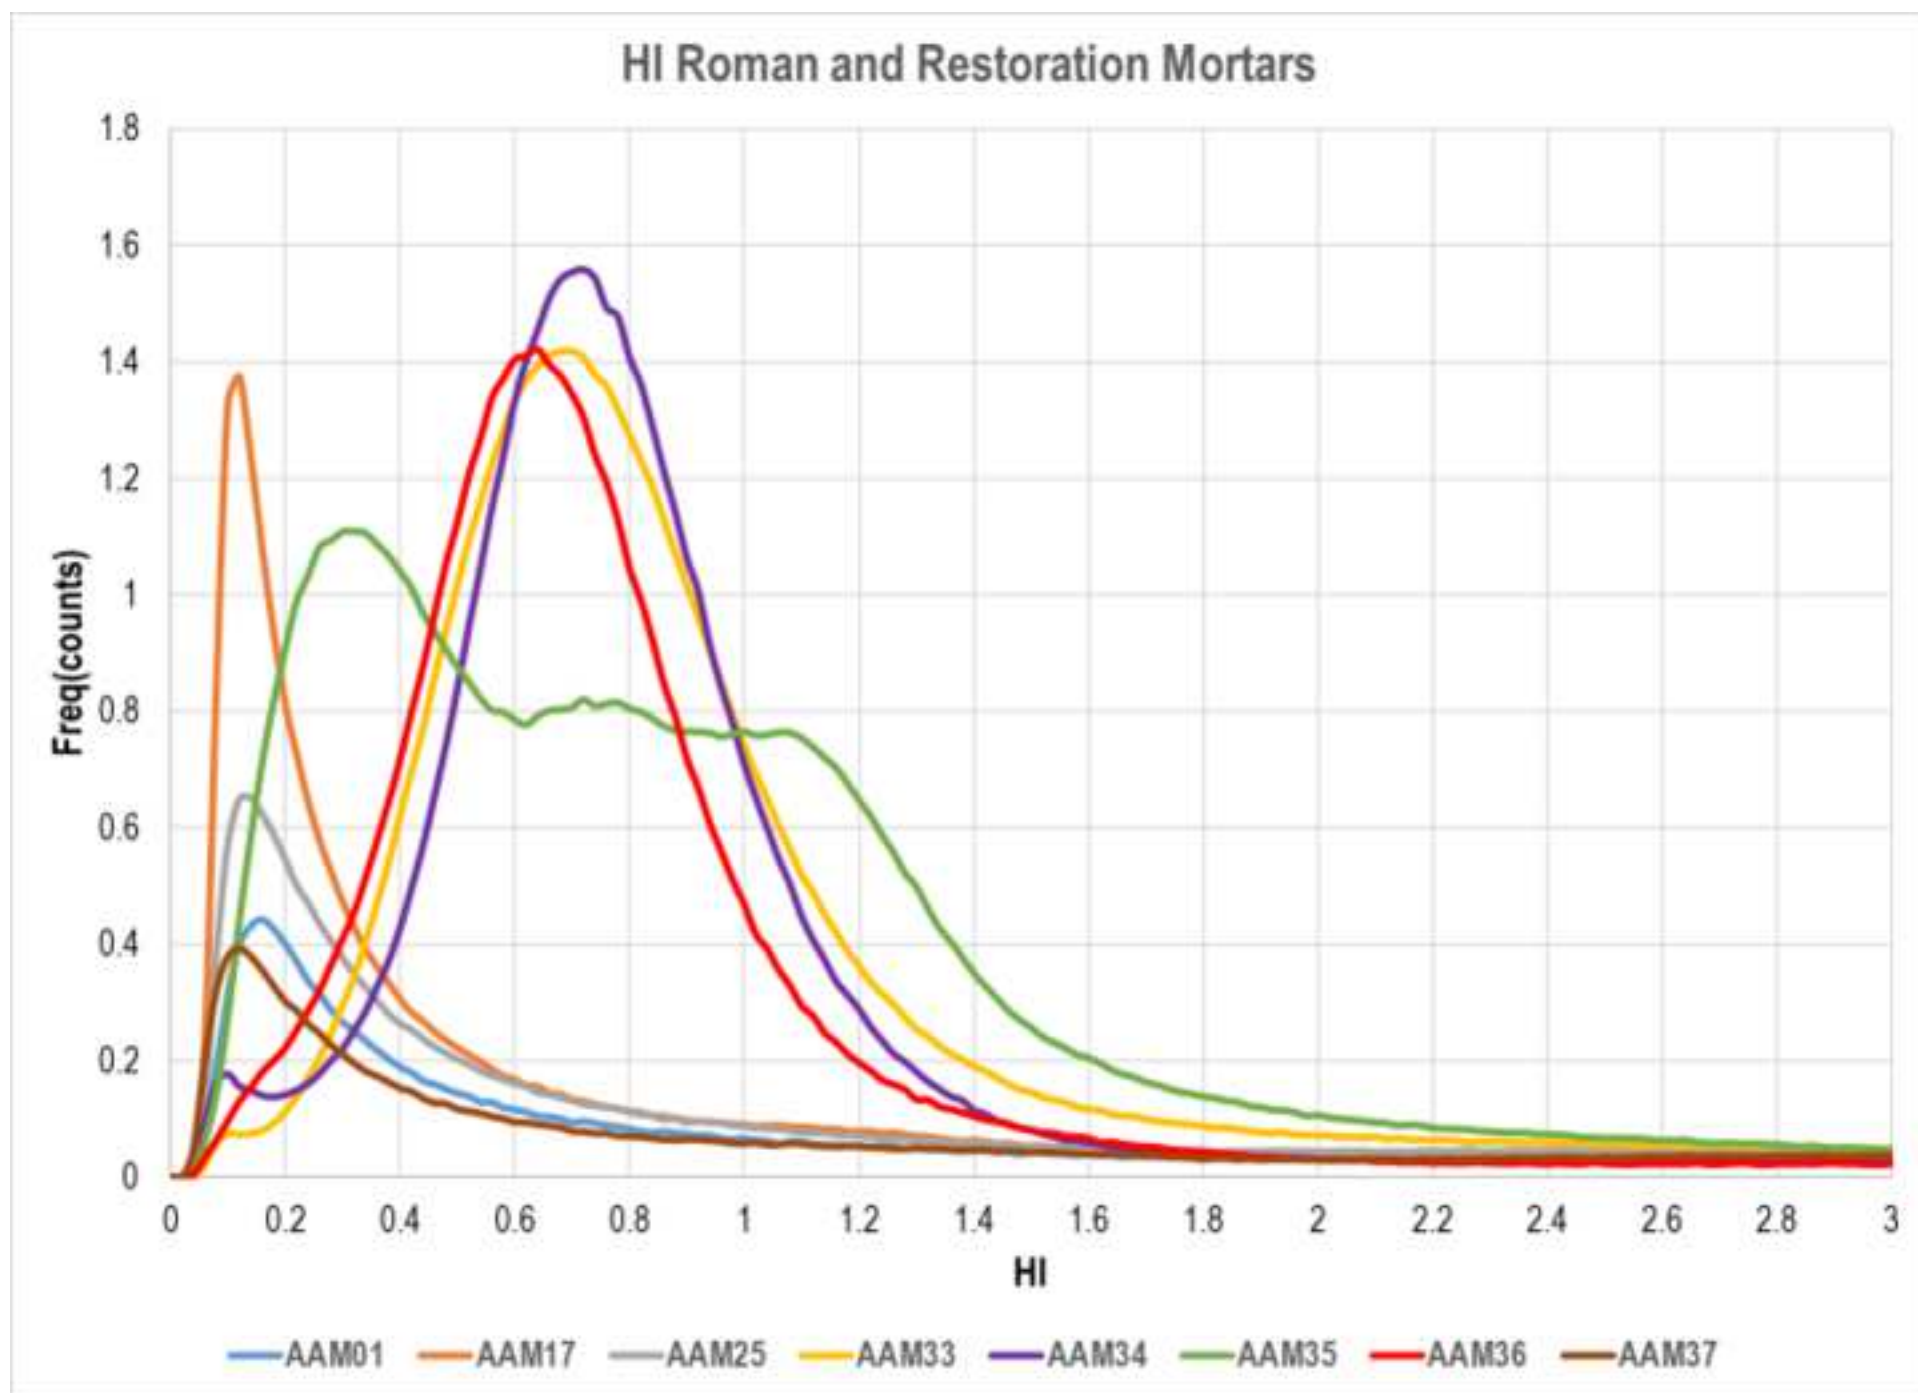
37 **Fig. 11** Histograms of Roman (AAM01, AAM17, AAM25, AAM37) and restoration (AAM33,
38 AAM34, AAM35, AAM36) mortars whose abscissa (500 values) shows the calculation of HI (from
39 >0 to <10) and the ordinate all the values of the percentage calculated on the total number of pixels
40 for each image (Freq(cnts)%).
41
42
43
44
