QLK5-CT-2002-01270

PLYBIOTEST

Biological performance testing methodology to evaluate the durability of plywood as an indicator for exterior construction purposes

**REPORT for the period
01/01/2003 – 31/12/2006
(finalized 10/11/2008)**

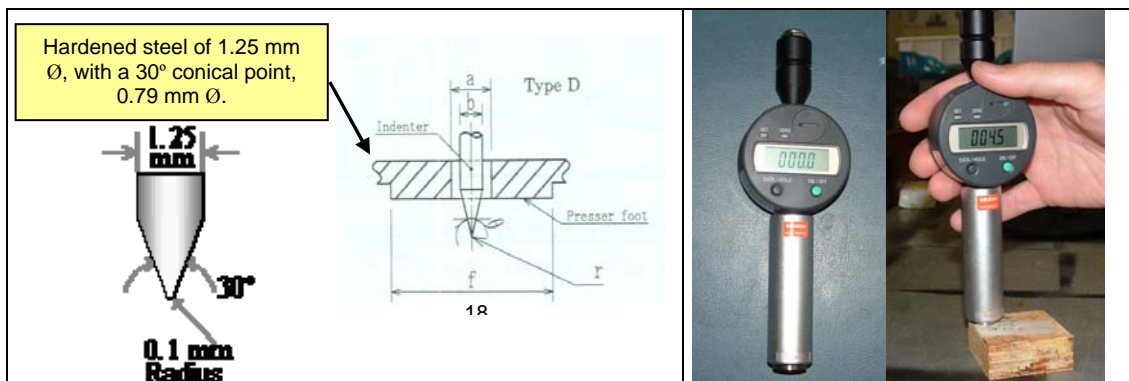
The results obtained during some preliminary tests have confirmed that especially shore D (for its better precision) is a reliable comparative for determining the surface hardness of plywood of the same type and structure (species/composition etc.). In this context it gives accurate results, with a good repeatability, homogeneous values and low standard deviations. Consequently, five different measurements for each sample were done on the reference plywood with shore D portable device. The measurements were made before and after exposure to the ENV 12038 test in correspondence of the four corners and the centre of each specimen.

Figure: Shore D portable device.

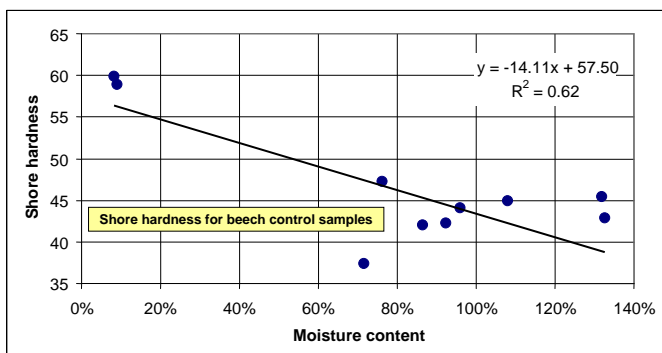
As expected, in the beech sound solid wood samples the shore hardness decreases with the increasing of MC and the same trend was registered for the reference sound plywood samples (see figures below). The results anyway show that generally it does not exist always a high correlation between shore hardness and MC since in some cases (for P3 and S4/S5 we found $r^2 < 0.5$).

For this reason, we stated that shore hardness test values and its relationship with MC may be quite accurate only for homogeneous groups of plywood (same specie and structure).

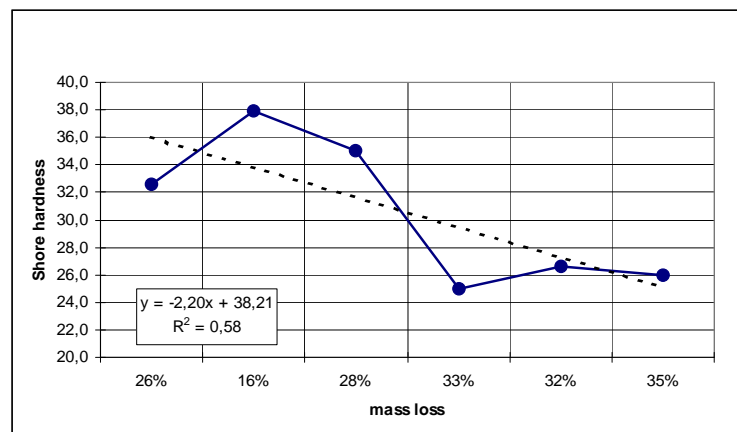
- generally, the analysis of the experimental results highlights that also between shore hardness and mass loss it does exist an high correlation because quite often the shore hardness shows irregular trend with the increasing of fungi attack;
- in some cases (C2 reference plywood) the above correlation gave us an $r^2 < 0.58$;
- considering the different types of samples the results show a different trend in the decreasing of the shore hardness for the same level of mass loss which seems difficult to be explained only for the influence of the different wood density and moisture content of plywood (after ENV 12038 test for Coriolus versicolor F2 samples show an average mass loss of 4.2% against an average decrease of shore hardness of 39%, while C2 samples show an average mass loss of 26% versus an average shore hardness variation of 52%).

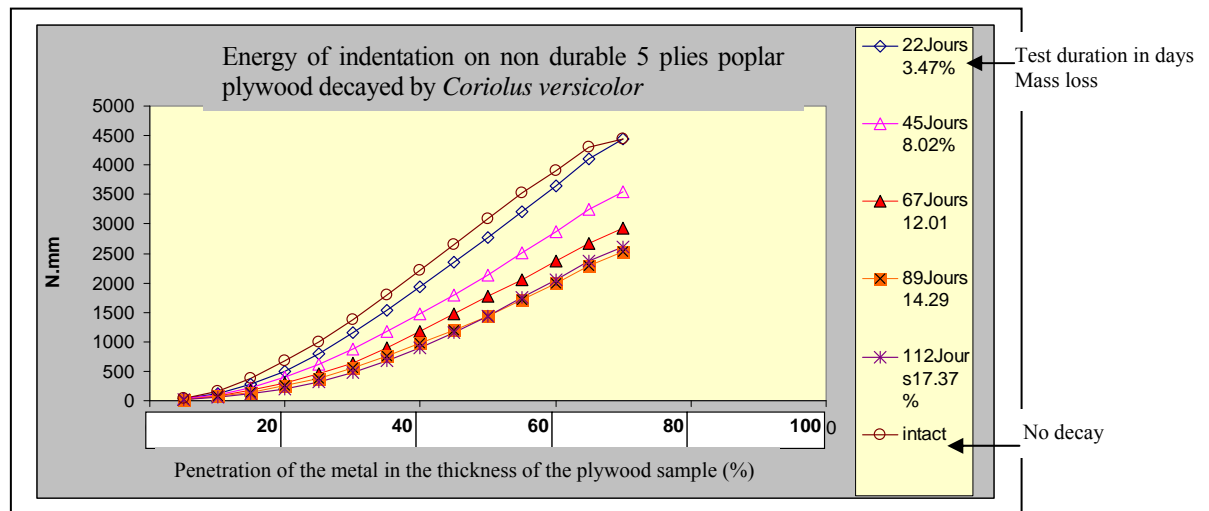
In order to evaluate the potential use of indentation tests to qualify plywood after biological degradation, biological tests were carried out on non durable plywood (5 plies, made of non durable timber, only one timber used per plywood). The biological tests were done according to ENV12038, using *Coriolus versicolor* or *Coniophora puteana*, and the test was stopped at 22, 45, 67, 90 and 112 days (112 days being the total duration of the test). Mass loss was determined and samples were conditioned at 20°C, 65% RH prior to the indentation tests. Mechanical tests were performed only with the samples degraded by *Coriolus versicolor*. *Coniophora puteana* caused too important decay to allow the re-use of the samples. From Figure 1, it can be seen that the energy of indentation can be correlated with the mass loss of the sample. Moreover, the curves obtained can explain the behaviour of the plywood.

Figure 1. Energy of indentation obtained on poplar plywood decayed by *Coriolus versicolor*.

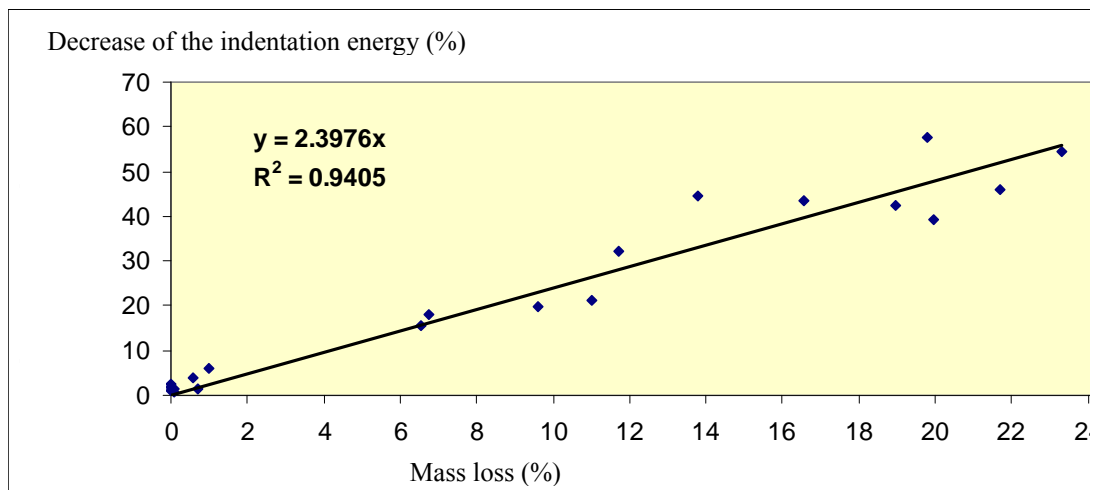
In the same manner, indentation tests have been done after fungal exposure to *Coriolus versicolor* (for 16 weeks according to ENV 12038) on experimental plywood. For each case, the mass loss was correlated to the decrease of indentation energy (decrease between non-decayed samples and samples exposed to fungal attack). Figure 2 shows the results obtained for the “pure” durable and non-durable plywood (plywood made of one timber only). These results indicate that this linear correlation is very good, and this for low weight loss as well as for high decay; contrary to ultrasonic measurements, for which decay above 16% could not be linked to a decrease of ultrasonic velocity. Figure 3 shows the same relation established for all the experimental plywood, including the plywood with durable top-veneers. On average, the proportionality between the mass loss and the decrease of indentation energy is 2.5. This indicates that the indentation is a more sensitive test, and that it could be useful to detect the early stages of decay.

Figure 2. Relation between the decrease of the indentation energy and the mass loss due to fungal decay (20 plywoods tested, 12 samples for each plywood).

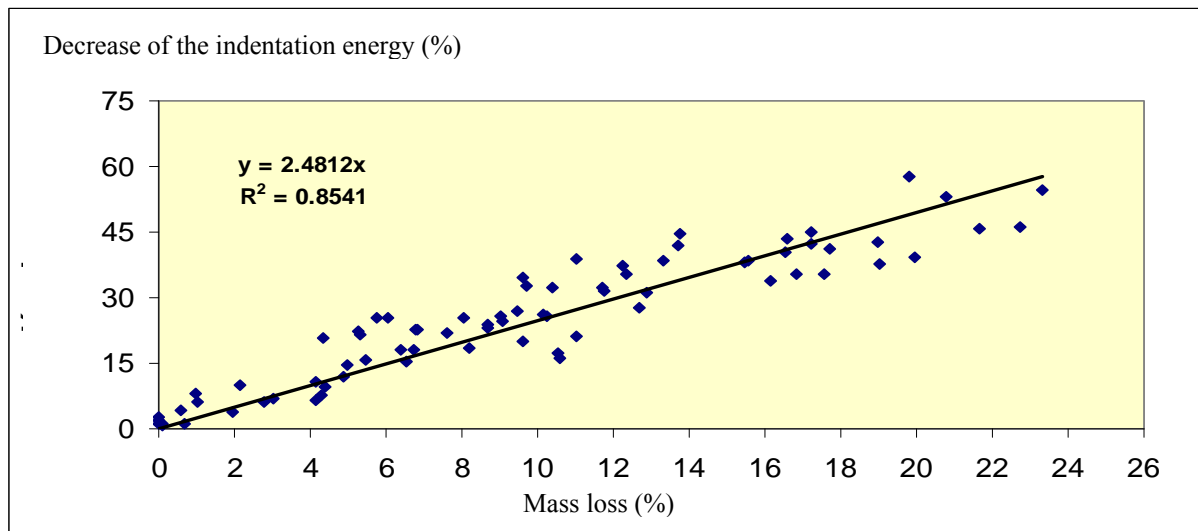
Figure 3. Relation between the decrease of the indentation energy and the mass loss due to fungal decay (96 plywoods tested, 12 samples for each plywood).

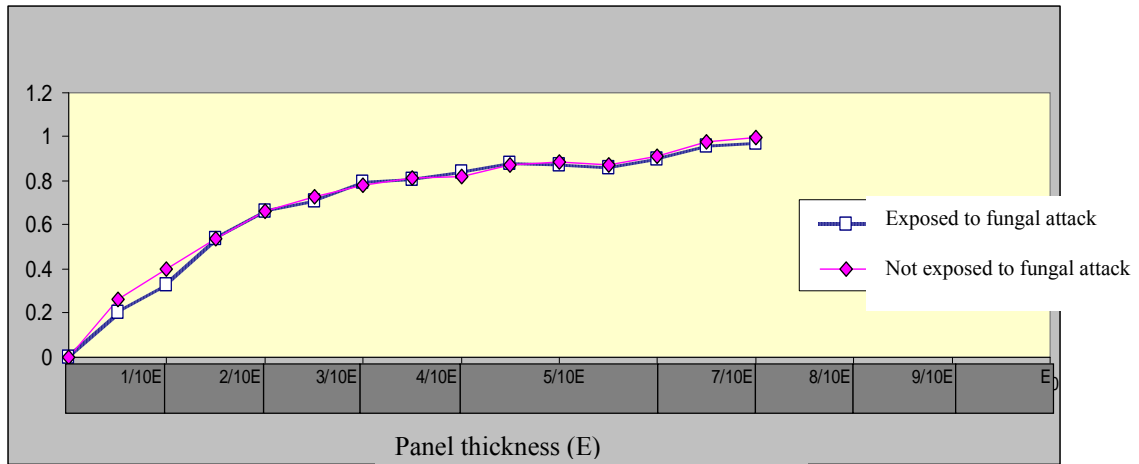
Figure 4. Indentation force for “pure” durable plywoods, made of chestnut, cedar or cypress heartwood.

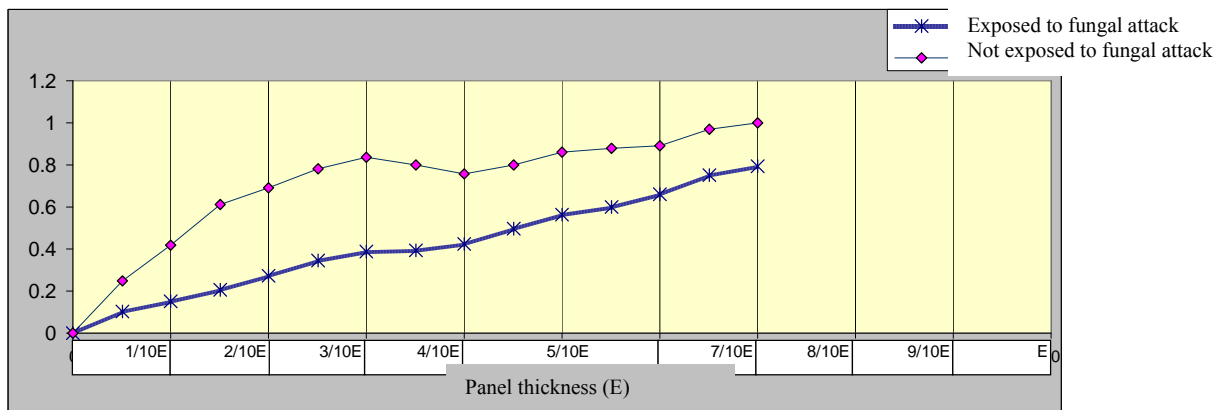
Figure 5. Indentation force for “pure” non durable plywoods, made of poplar or beech.

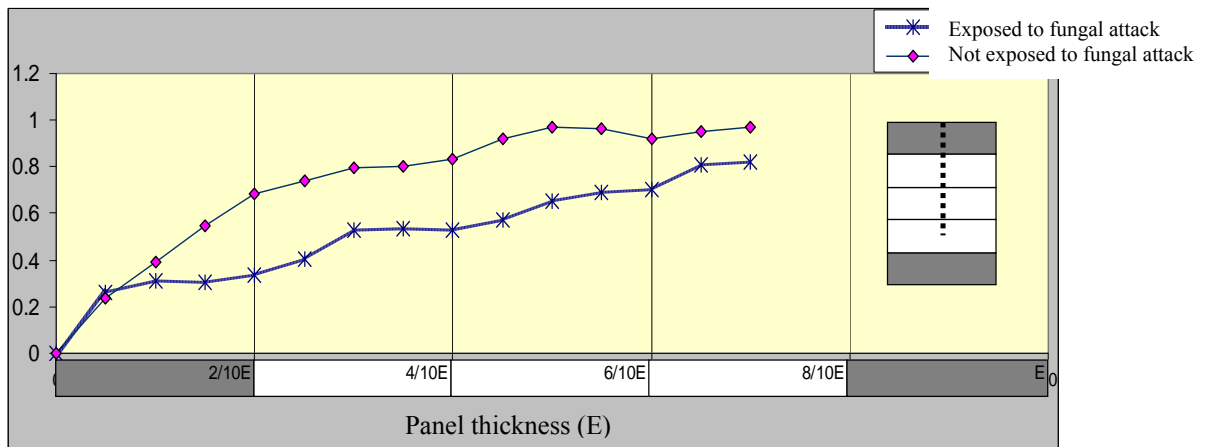
Figure 6. Indentation force for 5 plies plywoods, made of durable top veneers (Model 1)

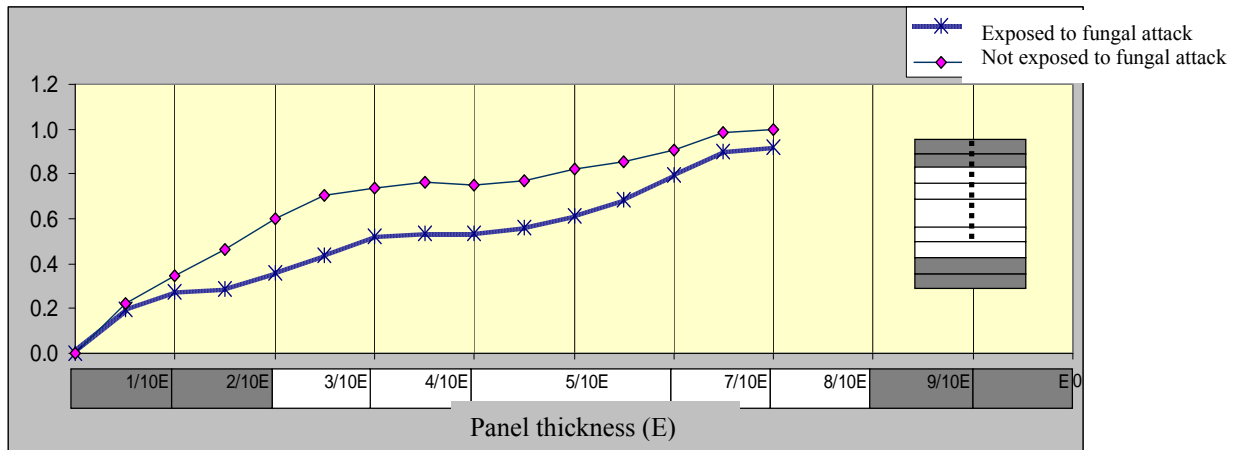
Figure 8. Indentation force for 9 plies plywoods, made of durable top veneers (2 exterior plies on each face) (Model 2)

For the model 2 (figure 8), the average mass loss between all plywood tested was 8.6% against *Coriolus versicolor*. The curves obtained are very similar to those found for the model 1. The difference between the models is the number of plies, and the number of glue lines, thus increasing the resistance towards the fungus.

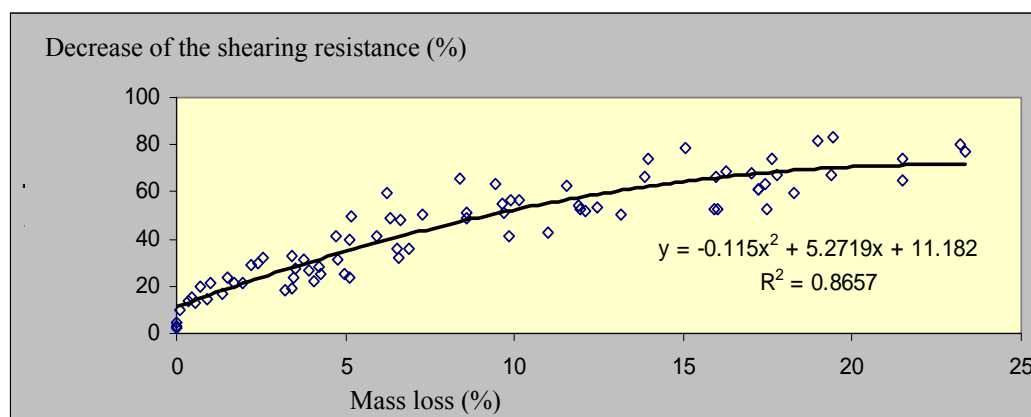
The mass loss of the plywood is well correlated to the decrease of shearing resistance. On average, this mechanical test is 3.5 times more sensitive than the mass loss measurement. The shearing test is the most pertinent test (used in this study) to evaluate the loss of mechanical integrity of the plywood samples.

Figure 9. Relation between the decrease of the shearing resistance and the mass loss due to fungal decay (96 plywoods tested, 12 samples for each plywood).

As the indentation test is extremely little destructive, shearing test was performed afterwards on the same samples. Initial shearing resistance was determined from spare samples of each plywood type. The relation between the decrease of shearing resistance (before and after fungal attack) and mass loss, obtained for all experimental plywood types, is presented in Figure 9.

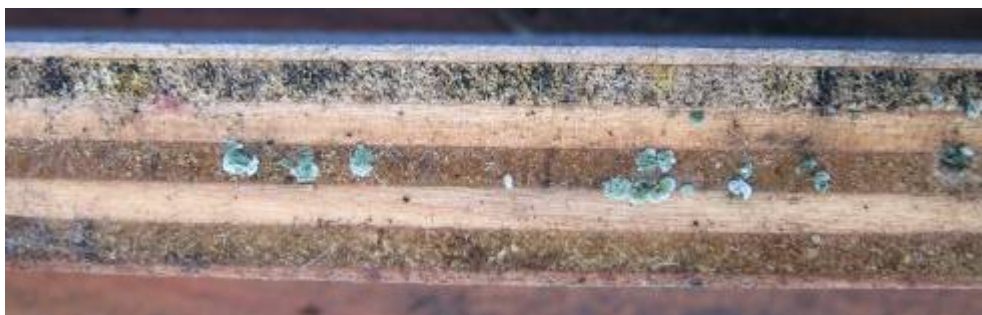
Figure: Beech/Poplar, C4 Mycelium on edges

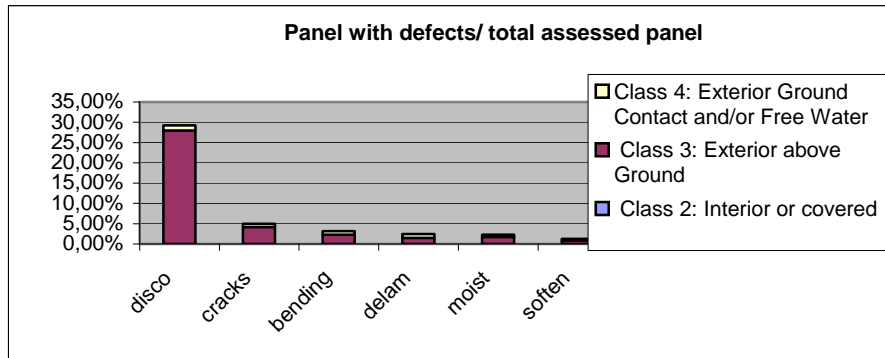
- Rot has been detected in only 1,2 % of the 1700 assessed plywood panels
- These results occurred in:
 - 5 types of plywood
 - Major in hazard class3 situations (80%)
 - In continental and oceanic climates
 - From 0 to 30 years old

Figure 1 Panels with defects / total assessed panels by type of defects

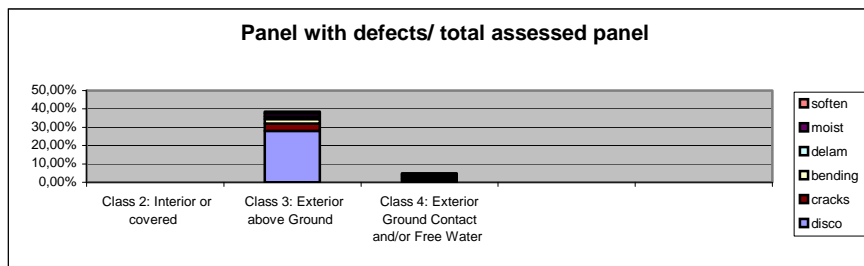
Figure 2 Panels with defects / total assessed panels by Hazard Class 2, 3 and 4

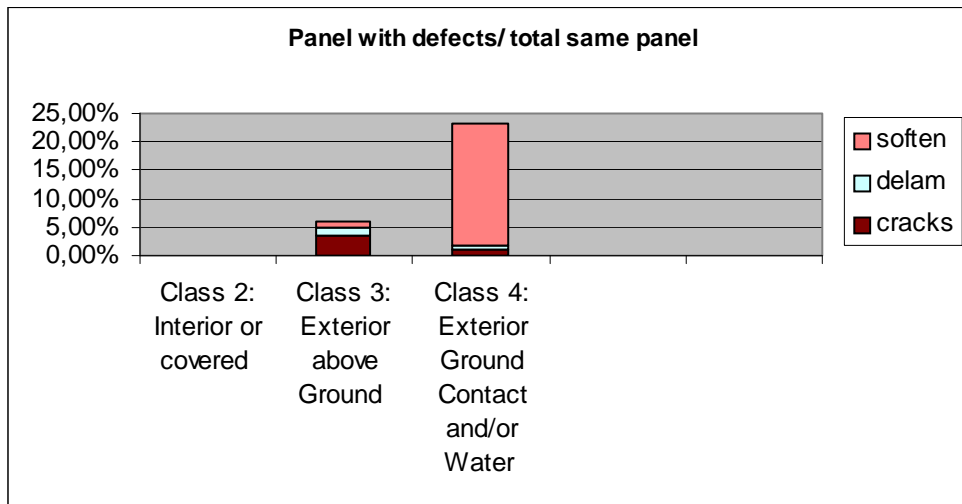
Figure 3 Panels with defects / total assessed panels by hazard class

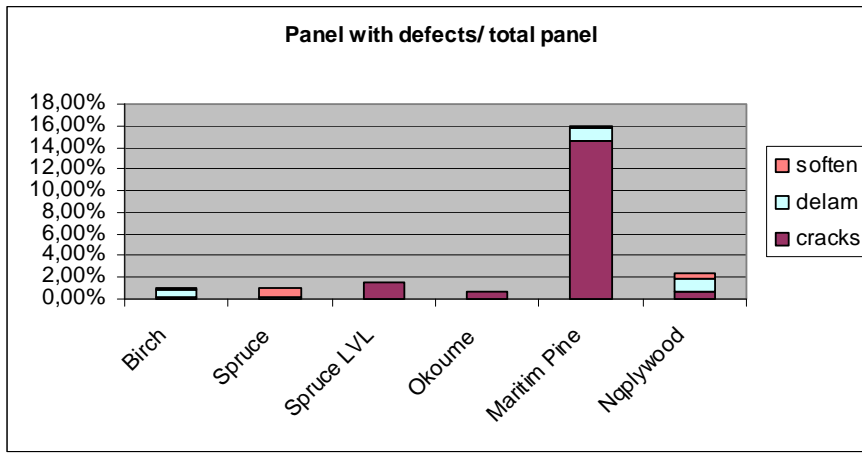
Figure 4 Hazard Class 3 situations, panels with defects / total assessed panels by type of panel

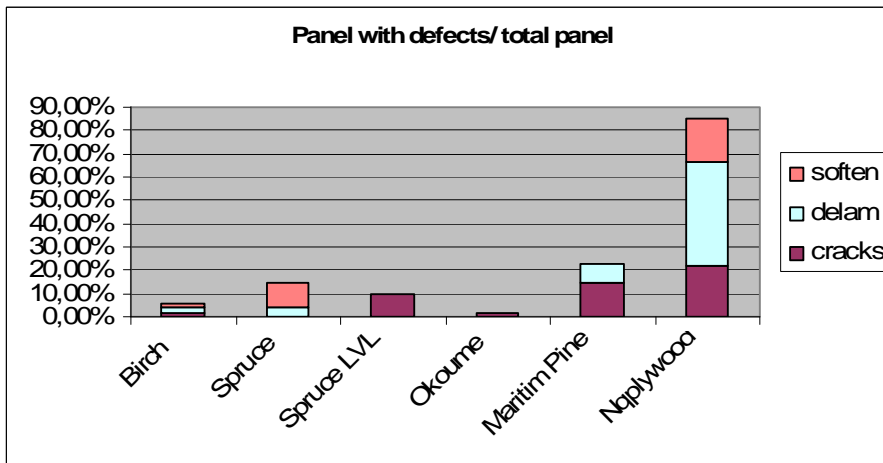
Figure 5 Hazard Class 3 situations, panels with defects / total assessed panels of the same category by type of panel

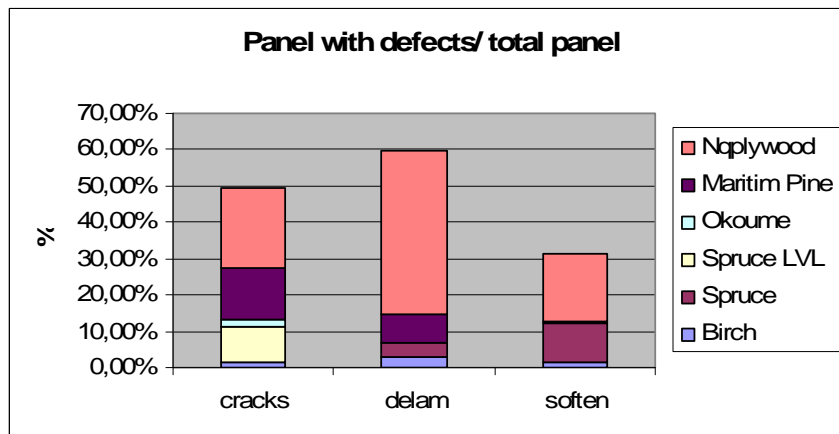
Figure 6 Hazard Class 3 situations, panels with defects / total assessed panels of the same category by type of decay.

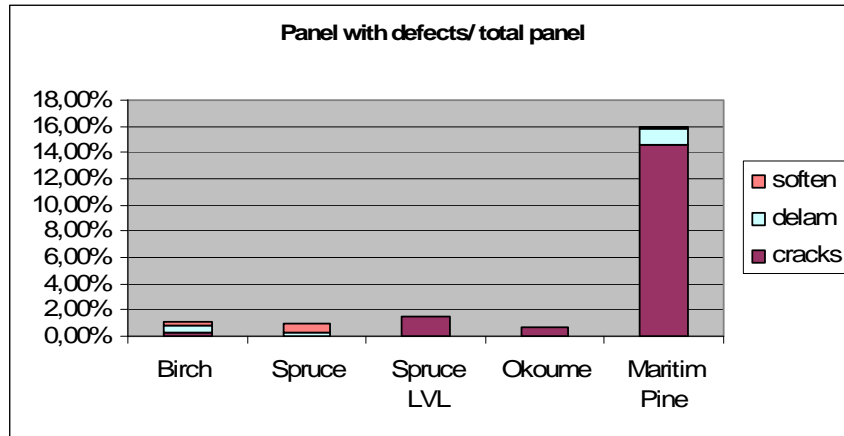
Figure 7 Hazard class 3 situations, panel with defects/total assessed panels by type of panel.

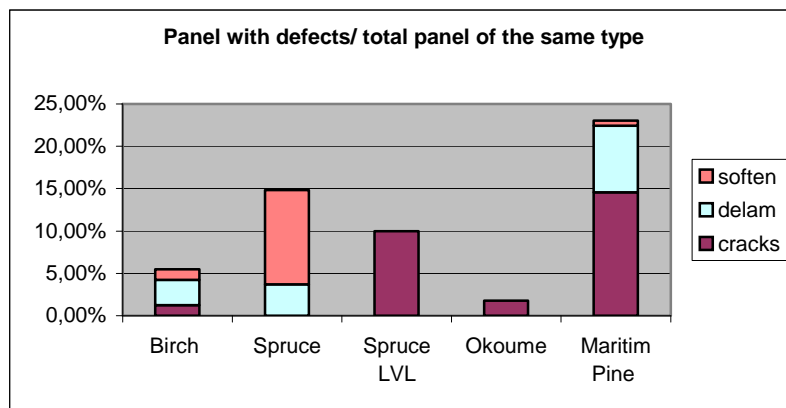
Figure 8 Hazard class 3 situations, panel with defects / total assessed panels of the same category by type of panel.

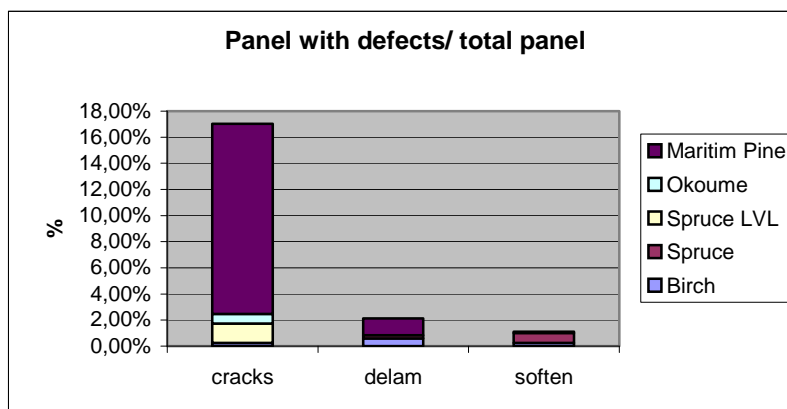
Figure 9 Hazard class 3 situations, panel with defects / total assessed panels of the same category by type of decay.

Looking for decay rot has been detected in only 1,5 % of the 2000 assessed plywood panels. It has been detected in spruce, birch, and maritime pine plywood.
