A new experimental snow avalanche test site at Seehore peak in Aosta Valley (NW Italian Alps) - Part II: Engineering aspects.

A new experimental snow avalanche test site at Seehore peak in Aosta Valley (NW Italian Alps) – Part II:

engineering aspects

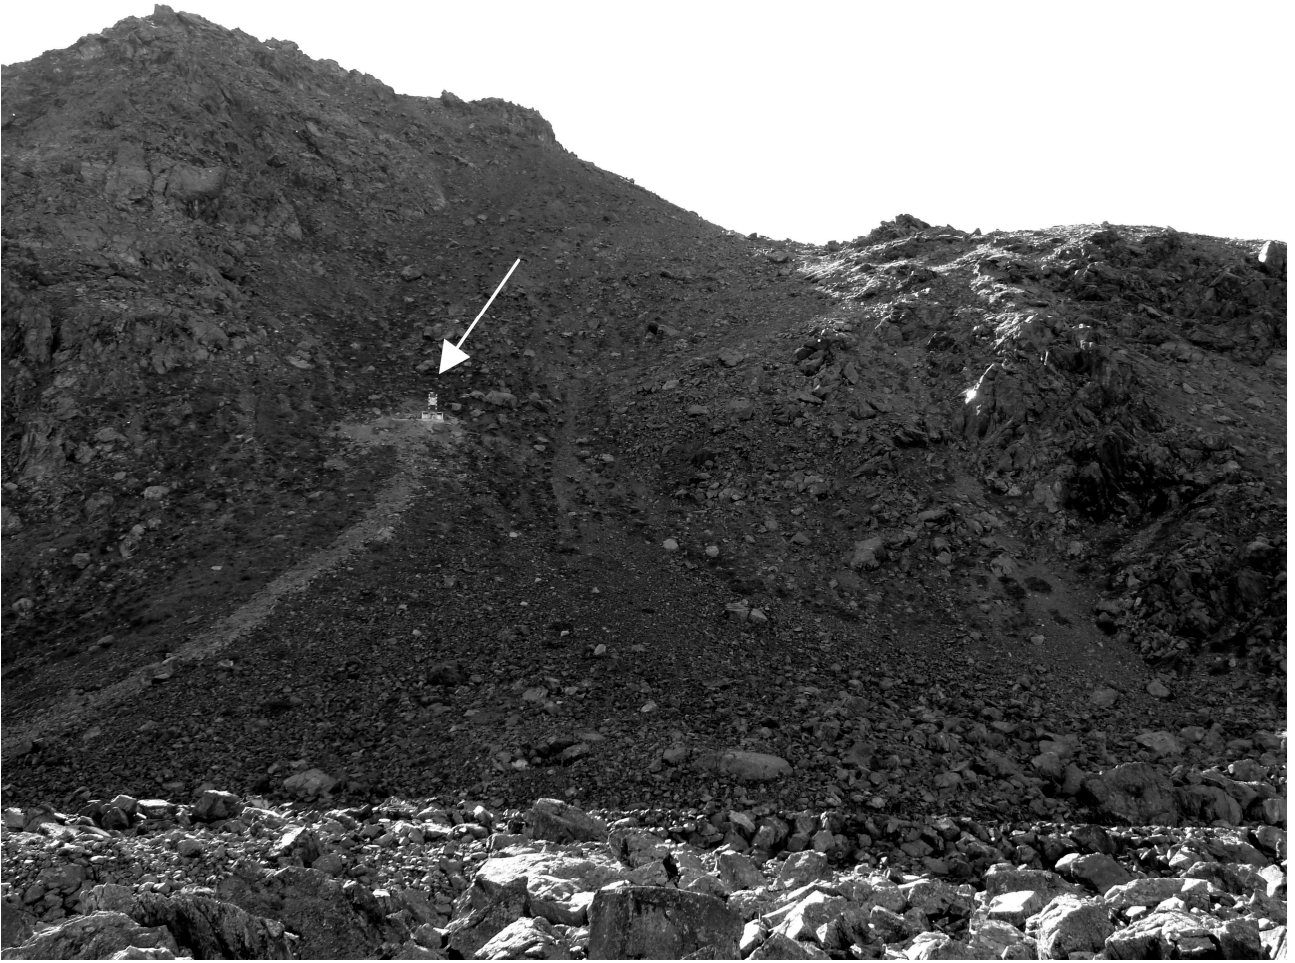
Figure 2: Frontal view of the test site in summer. The arrow marks the obstacle position.

Close to the location of the instrumented obstacle the following types of coverage were observed (see Figure 2):

Gravitational deposits of a scree and an alluvial fan: it is mostly very coarse material, consisting of angular blocks typically of decimetre size, but also larger, practically without fine matrix, at least on the surface;

Accumulation of rockfall blocks: these are very coarse deposits, sometimes with metric-sized blocks.

The obstacle and the measurement systems rest on a concrete slab 3m long by 3m wide and 0:6m thick, placed approximately in the position shown in Figure 2. They were designed to resist the impact of avalanches running along the path and to measure velocity and impact forces. The foundation was embedded so that it emerges only 0:6m from the natural slope. Gabions filled with material readily available on site were used to support the excavation; this choice helped to minimize the environmental impact, also reducing the amount of concrete to be cast in place (Figure 3).

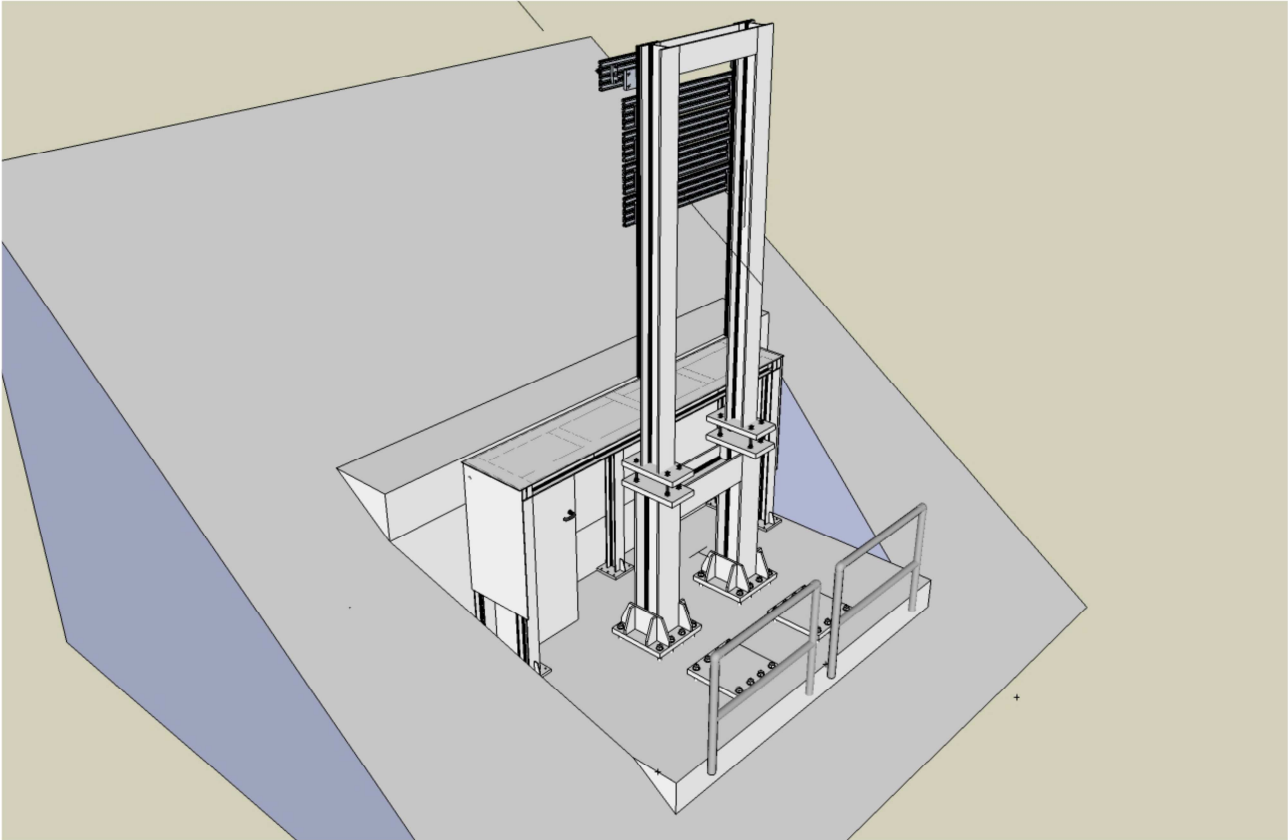
Figure 3: Sketch of the platform with the obstacle and the shed behind.

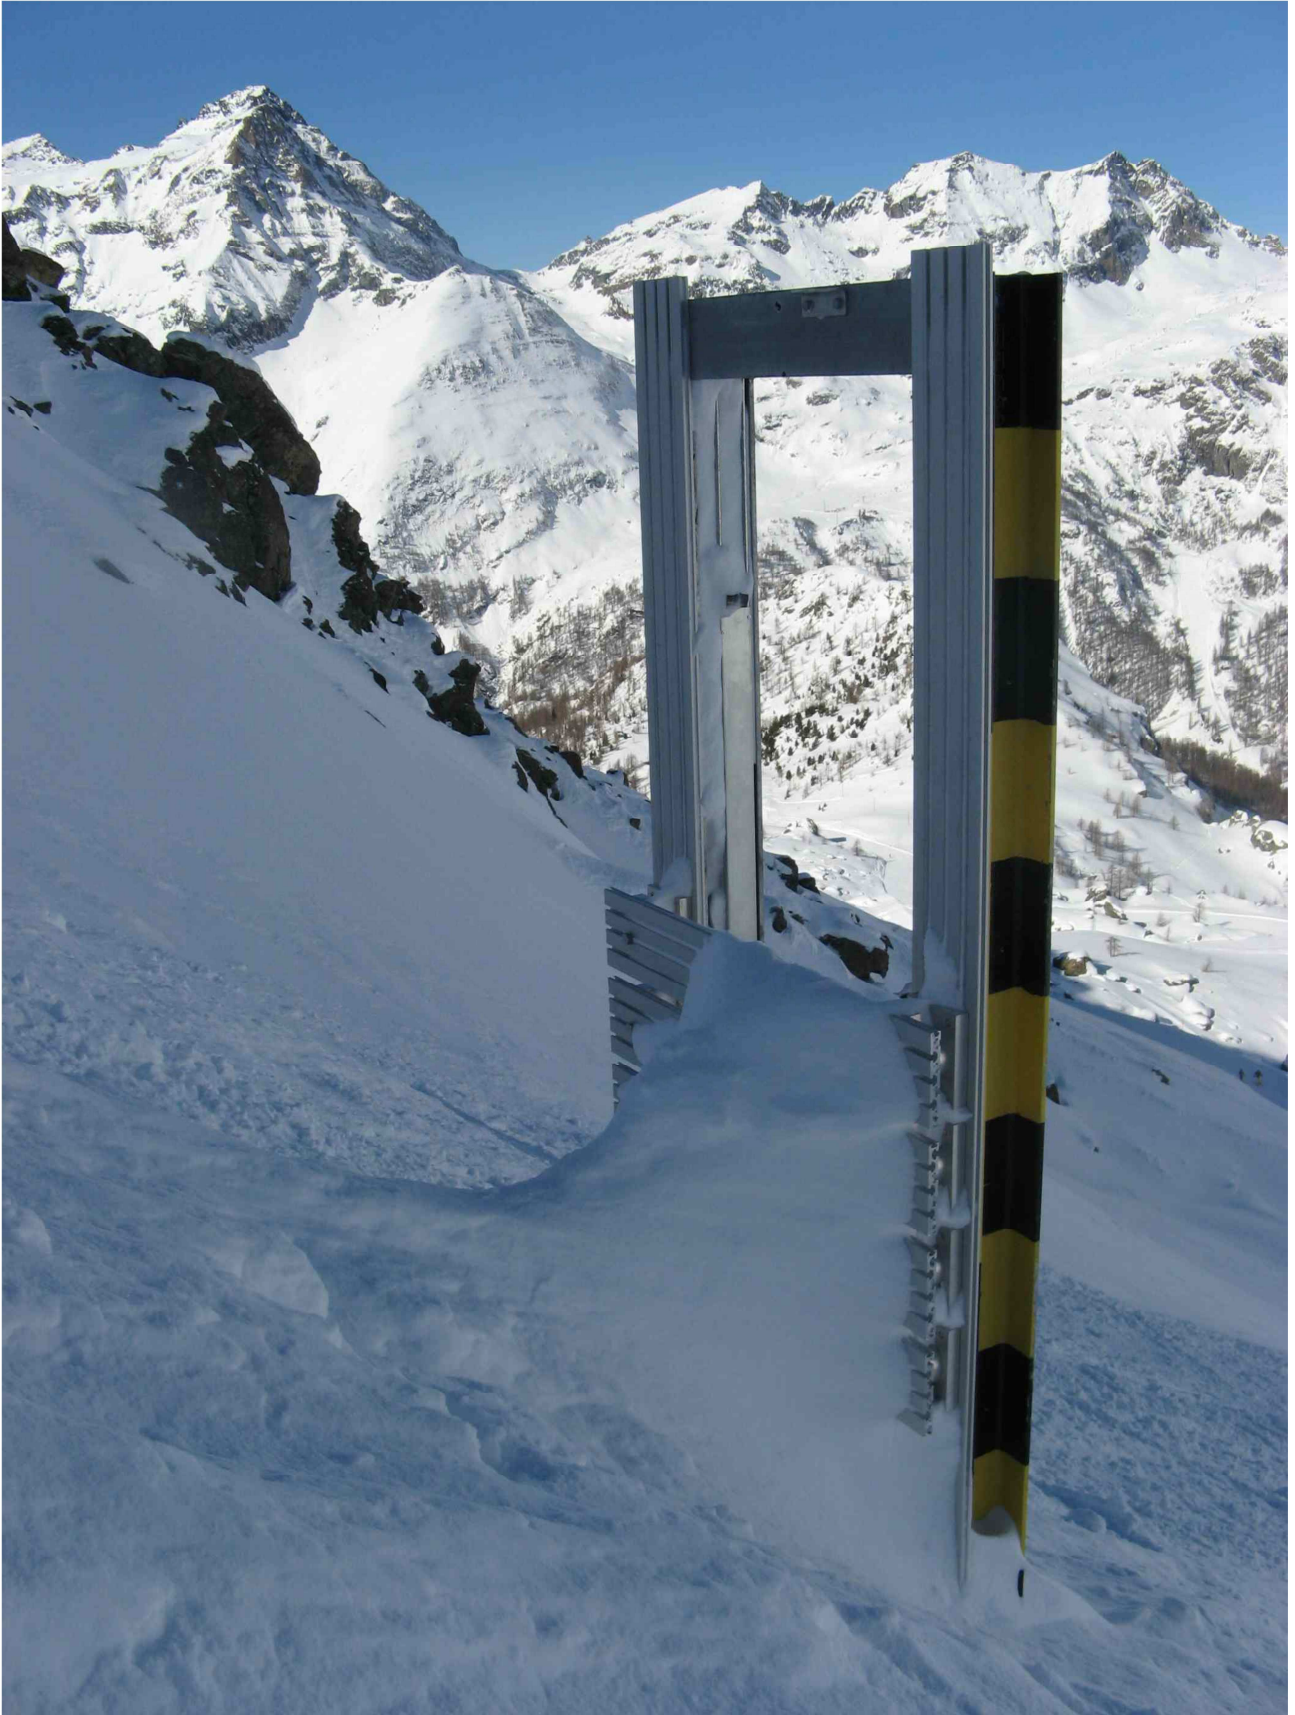
Figure 4: View of the obstacle after an avalanche event. Only the upper part of the steel structure emerges from the snowpack.

The following main parts were assembled (Figure 4):

1. a vertical obstacle made of galvanized steel profiles (4:0m high, protruding 2:8m from the natural slope profile), consisting of a lower section bolted to the concrete foundation, serving as a support for the upper part which carries the sensors, directly exposed to the avalanche impact;
2. a sealed electric cabinet that hosts the acquisition and control systems, terminal

146 The impact surface is made of an array of 5 aluminum grooved plates placed at
different heights, each one supported by two load transducers, which are connected to
the structure. The load transducers are, in turn, mounted on slides that can be easily
moved along vertical guides: this design permits their positioning at the desired height
above the ground level. The total area of the impact plates is 1m² (Figure 4).

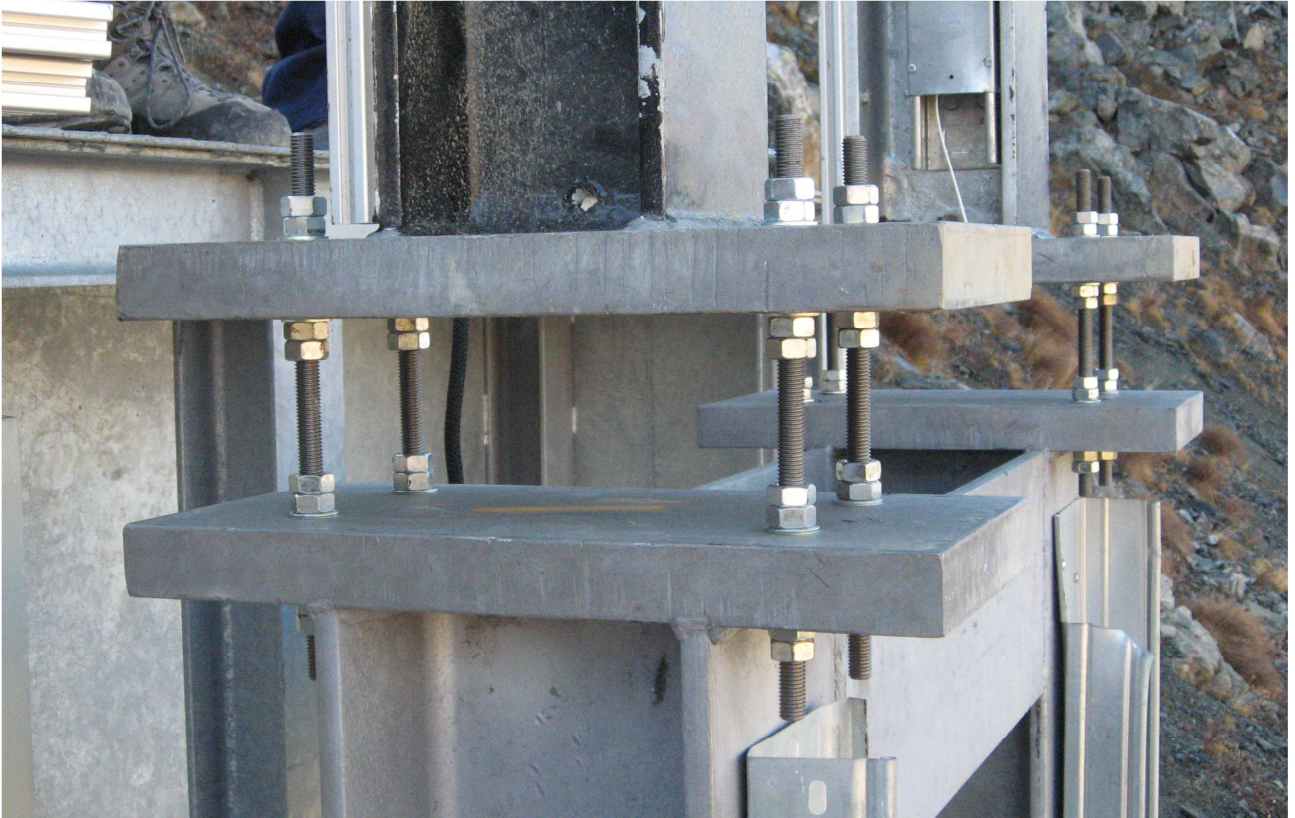
Figure 5: Detail of the load limiter device linking the two parts of the obstacle.

To ensure adequate safety margins to the platform in all the operating conditions, the decision was made to limit the load on the foundation, by sacrificing the structural integrity of the instrumented obstacle when an impact force would reach the prescribed limit value. To this purpose, the link between the lower and upper parts of the obstacle was designed as a weak point with a predefined limit load (Figure 5). The design followed the rules of capacity design, i.e., the increasing loads activate a prescribed sequence of failure mechanisms. According to these principles, the design of the structure is calibrated in such a way that the foundation would always be safe, even under extreme events.

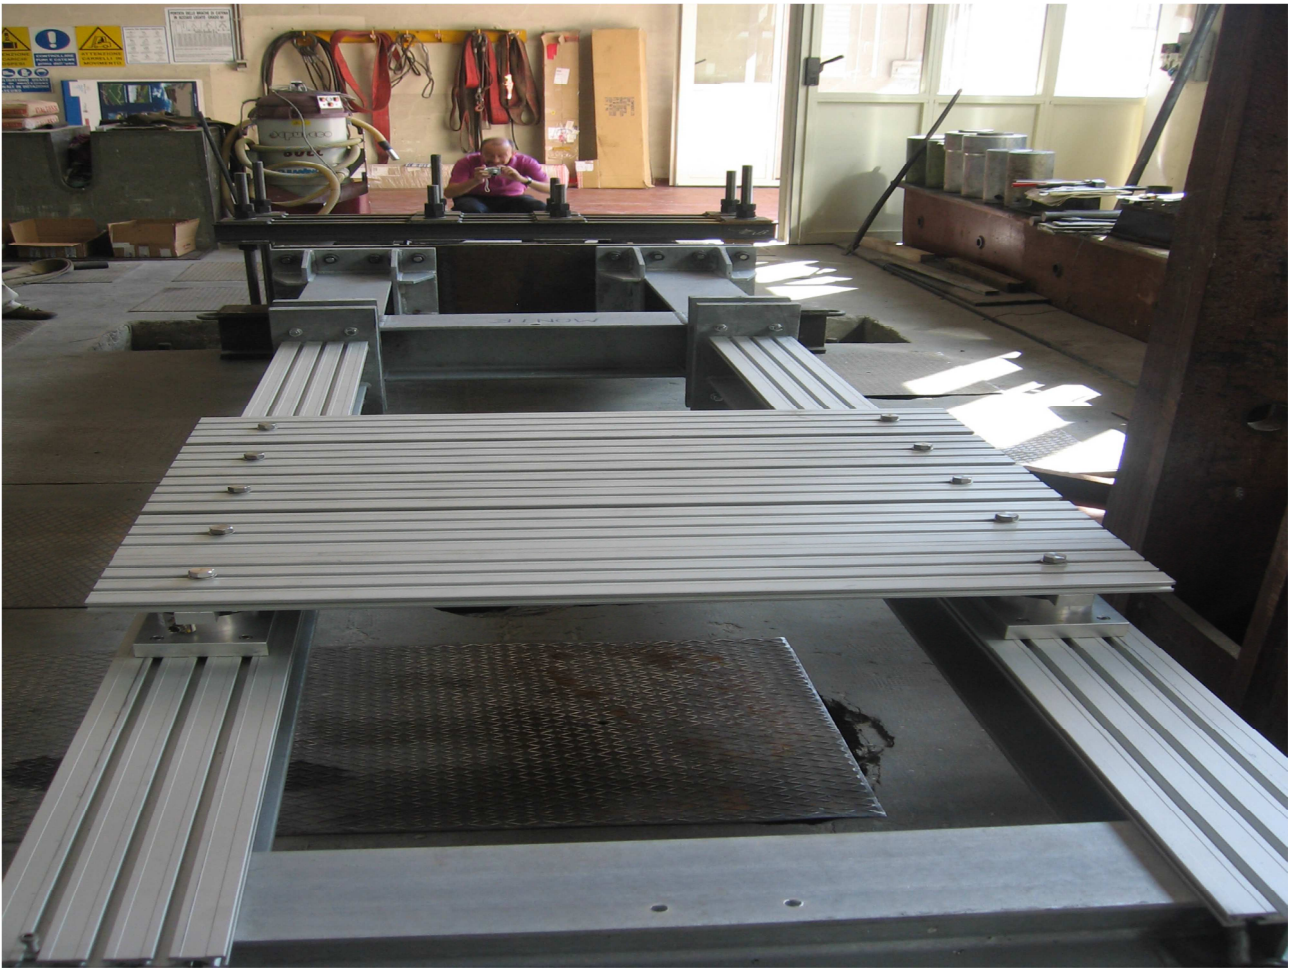
Figure 6: The obstacle mounted in horizontal position as tested in the laboratory.

In order to validate the design assumptions, a number of tests have been carried out at the laboratory of structural mechanics of the Department of Structural, Geotechnical and Building Engineering of the Politecnico di Torino. The complete structure had been assembled within a specially built testing frame in order to place the obstacle in a horizontal position (Figure 6).

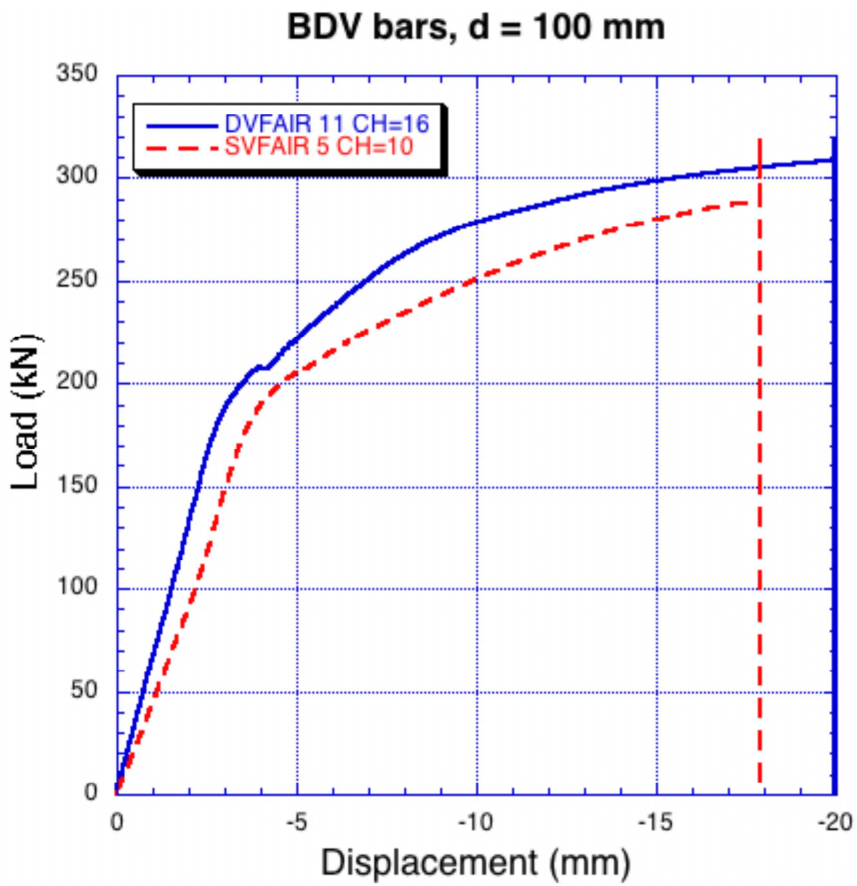
Figure 8: Total load vs. relative displacement for left (dashed) and right (solid) load limiter device (distance

of load limiter plates equal to 100 mm).

In addition, static tests leading to failure of the load limiter device have been conducted, simulating different real loading conditions. Some results are presented in

Figure 8, where the total load applied by the testing machine on the obstacle is plotted against the relative displacement of the load limiter plates. Such tests have been carried

out for different distances of the load limiter plates, i.e., for different length of the steel bars linking the lower and the upper part of the obstacle.

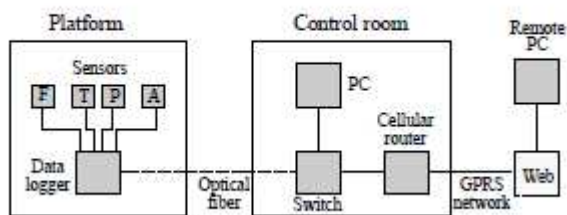
Figure 9: Block diagram of the

communication network of the system. F, T, P, A denote the physical quantities

The system conceived to fulfill the design tasks were divided logically into two main parts, namely, 1) the measuring and data logging part, located on the platform, easily accessible. The two parts are physically connected by a power line and an optical fiber for data transmission, both lying in a buried PVC duct, which ensures a permanent and reliable link. The control room is also connected, via cellular network, to the Internet, providing the possibility of remote operations. A scheme with the connections between the parts of the system is shown in Figure 9.

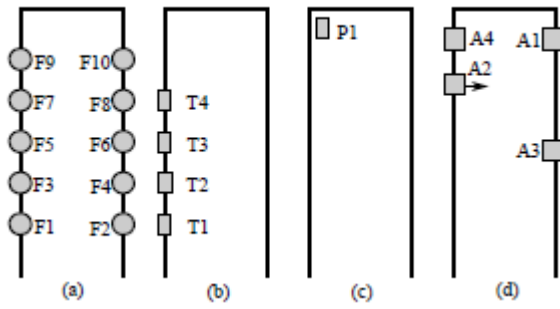
Figure 10: Schematic of the position of the

sensors on the upper part of the obstacle, as seen looking

In principle, any type of devices that measure physical quantities of the impacting avalanches can be installed on the obstacle. The present setup of the measuring system enables the measurement of the impact forces and of the acceleration of the resisting structure. A scheme of the installed sensors is shown in Figure 10.

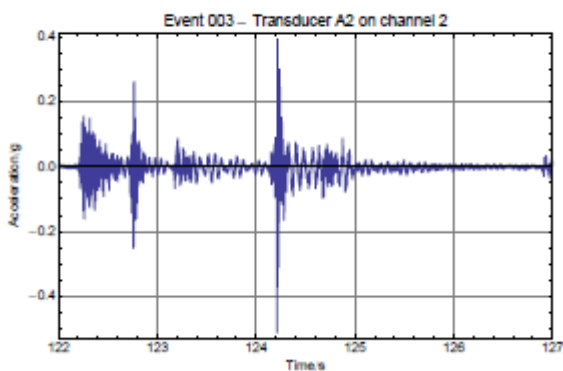
Figure 11: Example of measurements of acceleration plotted vs. elapsed time for an artificially triggered avalanche.

An example of the recorded data is shown in Figures 11 and 12, where the signals obtained from two sensors (an accelerometer and a load transducer), converted to engineering variables, are plotted for a time interval of 5 s beginning about 0:2 s before
