## STUCCO AND CLAY IN THE DECORATION OF THE MONUMENTAL BUILDINGS OF OLD NISA

*Carlo LIPPOLIS*

**Abstract** – Unlike the terracotta decoration and the clay sculpture, the stucco production in Old Nisa has been only marginally studied. This is mainly due to the scarcity of figured materials available. Anyhow, recent excavations<sup>1</sup> have unearthed some fragments of sculptures in stucco and clay, along with double-moulds in gypsum mortar that shed new light on techniques for the manufacturing of sculptures. The manufacturing process of a sculpture is similar for both materials, since the modelling of the figure occurs through the gradual application of layers of clay or stucco (or both) more and more fine and purified. Moreover, for the two materials, is attested both the simple hand modelling and the use of moulds.

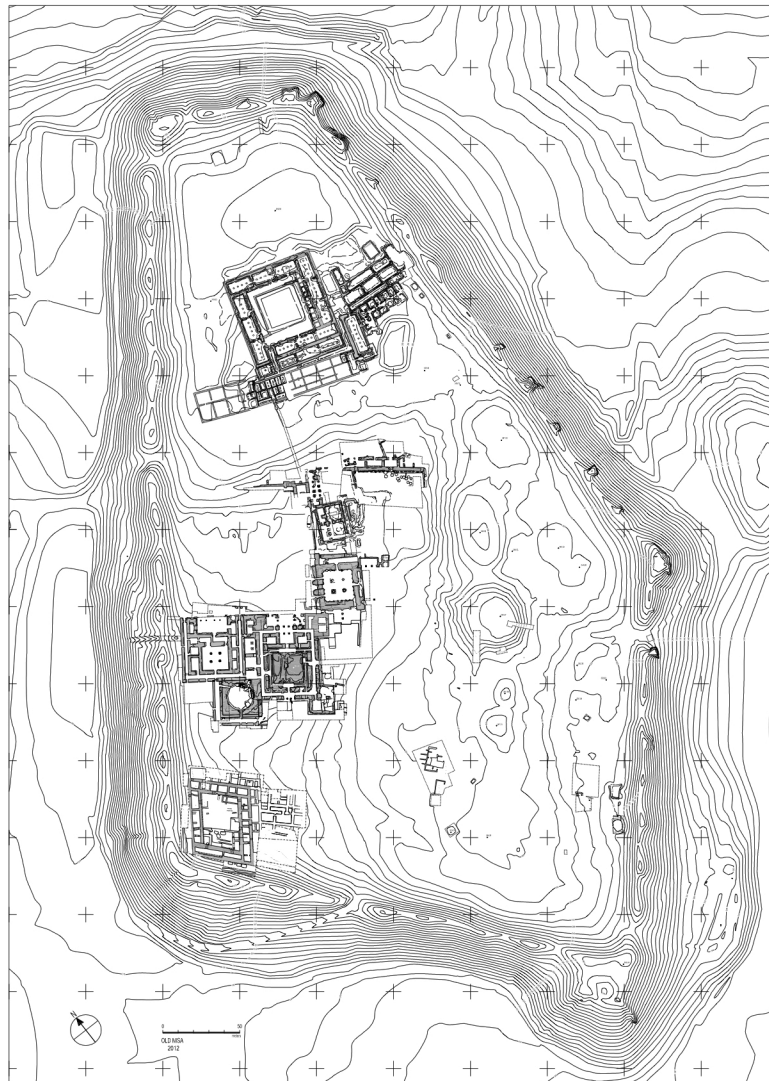
Figure 1. Old Nisa, plan © Archive Centro Ricerche Archeologiche e scavi di Torino

Today, Old Nisa (**fig. 1**) is generally interpreted as a great ceremonial centre dedicated to the glorification and celebration of the first Arsacids, the Parthian rulers, and its main buildings are dated between the 2<sup>nd</sup> cent. BC and the 1<sup>st</sup>-2<sup>nd</sup> cent. AD; it was then abandoned.<sup>2</sup>

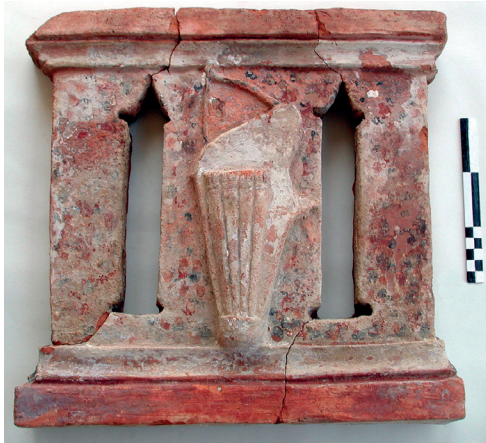
Figure 2. Old Nisa, metope in terracotta from the Red Building © Archive Centro Ricerche Archeologiche e scavi di Torino

The building material employed at Nisa was mainly clay.<sup>3</sup> In terracotta were made, for instance, the so-called metopes (not metopes in a Greek-sense but slabs with a central symbolic motif flanked by arrow/column-like slots: the quiver, the Heracles' club, the lion's head, the Seleucid anchor, the crescent, the circle/sun), decorative slabs with a central rosette or palmette, indented bricks, stepped merlons with an arrow slot, acanthus leaves or plaques with volutes for Corinthian and Ionic assembled capitals (fig. 2-3).

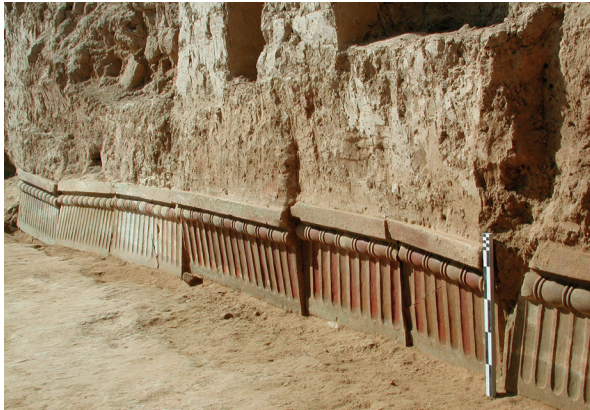
Figure 6. Red Building: stone dado-frieze  
© Archive Centro Ricerche Archeologiche e scavi di Torino

The use of stone is rare in the architectural decoration of Nisa. Indeed, the material is not readily available in the area. From the oldest Parthian levels and especially from the façade of the Red Building comes a stone frieze: the bead-and-reel (astragalos) motif is western in its origin (though not unknown to the Achaemenid tradition)<sup>6</sup> but here it is re-interpreted and displayed not on the top of the wall but in its lower portion, like a *dado*, with obvious functional purposes of protection (fig. 6).

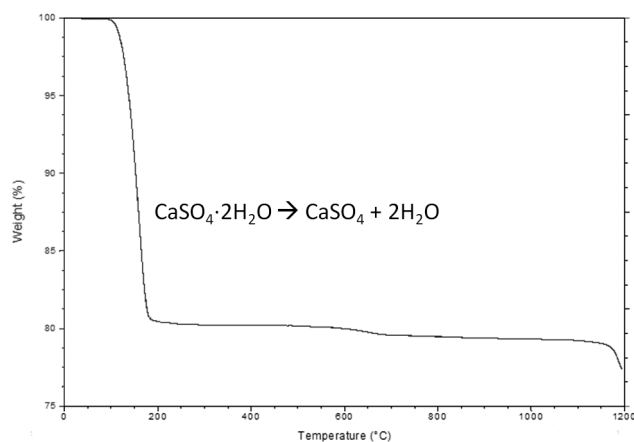
Figure 9. TGA diagram showing the % weight loss according to the increase of temperature, corresponding to the dehydration reaction transforming gypsum into anhydrite

The identification of gypsum over anhydrite was confirmed by the thermogravimetric results that showed a 20% weight loss between 35 and 200 °C related to an endothermic process revealing a two-water-molecule loss.

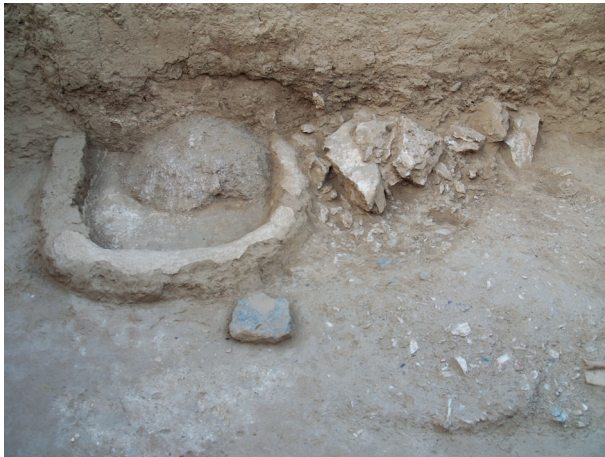
Figure 10. Old Nisa, South-Western Building: basin in room 44 © Archive Centro Ricerche Archeologiche e scavi di Torino

The production process of gypsum-based material may be recognized in some rooms of the recently excavated area (South-Western Area) at Old Nisa. Inside the so-called South-Western Building plastered basins were laying directly on the floor of room 44 (fig. 10). In the corner of two of these basins, two heaps of powdered “anhydrite” agglomerate were found. Immediately beside the basin, some raw blocks and crushed stones of this same mineral were lying on the floor of the room, clearly part of the two previous (i.e. intermediate) processing stages. It seems that here we have installations meant for the processing and production of mortar, plaster or stucco. Moreover, substantial traces of ashes and fire activities, clearly related to the same production process, were lying on the floors of rooms 45a and 45b, adjacent to room 44 where the agglomerates of anhydrite were found.<sup>15</sup>

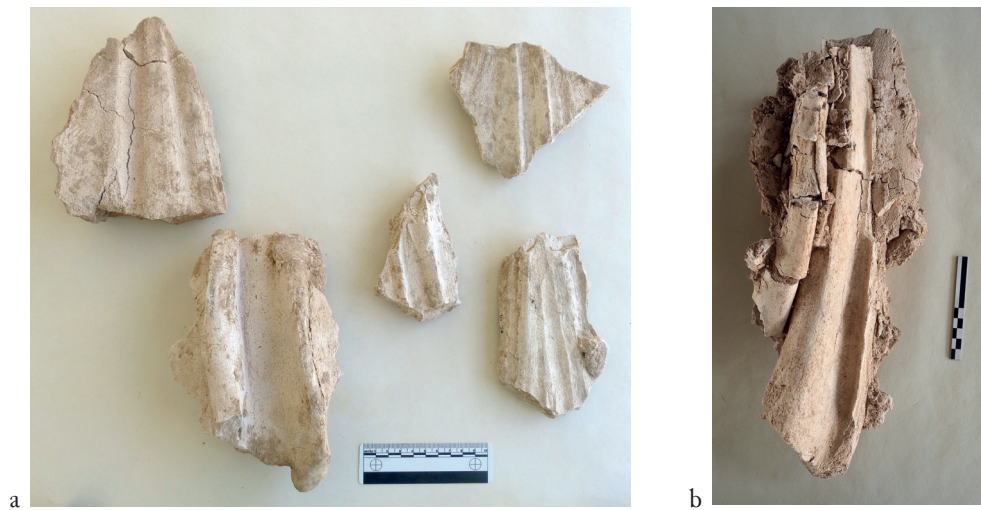
Figure 12. South-Western Building: gypsum-stucco fragments of statues from the pit  
 © Archive Centro Ricerche Archeologiche e scavi di Torino

This finest “plaster” coating is also visible on some fragments of stucco found in a large pit inside the South-Western Building, filled in a late stage with earth, pottery and architectural elements no longer in use (fig. 12). All the stucco fragments depict drapery of garments, and closely resemble similar fragments of clay statues discovered in the Round Hall.<sup>17</sup>

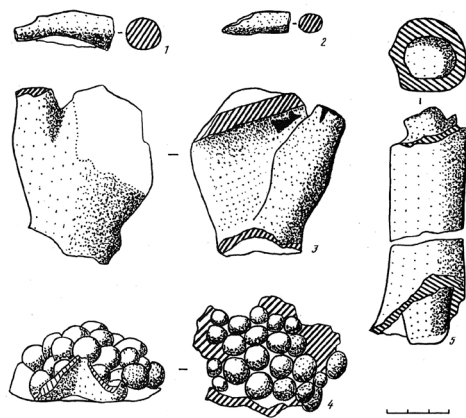
Figure 13. Stuccoes from the area of the Square Hall (after PILIPKO 2001, p. 263)

The fact that they were found in the fill of the pit could be indicative and suggest that they belong to one of the earliest building phases of Old Nisa. It should also be remembered that the few stucco fragments from the Square Hall (they include small plates with embossed edges and few fragments belonging to one or more human figures, at approximately half life size; fig. 13) are usually dated as being prior to its final reconstruction.<sup>18</sup>

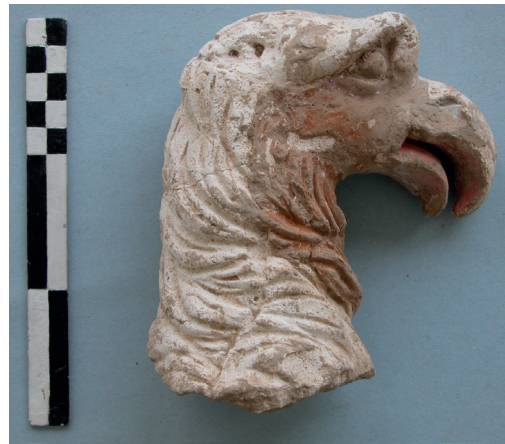
Figure 14. Red Building, southern façade: stucco eagle's head © Archive Centro Ricerche Archeologiche e scavi di Torino

That these two techniques, in clay and in stucco, were closely related is also evident in one final example. From the Red Building's southern façade come a few fragments of a stucco sculpture depicting an eagle (fig. 14). It seems likely that this sculpture, which was life size, belonged to a frieze originally displayed on the walls of the main tetrastyle hall of the building. This is not the place to discuss the symbolism of the eagle among the Parthians, but it is clear that the presence of this iconography on the walls of one of the main buildings of Nisa's ceremonial complex is closely linked to the idea and propaganda of the Arsacid kings. The figure, especially its head and neck, shows a rich and plastic treatment—we can say almost

In the Nisean eagle the colour was not directly applied on the stucco surface, but on a very thin (ca. 2 mm) layer of clay covering it. The application of a thin layer of purified clay on the stucco surface is a further confirmation of how the two production techniques, for stucco and clay sculptures, were similar, the final colouring providing uniformity to the whole and making imperceptible the difference between the two materials.

The stucco eagle(s) of Nisa were not sculptured in the round and were cast by single moulds. The back of the head is hollow and traces of housings for the metal clamps that originally fixed this sculpture to the wall are still clearly recognizable.
