Article

External Marginal Gap Variation and Residual Fracture Resistance of Composite and Lithium-Silicate CAD/CAM Overlays after Cyclic Fatigue over Endodontically-Treated Molars

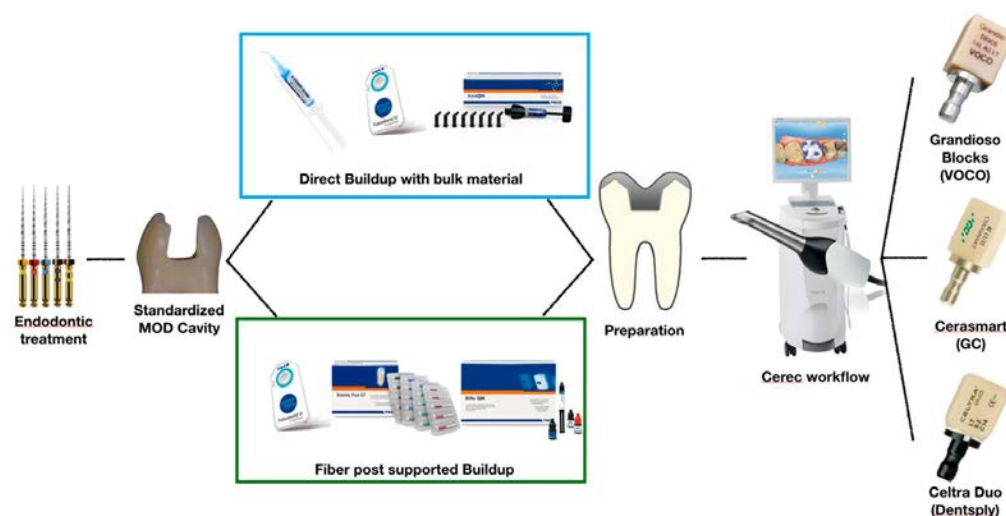
Figure 1. Specimen preparation workflow.

A summary of the specimen preparation protocol is presented in Figure 1.

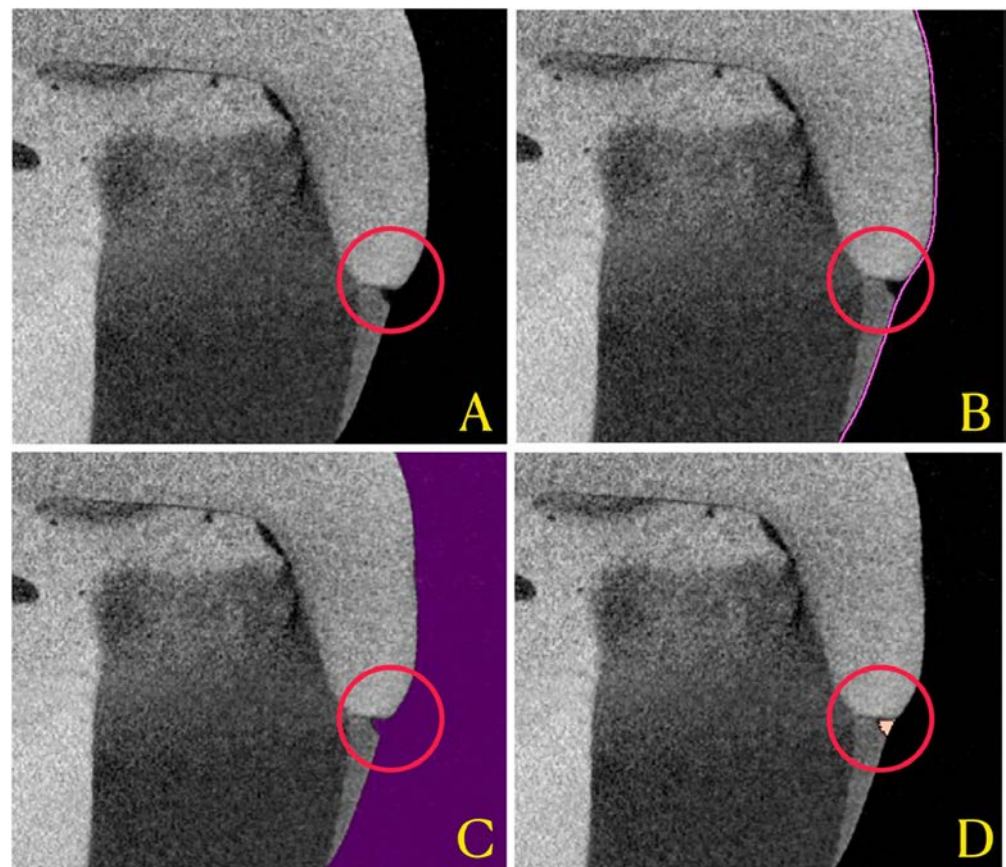
Figure 2. Applied workflow for 3D interfacial gap analysis. (A) represents the obtained micro-CT reconstructed image, imported in the segmentation software (Mimics 23, Materialise, Belgium). (B) shows the region of interest (ROI) defined by the software for gap analysis (pink line). (C) shows the void thresholding performed (violet mask) that defines “void” concept through all samples. (D) shows the intersection between the ROI and the void mask, ultimately representing interfacial gap (orange mask).

To reveal marginal gap progression between the indirect restoration and the tooth after cyclic loading, a tridimensional method of analysis was used. Through a dedicated software (Mimics Medical, ver. 23.0; Materialise, Belgium), thresholding of voids surrounding the restoration was performed automatically to include marginal voids only. Volumetric calculation of the resulting mask was performed by the software, and overall volume data of the residual marginal gap, expressed in mm³, were collected (Figure 2).

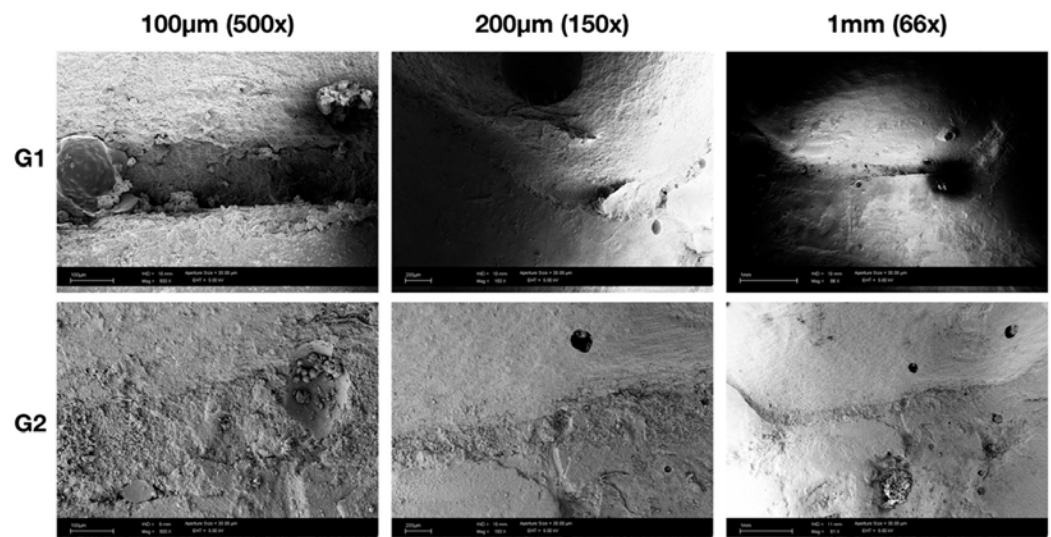
Figure 3. Representative SEM micrographs of the mesial surface from two random samples at different magnification. It's possible to notice that both present marginal degradation after cyclical intermittent loading, mainly at the corners of the box area.

SEM micrographs of adhesive margins showed marginal gaps after mechanical loading in all groups (Figure 3). Independently of the buildup, with or without fiber post, and the indirect restorative material tested, the typical localization of gaps was mainly located in mesial and distal areas of the interproximal box. It can also be noted that there is correspondence with the 3D reconstructions obtained from the renderings of the acquisitions via micro-CT (Figure 4), which, however, allowed for a quantitative and not only qualitative analysis of the marginal gap formation.

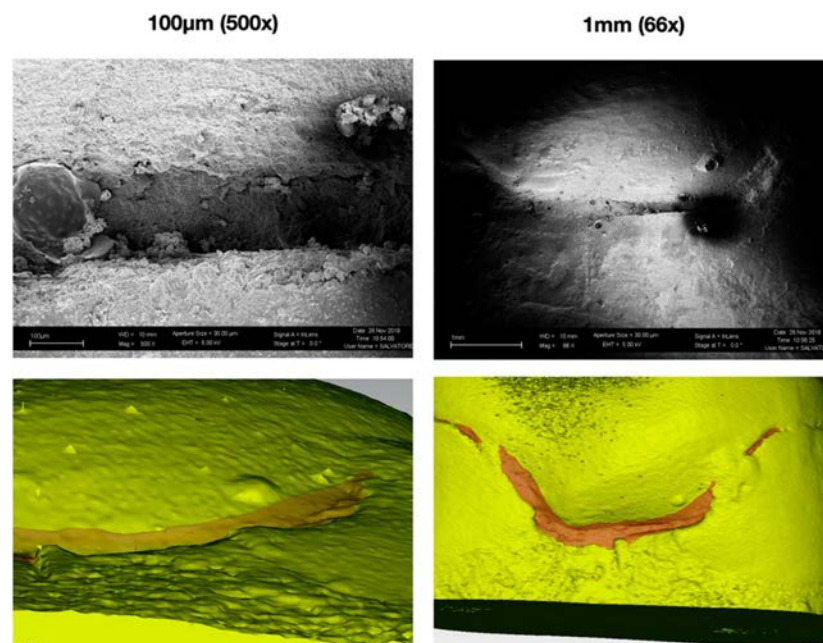
Figure 4. Previous sample from Figure 3 aside of micro-CT tridimensional gap analysis. For the present figure, images have been imported to an external software (Geomagic Qualify 12, 3D Systems, Rock Hills, SC, USA) and the analysis limited to the single box area for better visualization. Yellow volume represents the tooth-restoration complex, while the transparent red volume represents the marginal 3D gap that was calculated and analyzed.

SEM micrographs, above all at higher magnification, still offer a gold standard qualitative analysis of the external margins of adhesive restorations, as shown in Figure 4. Micro-CT, on the other hand, has the advantage of being a non-destructive method of analysis [45,46] that can offer not only a bi-dimensional, but also a tridimensional analysis of the sample before and after chewing simulation, therefore measuring gap progression in qualitative and quantitative ways. By contrast, SEM could be used to assess the presence of internal cracks even if sample sectioning is needed [47] and, when epoxy replicas are performed, only external margins can be inspected. Moreover, it must be noticed that micro-CT is also able to measure gap among the whole adhesive interface and not just external margins: Since forces also concentrate on internal edges, the study of internal gaps might be useful in the future. Analyzing gap localization through qualitative micrographs from SEM, it was also reported that margin opening seems to occur mostly in the interproximal boxes area. This can be considered in accordance with another study by Ausiello et al., which reported a high concentration of stresses in this area when applying forces on a finite element analysis (FEA) model [48].
