## STUCCO AND CLAY IN THE DECORATION OF THE MONUMENTAL BUILDINGS OF OLD NISA

*Carlo LIPPOLIS*

**Abstract** – Unlike the terracotta decoration and the clay sculpture, the stucco production in Old Nisa has been only marginally studied. This is mainly due to the scarcity of figured materials available. Anyhow, recent excavations<sup>1</sup> have unearthed some fragments of sculptures in stucco and clay, along with double-moulds in gypsum mortar that shed new light on techniques for the manufacturing of sculptures. The manufacturing process of a sculpture is similar for both materials, since the modelling of the figure occurs through the gradual application of layers of clay or stucco (or both) more and more fine and purified. Moreover, for the two materials, is attested both the simple hand modelling and the use of moulds.

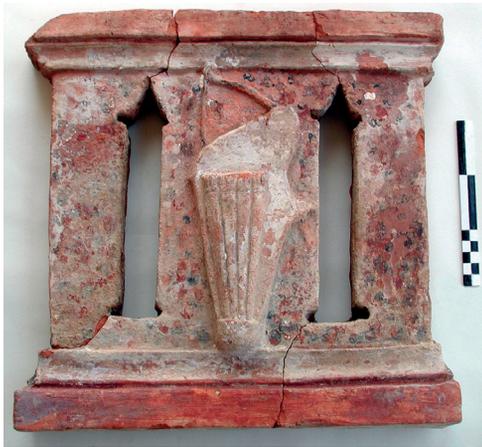
Figure 2. Old Nisa, metope in terracotta from the Red Building © Archive Centro Ricerche Archeologiche e scavi di Torino

The building material employed at Nisa was mainly clay.<sup>3</sup> In terracotta were made, for instance, the so-called metopes (not metopes in a Greek-sense but slabs with a central symbolic motif flanked by arrow/column-like slots: the quiver, the Heracles' club, the lion's head, the Seleucid anchor, the crescent, the circle/sun), decorative slabs with a central rosette or palmette, indented bricks, stepped merlons with an arrow slot, acanthus leaves or plaques with volutes for Corinthian and Ionic assembled capitals (fig. 2-3).

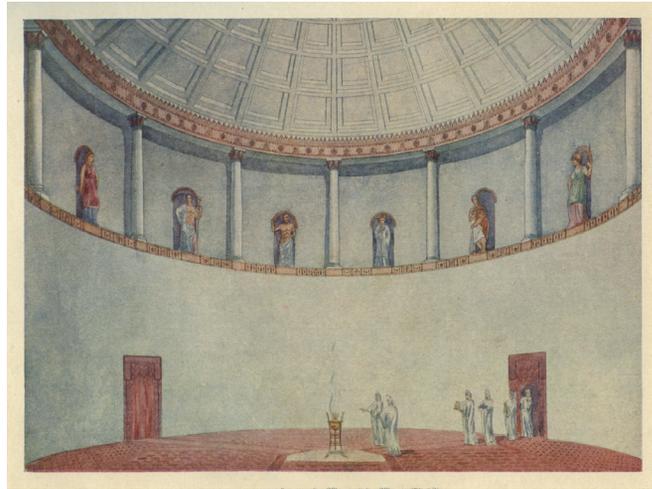
Figure 5. The Round Hall  
(after PUGAČENKOVA 1958, p. 104)

The beautiful reconstructions proposed by the Soviet archaeologists of the interior of the Square Hall and the Round Hall (fig. 4-5) still remain a good reference point, but they are not completely free from imperfections and uncertainties. For instance, the same display of decoration on the higher part of the walls of the Round Hall needs to be reconsidered today, to see if we agree with the new proposal of an elliptical dome with sloping walls starting from their own base.<sup>4</sup>

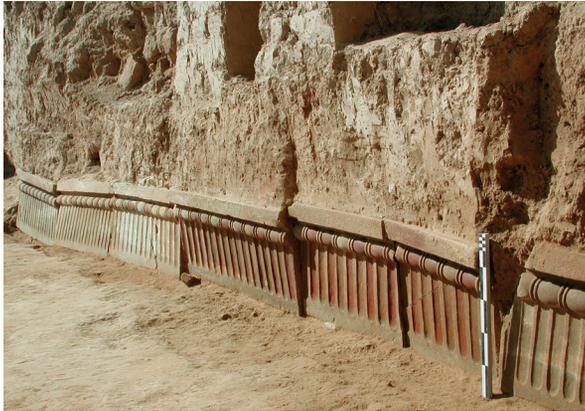
Figure 6. Red Building: stone dado-frieze  
© Archive Centro Ricerche Archeologiche e scavi di Torino

The use of stone is rare in the architectural decoration of Nisa. Indeed, the material is not readily available in the area. From the oldest Parthian levels and especially from the façade of the Red Building comes a stone frieze: the bead-and-reel (astragalos) motif is western in its origin (though not unknown to the Achaemenid tradition)<sup>6</sup> but here it is re-interpreted and displayed not on the top of the wall but in its lower portion, like a *dado*, with obvious functional purposes of protection (fig. 6).

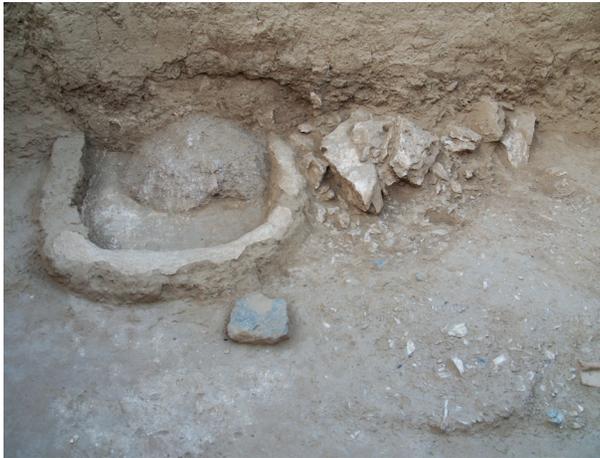
Figure 10. Old Nisa, South-Western Building: basin in room 44 © Archive Centro Ricerche Archeologiche e scavi di Torino

The production process of gypsum-based material may be recognized in some rooms of the recently excavated area (South-Western Area) at Old Nisa. Inside the so-called South-Western Building plastered basins were laying directly on the floor of room 44 (fig. 10). In the corner of two of these basins, two heaps of powdered “anhydrite” agglomerate were found. Immediately beside the basin, some raw blocks and crushed stones of this same mineral were lying on the floor of the room, clearly part of the two previous (i.e. intermediate) processing stages. It seems that here we have installations meant for the processing and production of mortar, plaster or stucco. Moreover, substantial traces of ashes and fire activities, clearly related to the same production process, were lying on the floors of rooms 45a and 45b, adjacent to room 44 where the agglomerates of anhydrite were found.<sup>15</sup>

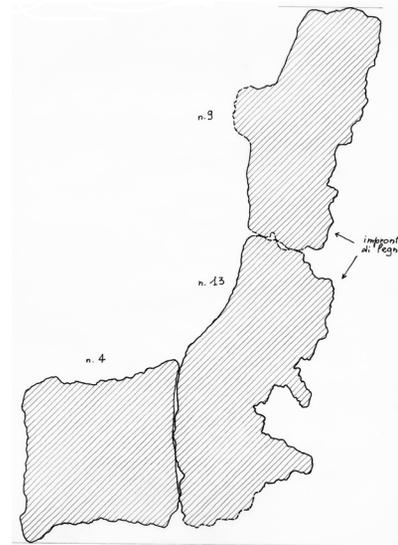
Figure 11. Gypsum fragments from the Round Hall © Archive Centro Ricerche Archeologiche e scavi di Torino

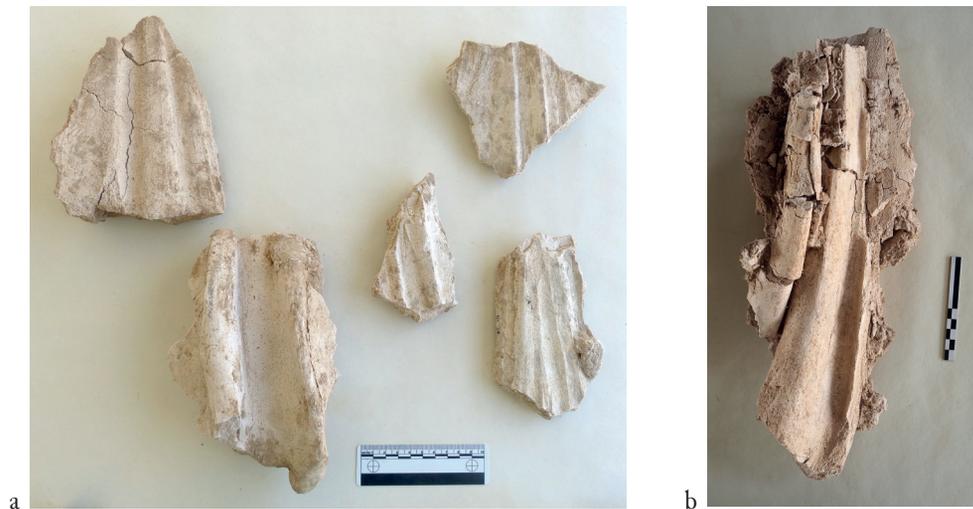
Figure 12. South-Western Building: gypsum-stucco fragments of statues from the pit  
 © Archive Centro Ricerche Archeologiche e scavi di Torino

This finest “plaster” coating is also visible on some fragments of stucco found in a large pit inside the South-Western Building, filled in a late stage with earth, pottery and architectural elements no longer in use (fig. 12). All the stucco fragments depict drapery of garments, and closely resemble similar fragments of clay statues discovered in the Round Hall.<sup>17</sup>

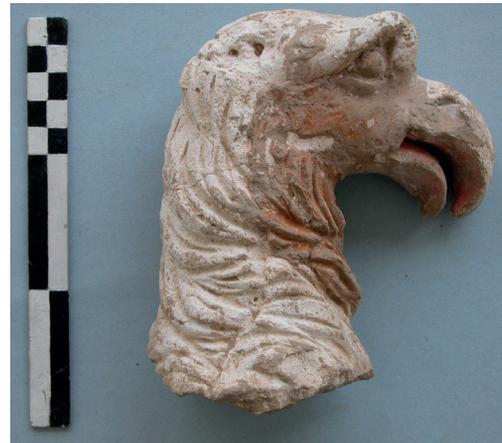
Figure 14. Red Building, southern façade: stucco eagle's head © Archive Centro Ricerche Archeologiche e scavi di Torino

That these two techniques, in clay and in stucco, were closely related is also evident in one final example. From the Red Building's southern façade come a few fragments of a stucco sculpture depicting an eagle (fig. 14). It seems likely that this sculpture, which was life size, belonged to a frieze originally displayed on the walls of the main tetrastyle hall of the building. This is not the place to discuss the symbolism of the eagle among the Parthians, but it is clear that the presence of this iconography on the walls of one of the main buildings of Nisa's ceremonial complex is closely linked to the idea and propaganda of the Arsacid kings. The figure, especially its head and neck, shows a rich and plastic treatment—we can say almost

In the Nisean eagle the colour was not directly applied on the stucco surface, but on a very thin (ca. 2 mm) layer of clay covering it. The application of a thin layer of purified clay on the stucco surface is a further confirmation of how the two production techniques, for stucco and clay sculptures, were similar, the final colouring providing uniformity to the whole and making imperceptible the difference between the two materials.

The stucco eagle(s) of Nisa were not sculptured in the round and were cast by single moulds. The back of the head is hollow and traces of housings for the metal clamps that originally fixed this sculpture to the wall are still clearly recognizable.
