Lithobiotic recolonization following cleaning and preservative treatments on the rock engravings of Valle Camonica, Italy: A 54-months monitoring

Sergio E. Favero-Longo^{a,*}, Enrica Matteucci^{a,b}, Samuele Voyron^a, Paola Iacomussi^c, Maria Giuseppina Ruggiero^d

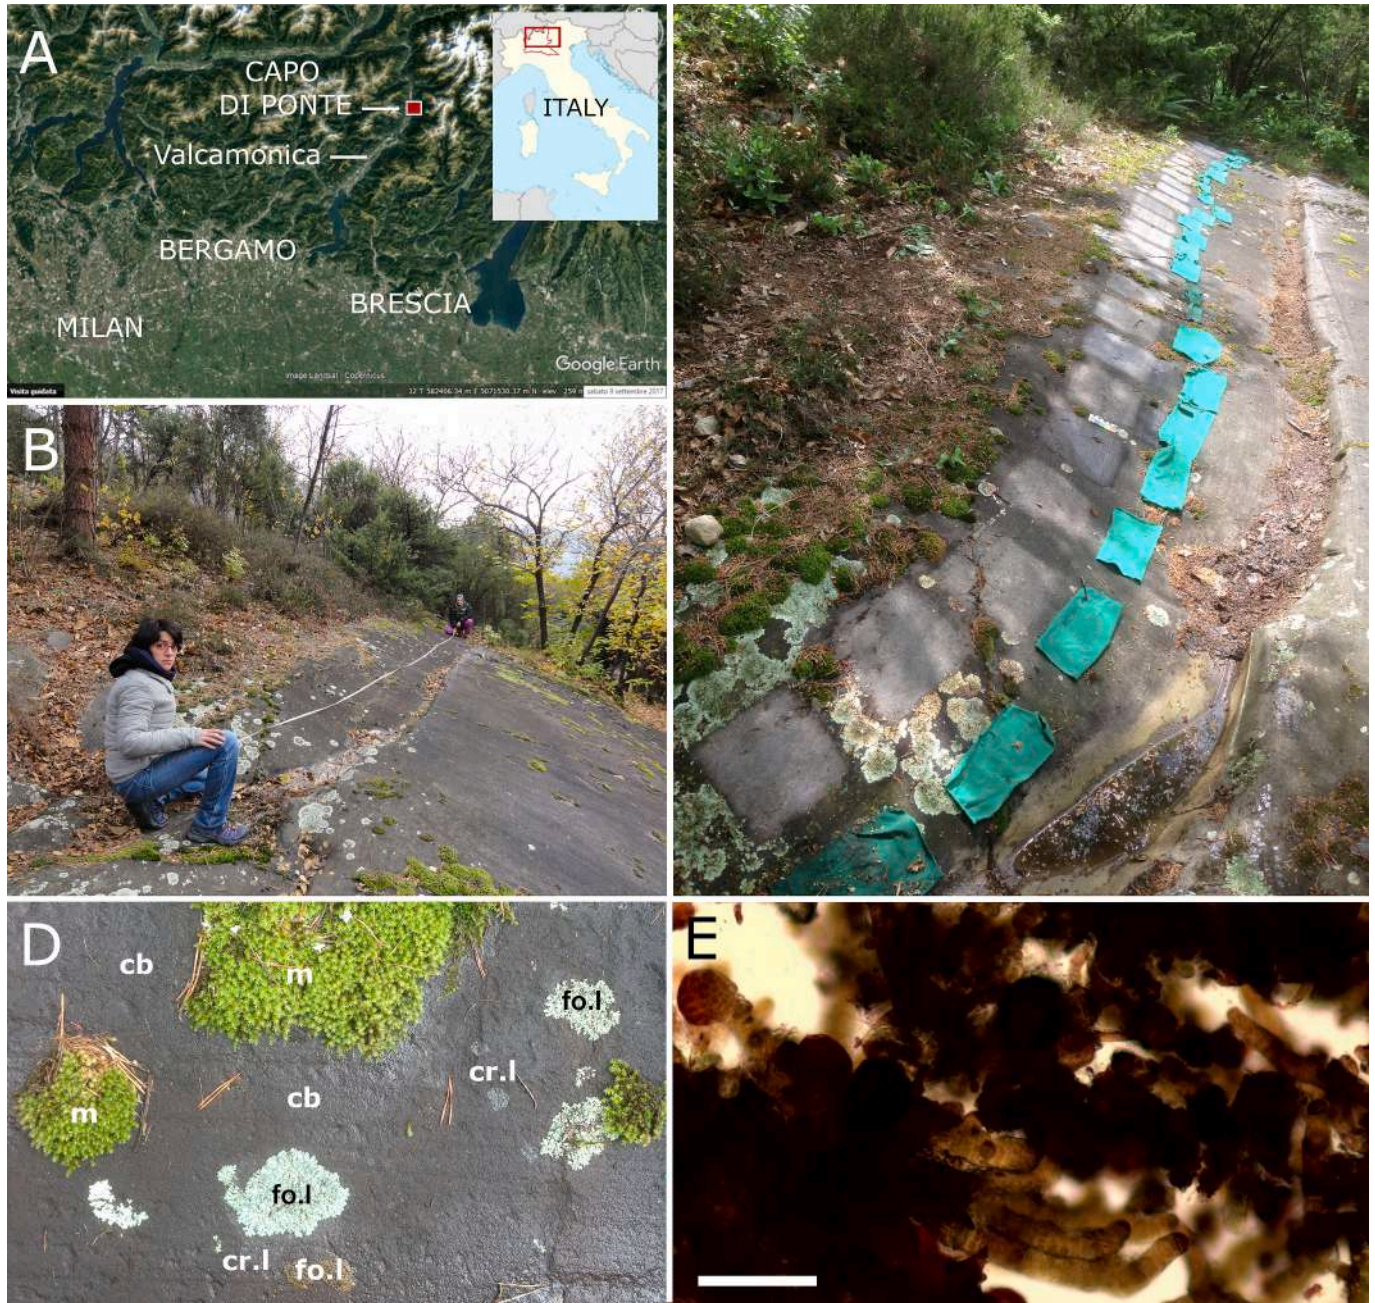
Fig. 1. Study site and monitored rock-art surfaces. (A) Localization of the Rock Engravings National Park of Naquane (red dot) in Capo di Ponte (Valle Camonica, Italy). (B–C) Rock 30 before (B) and immediately after (C) the cleaning of 27 parcels, oriented from north (z3, in the foreground) to south (z1, in the background). (D) Lithobiontic community on the rock surface (representative image from a parcel before its cleaning), including a cyanobacteria-dominated biofilm (cb; microscopic image in E, scale bar: 100 μ m), foliose (fo.l) and crustose (cr.l) lichens, and mosses (m).

Assays and monitoring activities were performed on Rock 30 (Fig. 1B), for which no cleaning interventions are documented since the start of their registration for the Park in early 1980s (www.irweb.it). In particular, experiments were conducted in the upper part of the outcrop (approx. 11.5 × 1.5 m), delimited by vegetated ground upwards and a 20 cm wide channel on the rock surface related to glacial erosion downwards.

striations, some engravings and an inclination of approx. 30°, 27 parcels approx. 25 × 25 cm were aligned, distanced by approx. 15–20 cm (Figs. 1C; 2A). The first set of nine parcels, in the southern side (z1), was more strictly surrounded by shrub vegetation and shaded by trees at the southern extreme, contributing a prolonged time of wetness after rain events with respect to the other zones; the second set, in the central zone (z2), was open and rather distanced from vegetation upwards; the third set, in the northern zone (z3), was covered by a *Pinus sylvestris* tree, but open to direct irradiation from the South (Fig. S1). The different surface wetness was not instrumentally monitored, but, as a reference term, it is worth noting that on measuring days in late March and mid-October which followed rainy nights, surfaces in z2 and z3 generally dried before the subsequent evening, while surfaces of z1 did not.

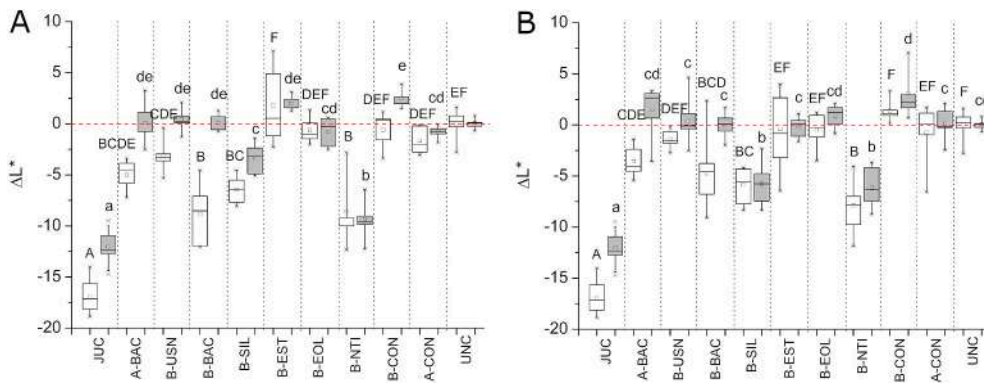
Fig. 5. Lightness (L^*) values of the parcels of z3 (white boxes) and z2 (grey boxes) after 37 (June 2021, A) and 49 (June 2022, B) months from the cleaning intervention, quantified in areas free of mosses (and debris) and expressed as difference from L^* values of related uncleaned and unprotected areas. JUC, freshly cleaned parcels; other treatment codes are detailed in the main text. For each zone, box plots not sharing at least one letter are statistically different (z3, capital letters; z2, lowercase letters; ANOVA with post-hoc Tukey's test; $P < 0.05$).

On the basis of colorimetric measurements after 37 and 49 months, the application of nanocrystalline TiO_2 (B-NTI) and, subordinately, the polysiloxane-based water repellent (B-SIL) determined the best results in limiting the re-darkening of the sandstone surfaces. Lower plant cover on NTI parcels in both z3 and z2 likely contributed to activate the photoinhibitory effect of the product (Fonseca et al., 2010), not observed in the more shaded z1 parcel. The lowest F_0 values quantified after 41 months indicated that the chromatic divergence from the other parcels was not (only) due to the white color of the applied product. It is worth to remark that, although the product gave positive results in preventing recolonization, its application implied the addition of a mineral exogenous component which cannot be removed from the stone surface and thus determined a permanent modification, likely undesirable. On the other hand, although in this work a white nanocrystalline anatase was used, some other photoinhibitory nanoprecipitates were shown to not significantly affect the color of the treated surfaces (Goffredo et al., 2017). Application of water repellents, including polysiloxanes, already showed the capacity of delaying for several years the recolonization of treated surfaces, their influence resulting more important than that of biocides used in preliminary devitalization treatments, which are rinsed (Salvadori and Charola, 2011). A durable protective effect was particularly observed for water repellents
