PLYBIOTEST

Biological performance testing methodology to evaluate the durability of plywood as an indicator for exterior construction purposes

**REPORT for the period
01/01/2003 – 31/12/2006
(finalized 10/11/2008)**

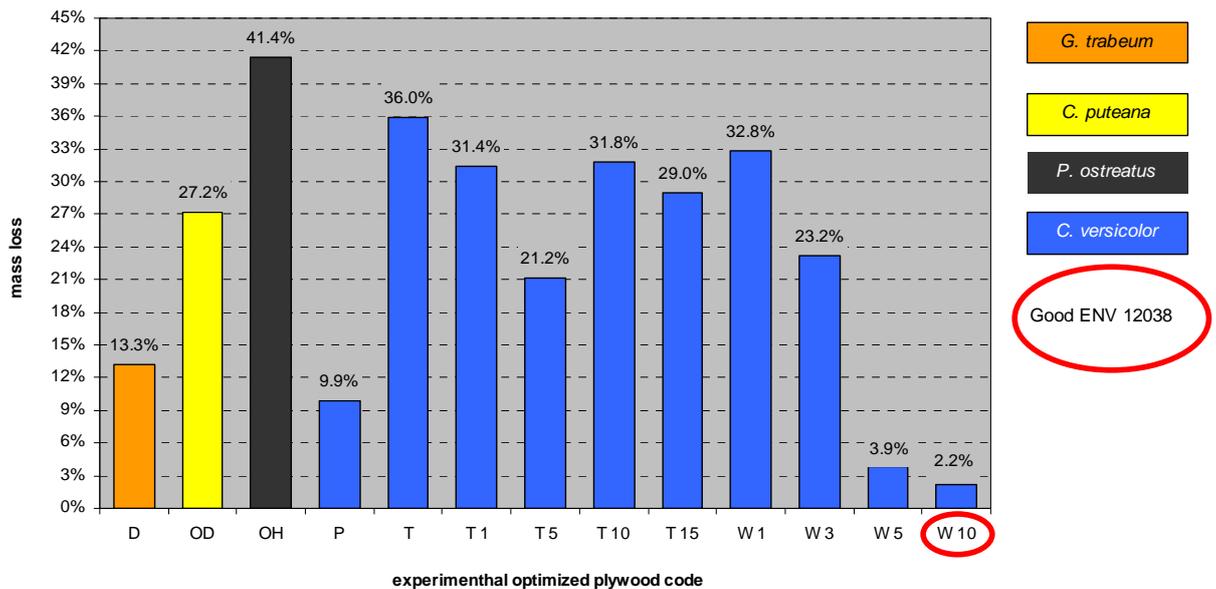
The following graph shows the mass loss averages recorded for each plywood type in respect to the critical fungus.

The results confirmed the vitro tests: only the panels with a Wolsit concentration above 5% were resistant to fungal decay.

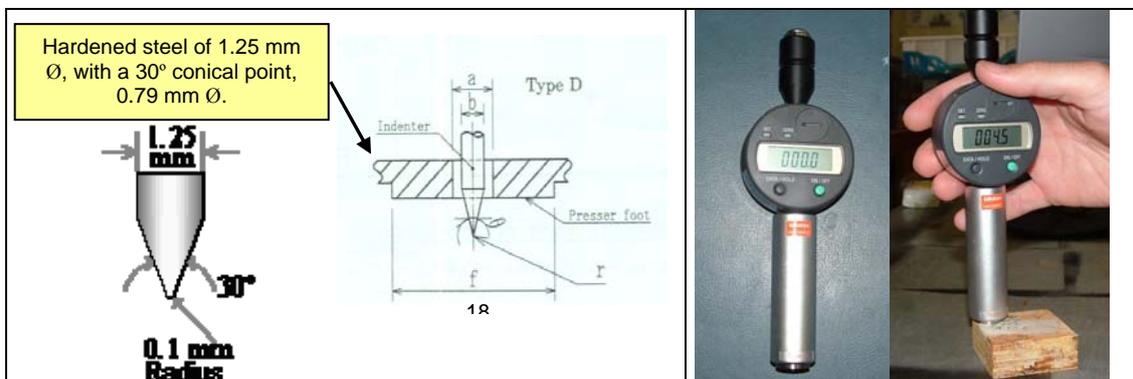
Figure: Shore D portable device.

The results obtained during some preliminary tests have confirmed that especially shore D (for its better precision) is a reliable comparative for determining the surface hardness of plywood of the same type and structure (species/composition etc.). In this context it gives accurate results, with a good repeatability, homogeneous values and low standard deviations. Consequently, five different measurements for each sample were done on the reference plywood with shore D portable device. The measurements were made before and after exposure to the ENV 12038 test in correspondence of the four corners and the centre of each specimen.

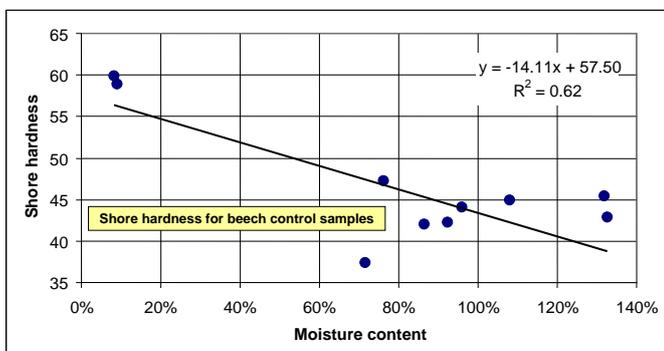
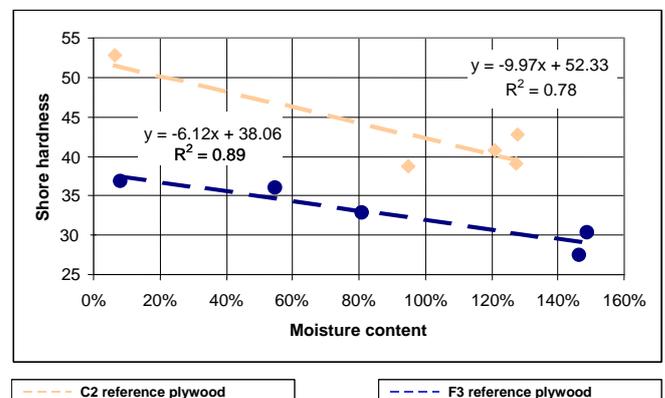
As expected, in the beech sound solid wood samples the shore hardness decreases with the increasing of MC and the same trend was registered for the reference sound plywood samples (see figures below). The results anyway show that generally it does not exist always a high correlation between shore hardness and MC since in some cases (for P3 and S4/S5 we found $r^2 < 0.5$).

For this reason, we stated that shore hardness test values and its relationship with MC may be quite accurate only for homogeneous groups of plywood (same specie and structure).

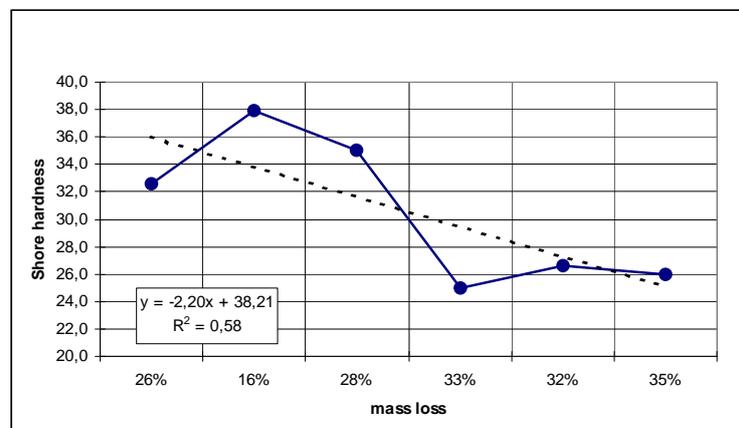
- generally, the analysis of the experimental results highlights that also between shore hardness and mass loss it does exist an high correlation because quite often the shore hardness shows irregular trend with the increasing of fungi attack;
- in some cases (C2 reference plywood) the above correlation gave us an $r^2 < 0.58$;
- considering the different types of samples the results show a different trend in the decreasing of the shore hardness for the same level of mass loss which seems difficult to be explained only for the influence of the different wood density and moisture content of plywood (after ENV 12038 test for Coriolus versicolor F2 samples show an average mass loss of 4.2% against an average decrease of shore hardness of 39%, while C2 samples show an average mass loss of 26% versus an average shore hardness variation of 52%).

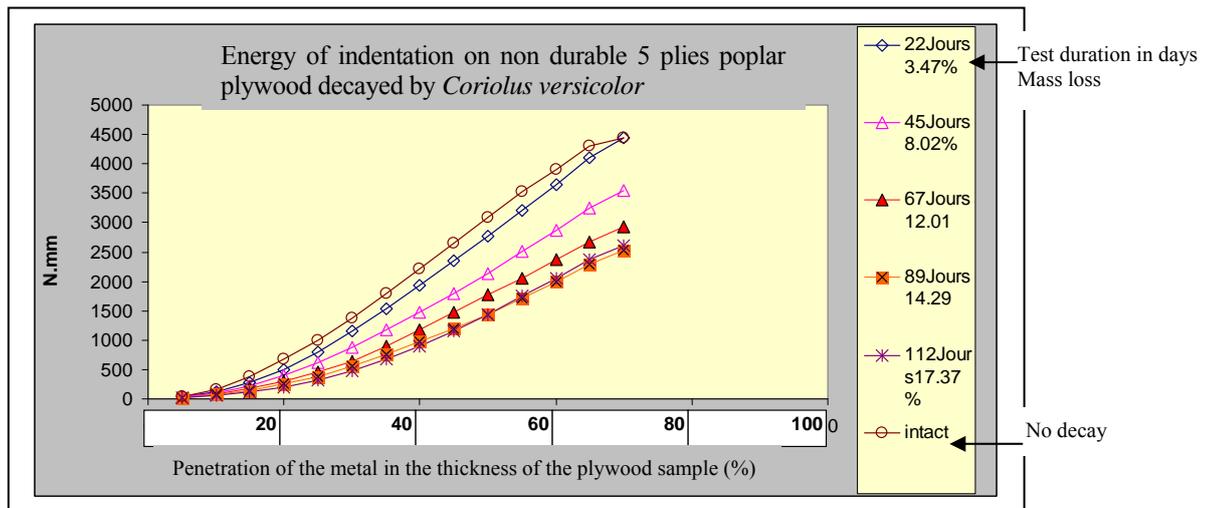
Figure 1. Energy of indentation obtained on poplar plywood decayed by *Coriolus versicolor*.

In order to evaluate the potential use of indentation tests to qualify plywood after biological degradation, biological tests were carried out on non durable plywood (5 plies, made of non durable timber, only one timber used per plywood). The biological tests were done according to ENV12038, using *Coriolus versicolor* or *Coniophora puteana*, and the test was stopped at 22, 45, 67, 90 and 112 days (112 days being the total duration of the test). Mass loss was determined and samples were conditioned at 20°C, 65% RH prior to the indentation tests. Mechanical tests were performed only with the samples degraded by *Coriolus versicolor*. *Coniophora puteana* caused too important decay to allow the re-use of the samples. From Figure 1, it can be seen that the energy of indentation can be correlated with the mass loss of the sample. Moreover, the curves obtained can explain the behaviour of the plywood.

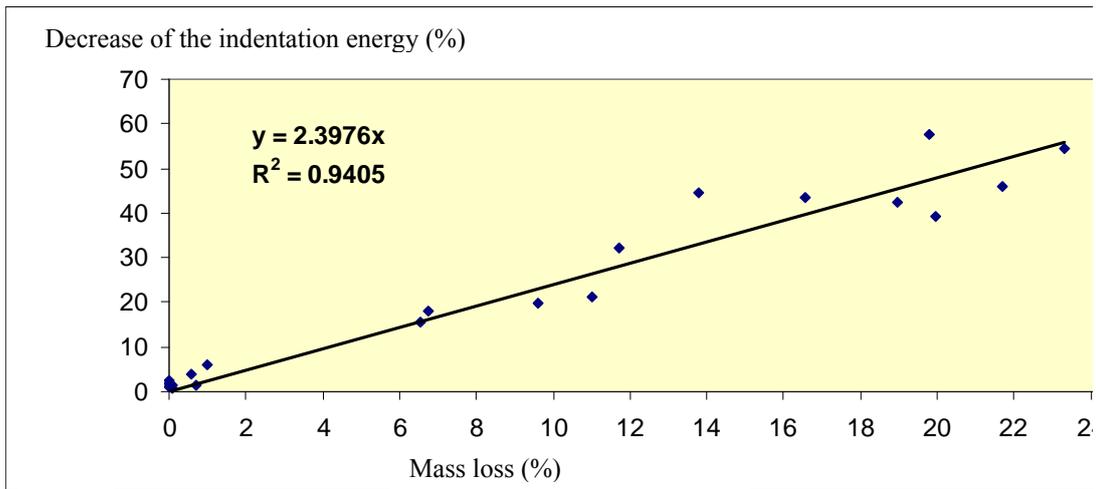
Figure 2. Relation between the decrease of the indentation energy and the mass loss due to fungal decay (20 plywoods tested, 12 samples for each plywood).

In the same manner, indentation tests have been done after fungal exposure to *Coriolus versicolor* (for 16 weeks according to ENV 12038) on experimental plywood. For each case, the mass loss was correlated to the decrease of indentation energy (decrease between non-decayed samples and samples exposed to fungal attack). Figure 2 shows the results obtained for the “pure” durable and non-durable plywood (plywood made of one timber only). These results indicate that this linear correlation is very good, and this for low weight loss as well as for high decay; contrary to ultrasonic measurements, for which decay above 16% could not be linked to a decrease of ultrasonic velocity. Figure 3 shows the same relation established for all the experimental plywood, including the plywood with durable top-veneers. On average, the proportionality between the mass loss and the decrease of indentation energy is 2.5. This indicates that the indentation is a more sensitive test, and that it could be useful to detect the early stages of decay.

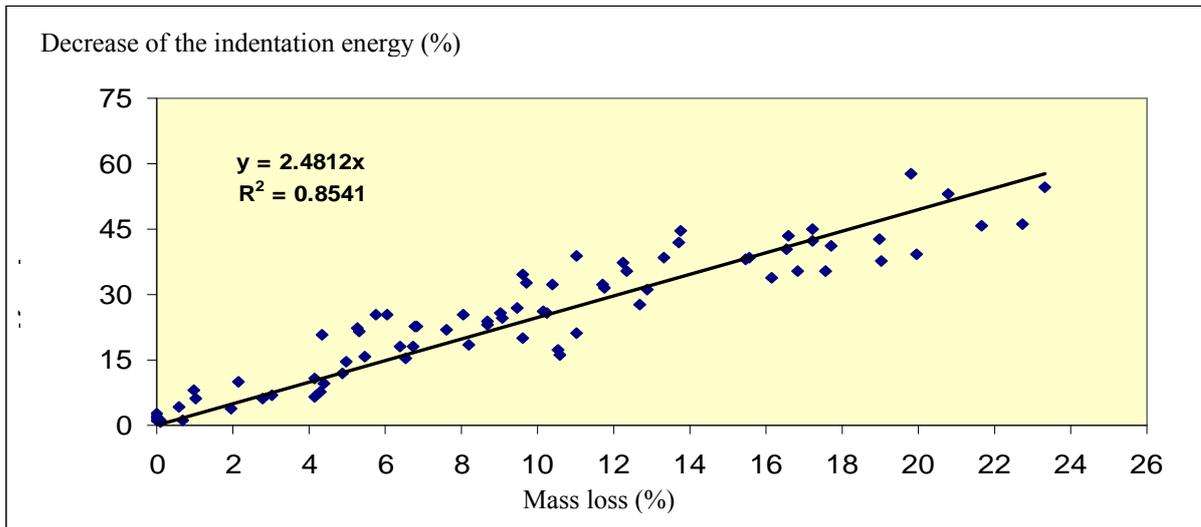
Figure 3. Relation between the decrease of the indentation energy and the mass loss due to fungal decay (96 plywoods tested, 12 samples for each plywood).

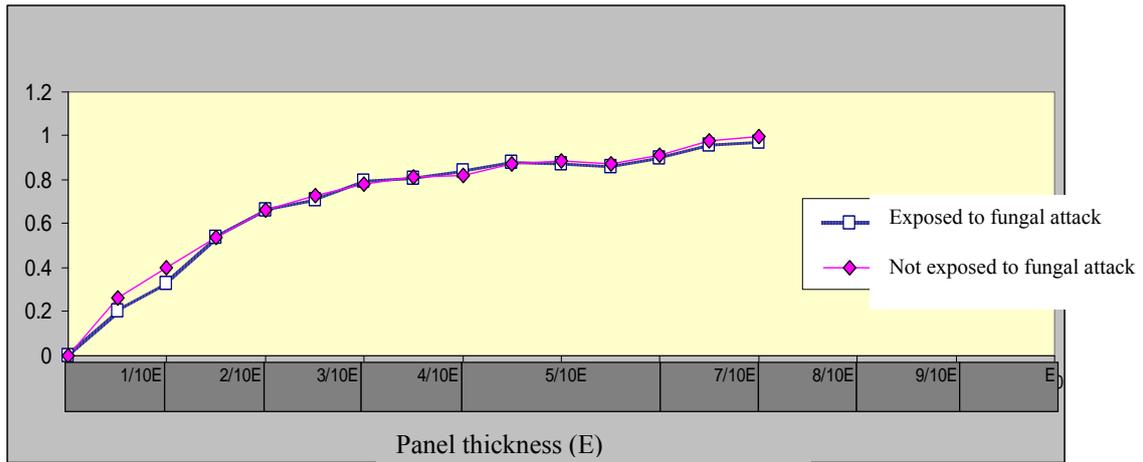
Figure 4. Indentation force for “pure” durable plywoods, made of chestnut, cedar or cypress heartwood.

Figures 4 and 5 show the results for the “pure” durable and non-durable plywood, and as a comparison, figures 6 and 8 show the results for the plywood with durable exterior plies only (for 1 or 2 durable plies). Two models of plywood are discussed. For the model 1 (figure 6), the average mass loss between all plywood tested was 10% towards *Coriolus versicolor*. The beginning of the curves is the same for the non-exposed and decayed samples, until about 1/4th of the 1st ply width (0.65 mm). It is the elasticity of this ply that explains the slope at the beginning of the test. It has not been modified by the fungal action (as this ply is durable). Once the 1st ply has been pierced, the increasing of the force due to the metal piece rubbing is quite similar for the degraded samples or not. Figure 7 presents the probable displacement of the 1st durable ply, this 1st ply being not supported anymore by the decayed inner plies.

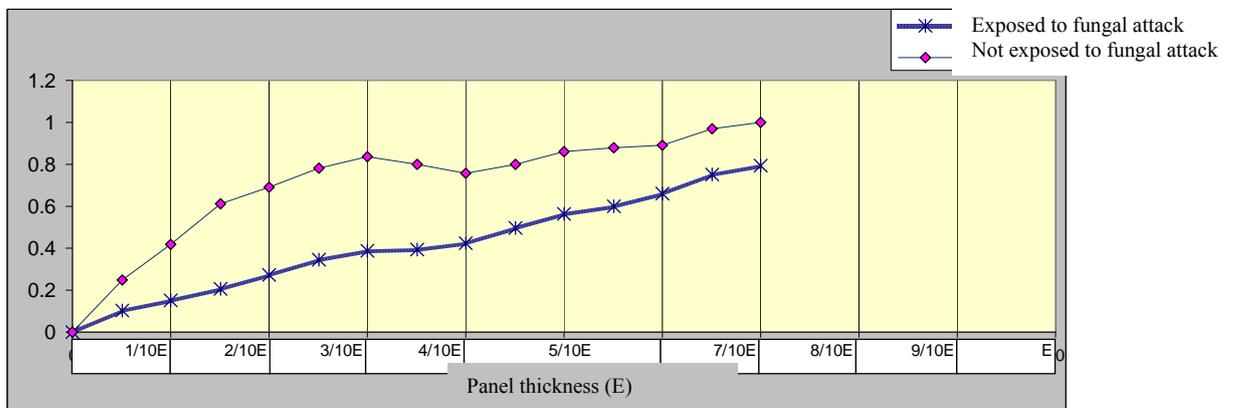
Figure 5. Indentation force for “pure” non durable plywoods, made of poplar or beech.

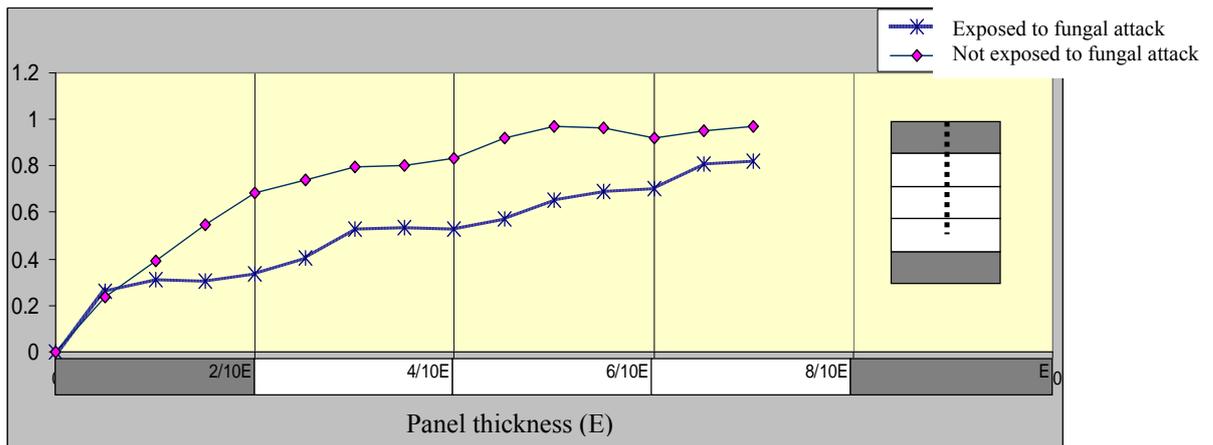
Figure 6. Indentation force for 5 plies plywoods, made of durable top veneers (Model 1)

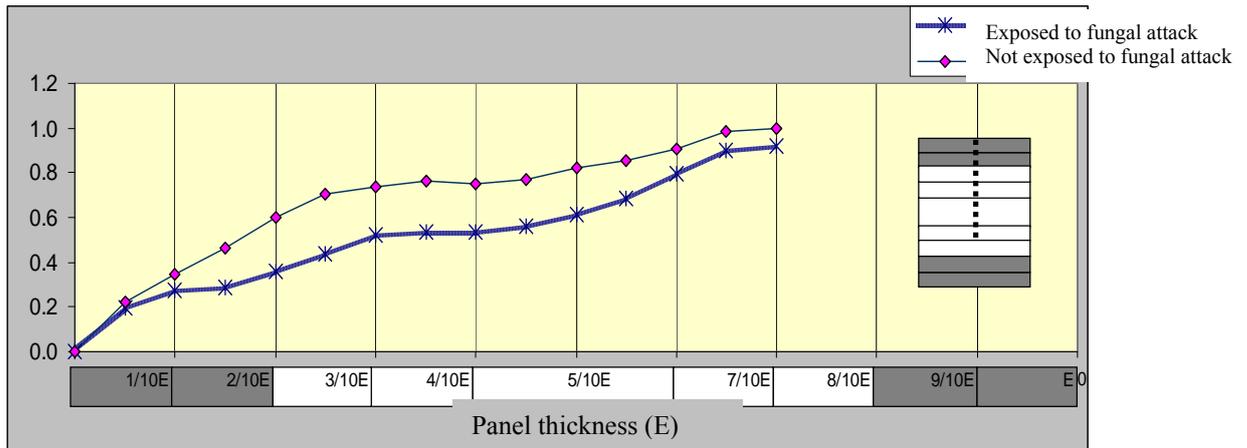
Figure 8. Indentation force for 9 plies plywoods, made of durable top veneers (2 exterior plies on each face) (Model 2)

For the model 2 (figure 8), the average mass loss between all plywood tested was 8.6% against *Coriolus versicolor*. The curves obtained are very similar to those found for the model 1. The difference between the models is the number of plies, and the number of glue lines, thus increasing the resistance towards the fungus.

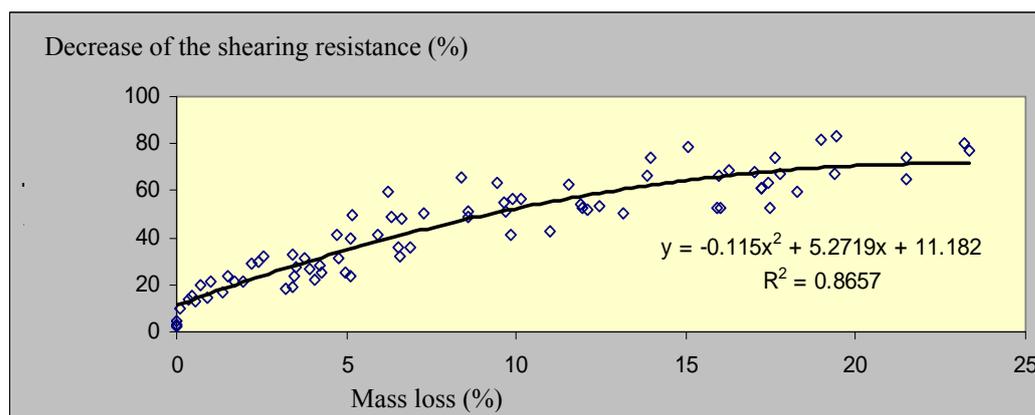
The mass loss of the plywood is well correlated to the decrease of shearing resistance. On average, this mechanical test is 3.5 times more sensitive than the mass loss measurement. The shearing test is the most pertinent test (used in this study) to evaluate the loss of mechanical integrity of the plywood samples.

Figure 9. Relation between the decrease of the shearing resistance and the mass loss due to fungal decay (96 plywoods tested, 12 samples for each plywood).

As the indentation test is extremely little destructive, shearing test was performed afterwards on the same samples. Initial shearing resistance was determined from spare samples of each plywood type. The relation between the decrease of shearing resistance (before and after fungal attack) and mass loss, obtained for all experimental plywood types, is presented in Figure 9.

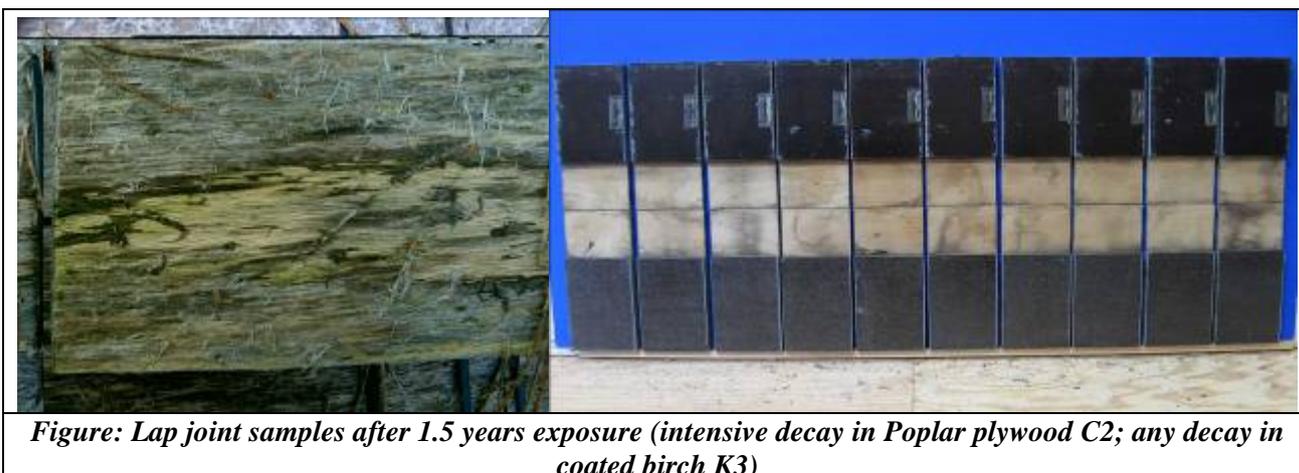
In the *Lap joint set up* several panel types were affected by starting decay (see table below). Two Poplar panel types (C2 and P3) showed intensive decay, while coated

Birch (K3) was not decayed. Regarding the timbers testes, decay started in all species except Maritime Pine (Maritime Pine was not exposed in the Double Layer Set up).

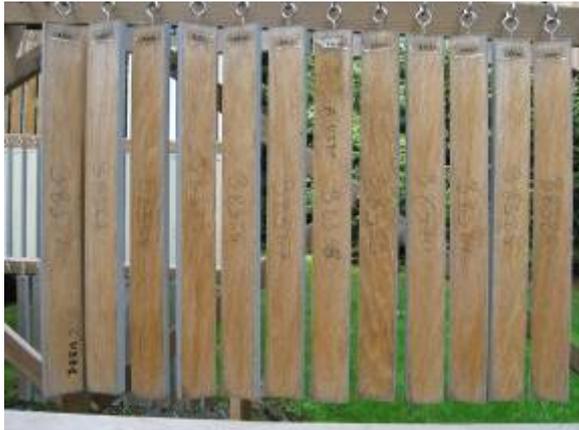
Figure: Oak plywood P 9

Regarding Single hanging with edge sealing no decay occurred at all. Focussing on discolouring, coated panels were in very good condition (P9 , R5 see figures below) and selected non-coated panels showed low staining while all others were discoloured heavily (Rating: 3 acc. to ENV 12037)

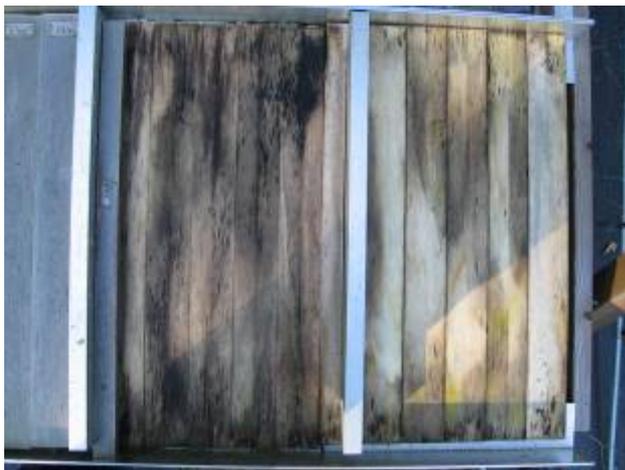
Figure: P6, Double layer set-up without edge sealing (opened): First decay in Poplar uncoated P6, Tannin glued left: lower side right: upper side

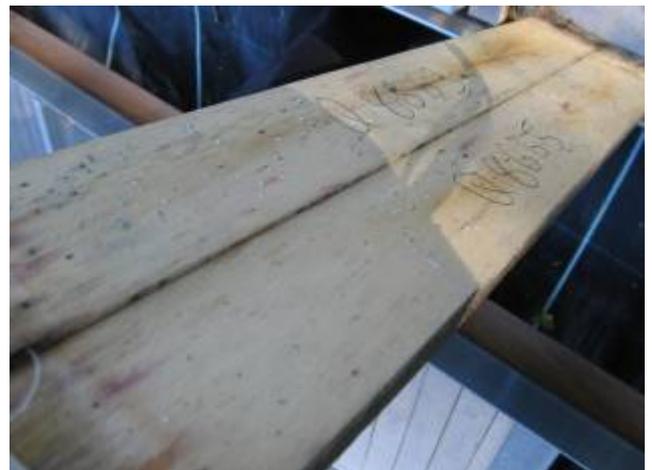
Figure: P12 , Poplar uncoated, MUF, P12: Moulds inside of double layer

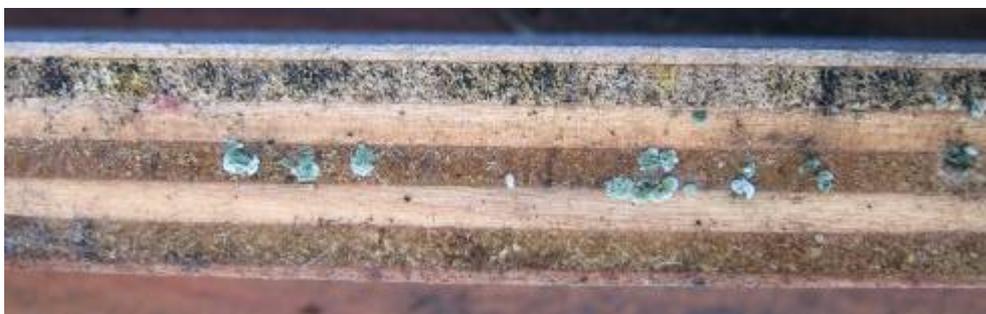
Figure: Beech/Poplar, C4 Mycelium on edges

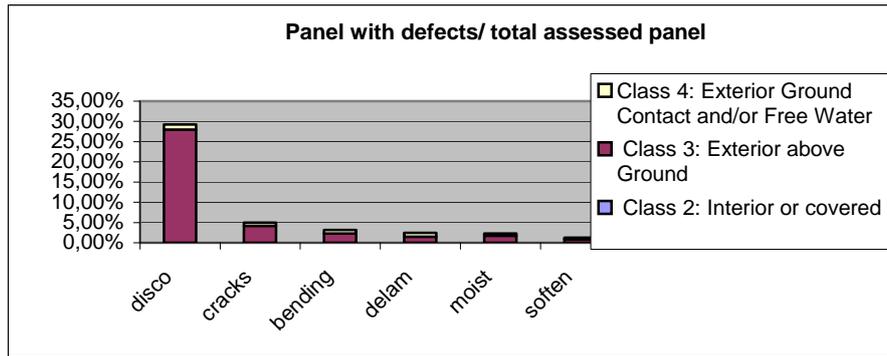
Figure 1 Panels with defects / total assessed panels by type of defects

- Rot has been detected in only 1,2 % of the 1700 assessed plywood panels
- These results occurred in:
 - 5 types of plywood
 - Major in hazard class3 situations (80%)
 - In continental and oceanic climates
 - From 0 to 30 years old

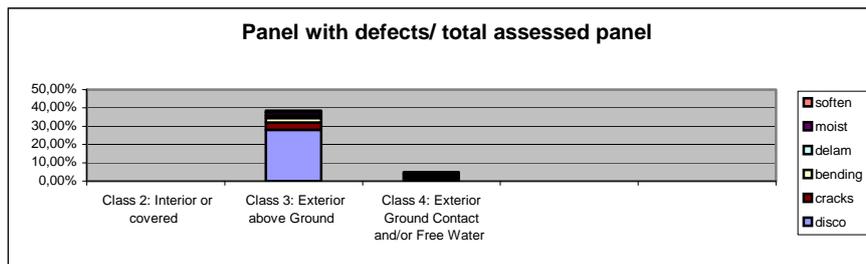
Figure 2 Panels with defects / total assessed panels by Hazard Class 2, 3 and 4
